519.

Visa International Mini Jets ride – modification to lower levelling bars

Regarding failure on Mini Jet Ride

Instant modification on lower leveling bar of mini jet rides.

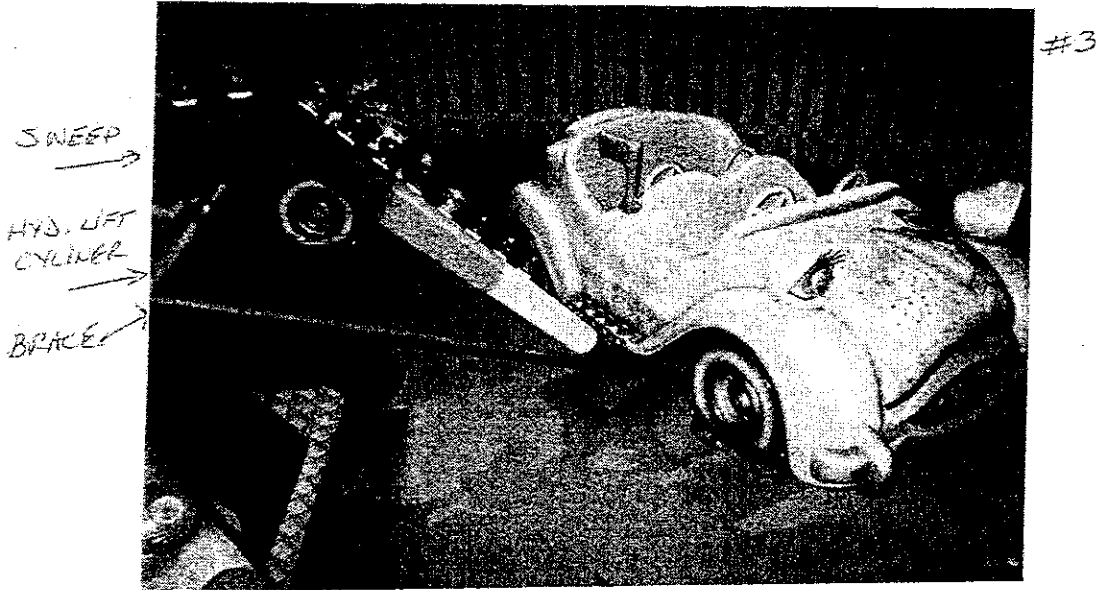
#1. This photo taken by Inspection Specialist Guay on 11/12/02 shows the ride configuration for one tub. The tube marked "Brace" goes from the center hub of the ride to underneath the tub. The "Brace" keeps the tub level as it is hydraulically lifted up approximately two feet.

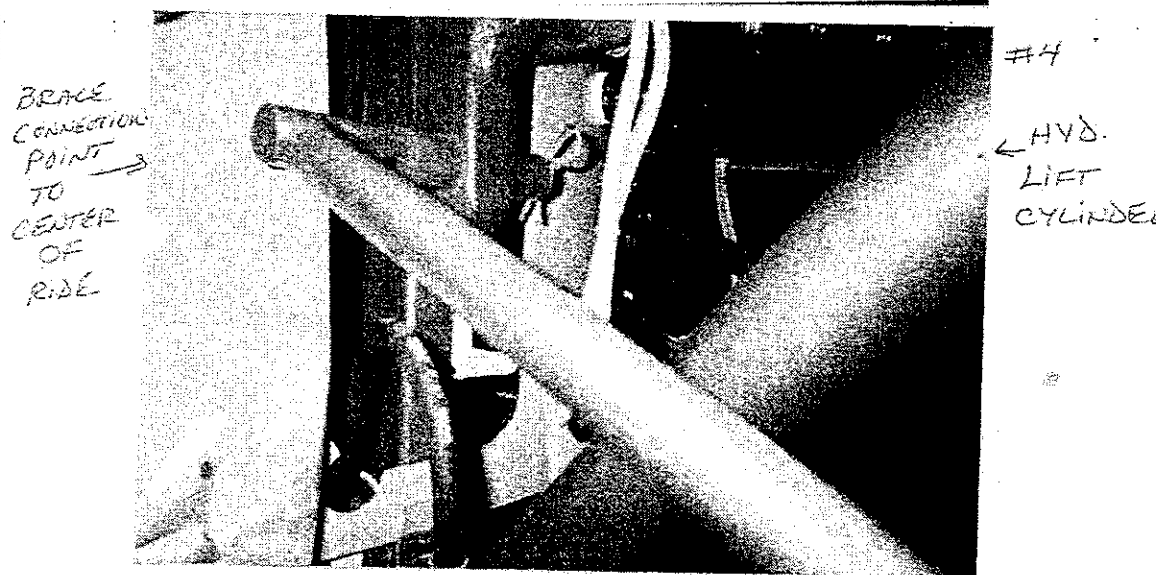
#2. This picture, also take by Inspection Specialist Guay on 11/12/02 shows where the "brace" attaches to the center of the ride above the hydraulic lift cylinder. There is no grease fitting on the brace or its' attachment point.

Dear Mike Reinhart, after reviewing you fax from Nov. 18.2002, an instant modification on the mini jet rides has to be to add 2 grease fittings on each of the upper support of the leveling bar (center hub connection). For this the leveling bars have to be dismantled two holes have to be drilled on each sweep (left and right side of tubing) and two grease fittings have to be added per support.

These grease points have to be greased every 40 operational hours.

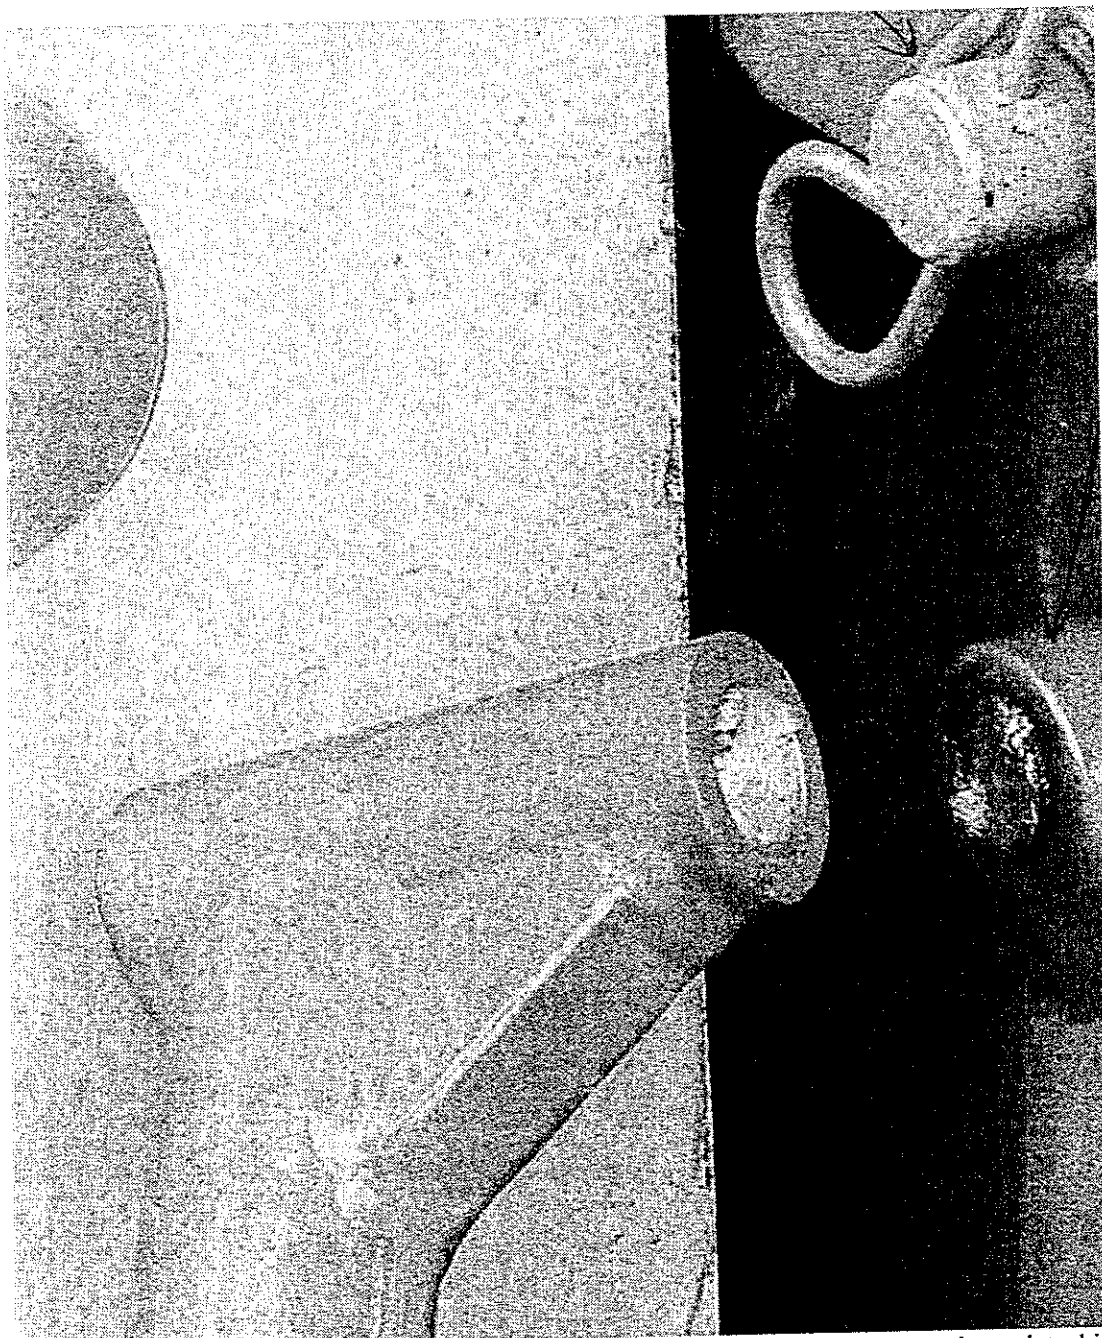
We feel that after this instant modification a seizing of the upper joint of those bars can be eliminated, and the ride can be operated safely.

#3. Digital photograph taken by "Sam's Fun City" employee showing the brace connection point which failed. Notice the pin is fused inside the sleeve on the right where it broke off of the brace.

Before installation of leveling bars, the bars have to be visually inspected for any deformation and the top pin (center hub side of the bar) has to be sanded, cleaned and greased.

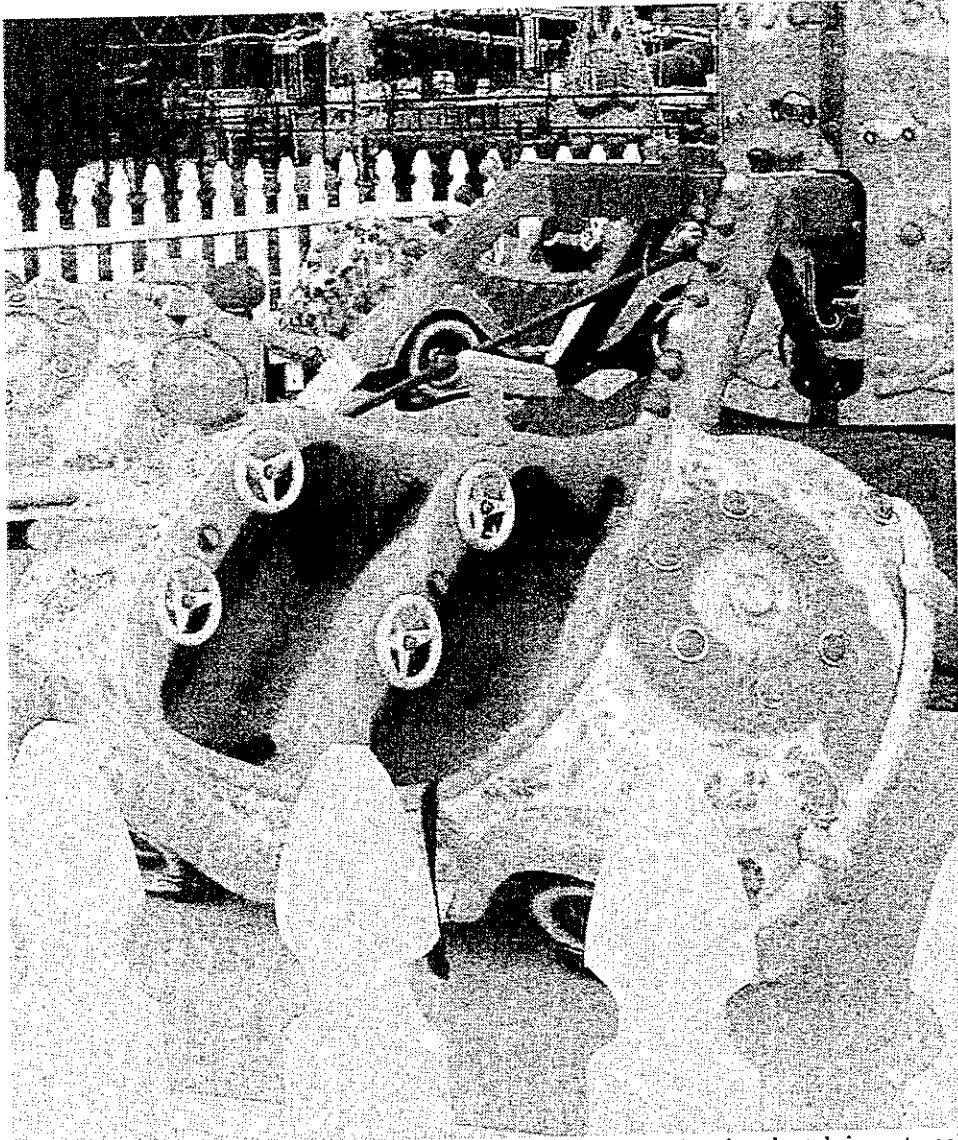
#4. Digital photograph taken by "Sam's Fun City" employee showing the tub in rest position after the brace failure. No children injured, only shaken up.
