**ADIPS Bulletin No. TB 001-24**

### **ADIPS Executive Summary : Jackson Waltzers – Cracking on Car Cast Pin Housing**

## **525 Jackson Waltzer Cracking**

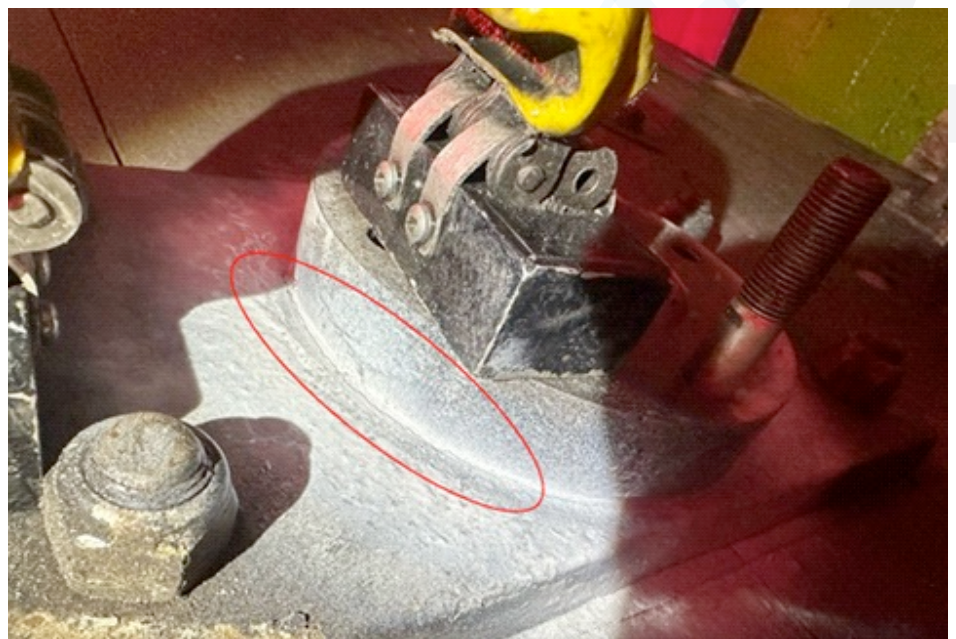
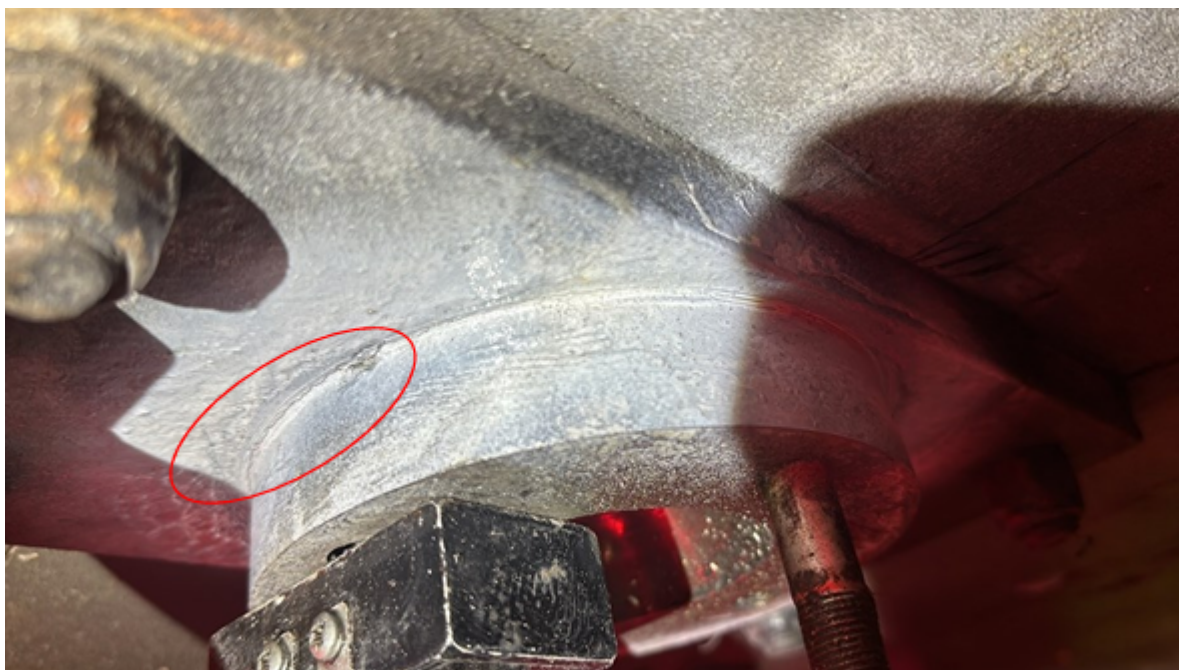
Propagation of cracks within the car cast pin housing as highlighted in this bulletin could result in the catastrophic failure of the assembly and possible ejection of the car and/or its passengers.

During the inspection, cracking was found on the car cast pin housing (see photographs below) and following discussions with several controllers it was confirmed that such defects have been discovered in this area on such rides on a number of previous occasions. There are different types of this housing and some do not rely on the casting for structural integrity, but in its original without modification, cracks in this component could contribute to a complete failure. In total, 5 of the 10 castings inspected contained cracks.

Regarding the defects found on the identical ride, as mentioned, this had NDT carried out again in this area and half the castings were cracked, indicating that other such devices may well have a problem.

Given the safety critical nature of this defect, controllers who operate these devices and IB's who undertake inspections of them are recommended to perform the following measures:

- Review the applicable NDT schedules to ensure these components are included.
- If the components are not included, update the NDT schedule accordingly. Industry good practice is to test these components annually.
- Ensure the correct NDT technique is used to test the components (if in doubt, consult PCN level 3 for clarification).
- Ensure any repairs made are completed by competent personnel in accordance with IB requirements.
- Ensure a copy of this Bulletin is retained with the ride documentation.
- Update ADIPS of any further failures found.
