Refurbishment Instruction for friction gear truss – Frisbee Assemblies 29.009-1 and 29.009.E-1 Relating refurbishment drawing: 29.009.S-2

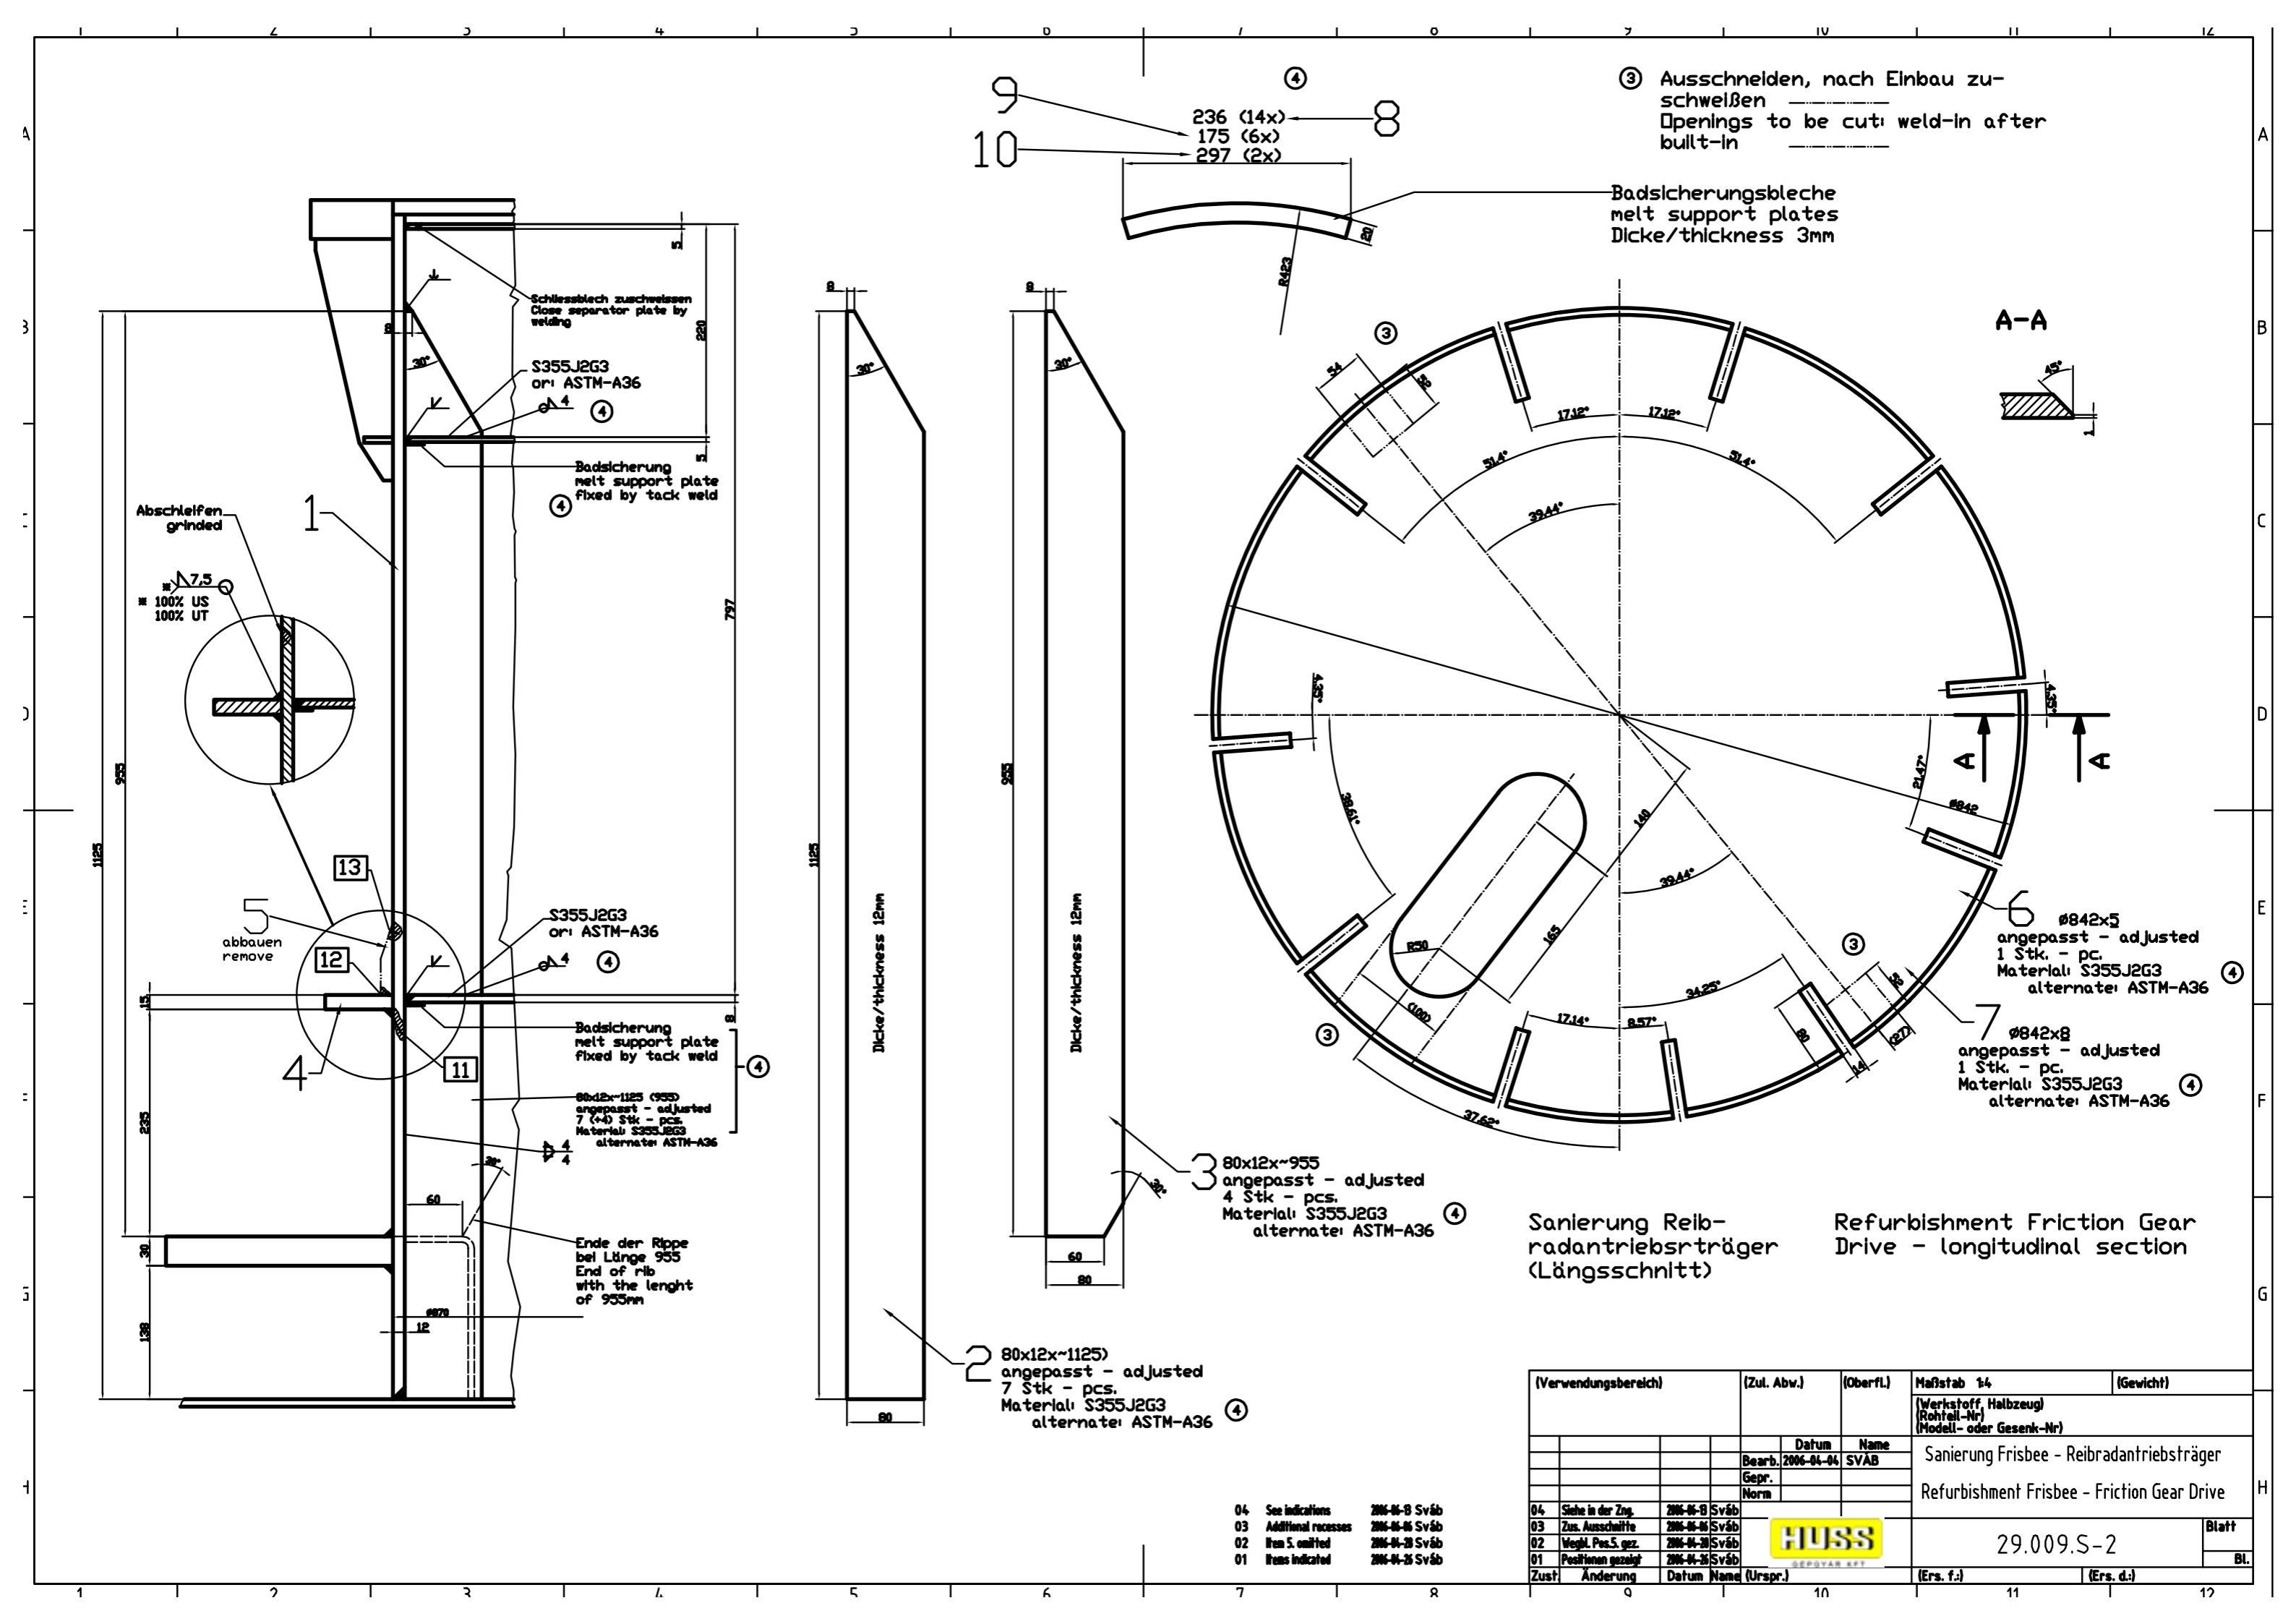
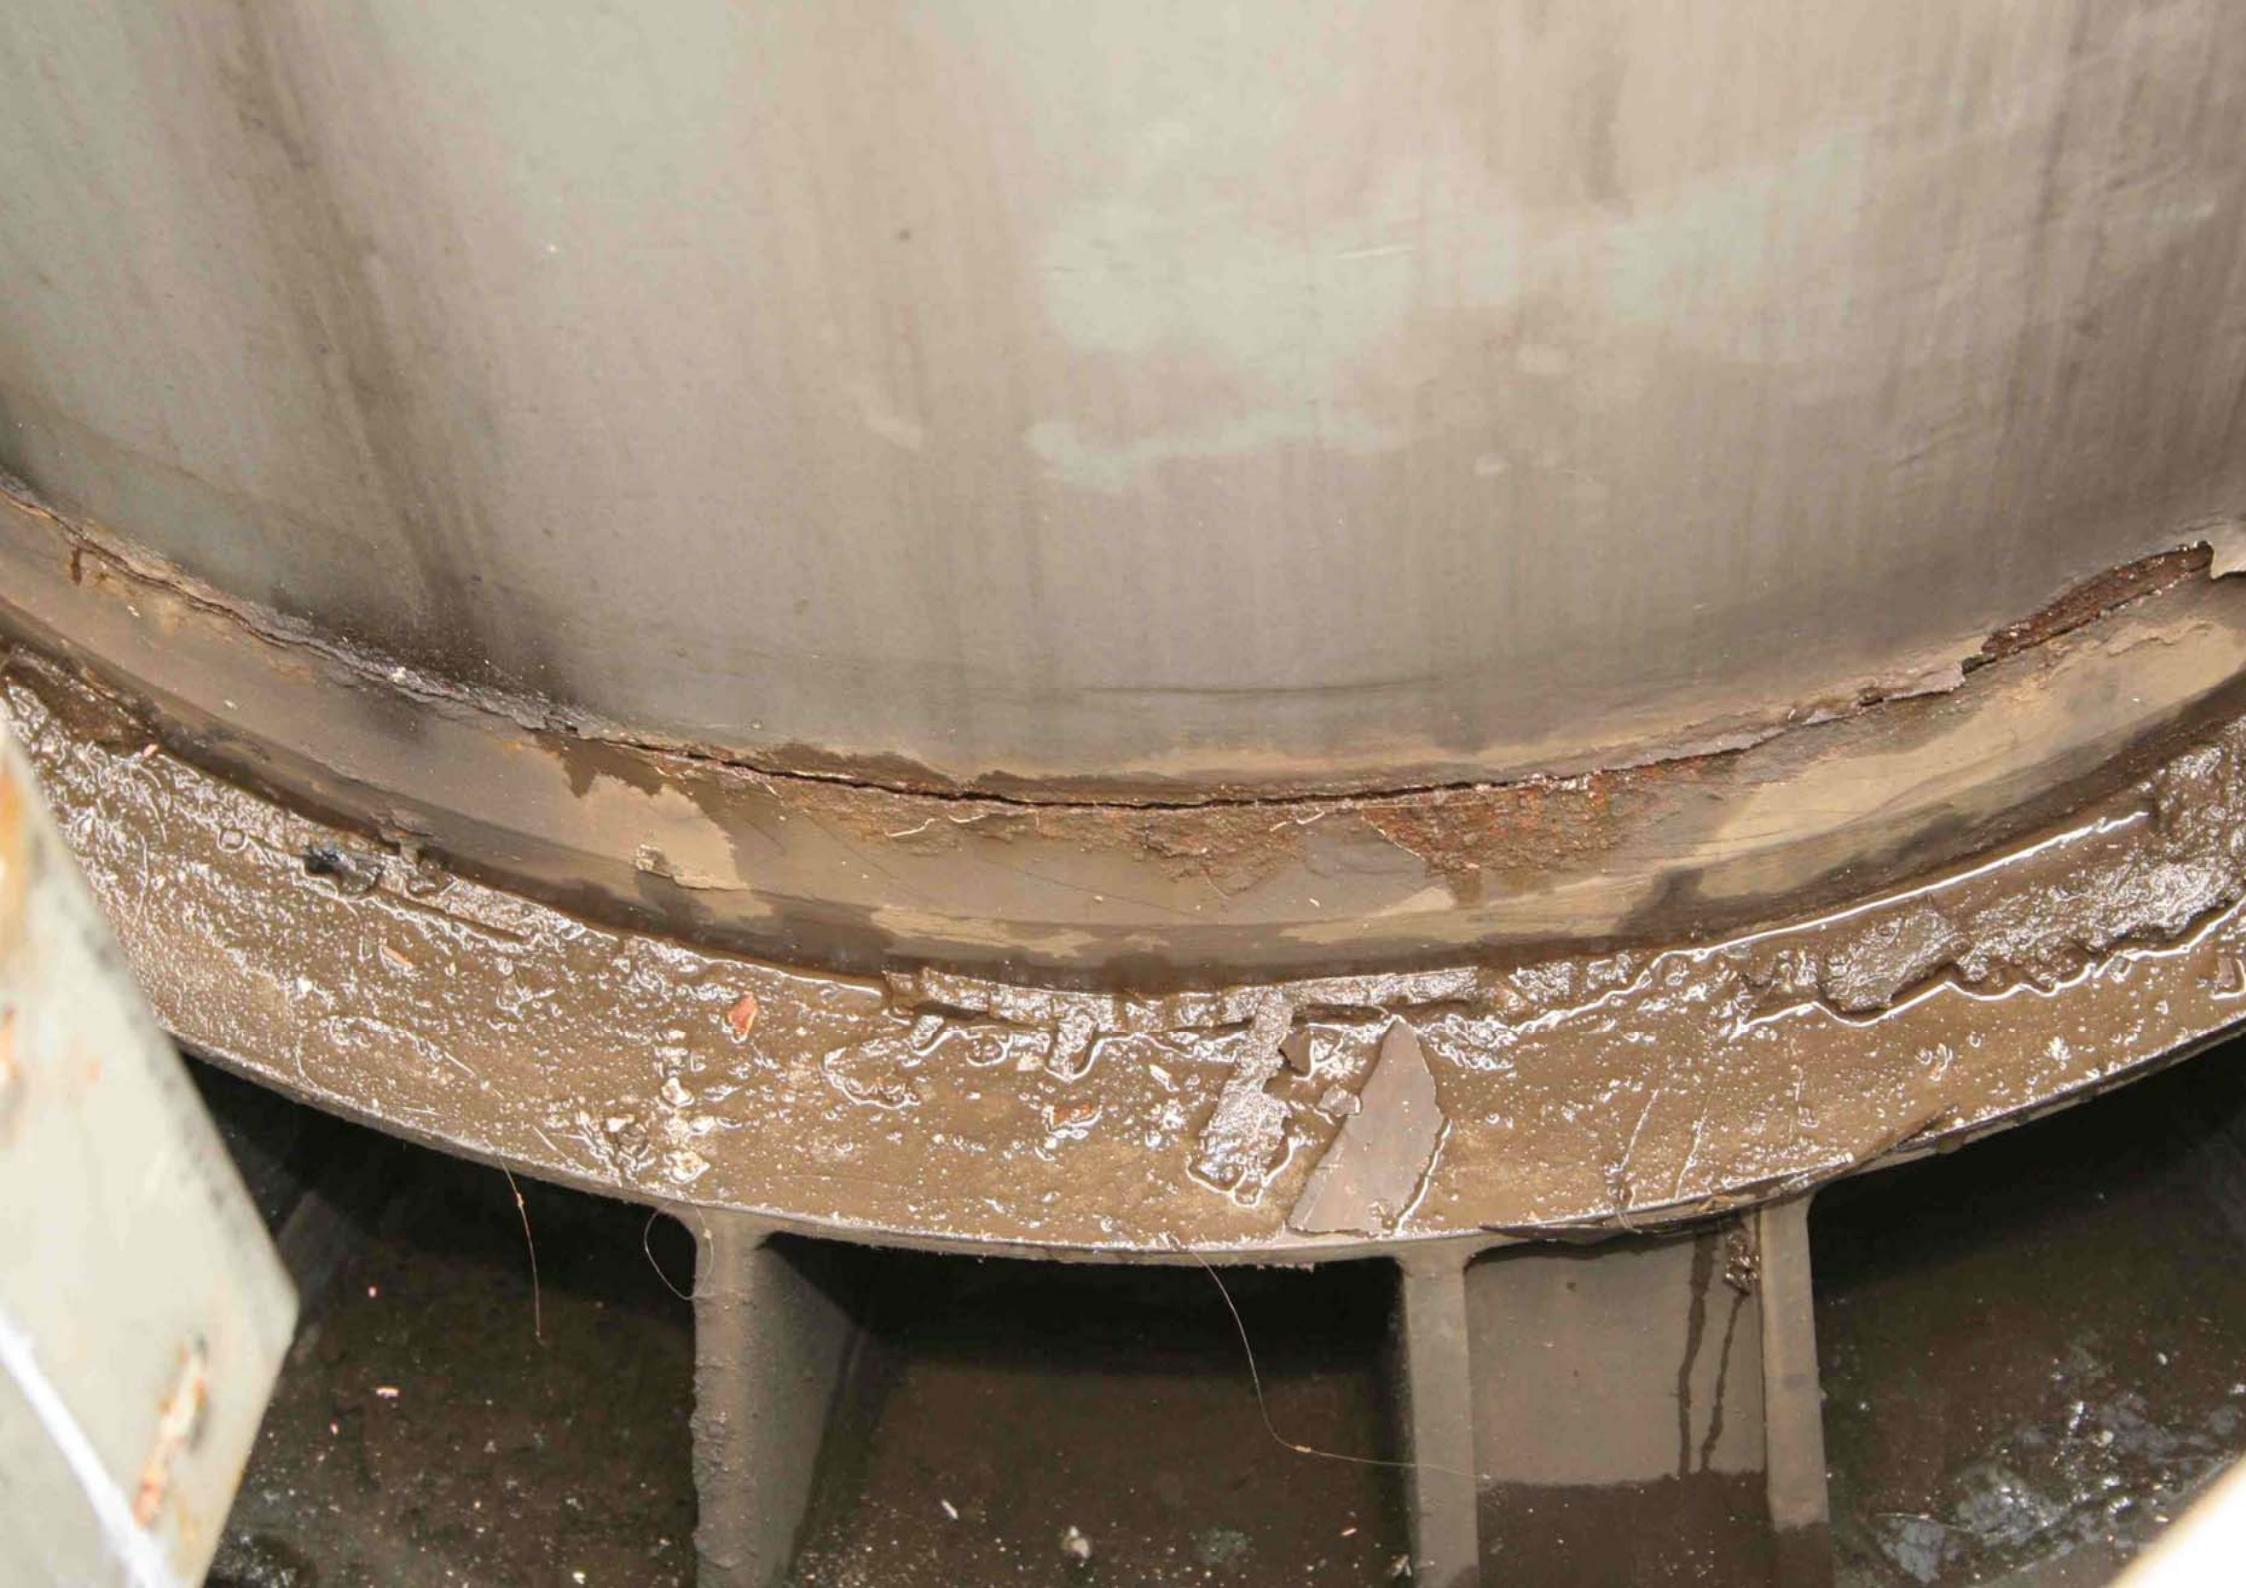
Encl.: Drawing 29.009.S-2

- 1. Crack in circulation direction inside the jacket plate (Pos. 1, 29.009.S-2), below the flange level (Pos. 4, 29.009.S-2).(marked with 11)
- 2. Crack at the edge of the seam between Pos. 5 and Pos. 4 outside the jacket plate (29.009.S-2) (marked with 12)
- 3. Crack in the seam between Pos. 5 and Pos. 1 (29.009.S-2) (marked with 13).

First, the crack under point 1 must be repaired. This must be worked out carefully, at least until a depth where the crack completely disappears. The assumed diffusion direction is going off beveled, possibly until the melting zone of the lower fillet weld between pos. 4 and Pos. 1. The adjacent interior faces of the jacket plate (Pos. 1) must be cleansed from rust and dirt. The welding is an continuous welding in several layers, whose surface must be finished evenly.

Secondly, the ring Pos. 5 must be deleted. For that purpose, the seams at the marks 12 and 13 must be abraded. At mark 12 it is a Half-V butt joint with not full cross-sections, i.e. dependant on the melting zone, a wedge-shaped countersinking with each 8-9 mm in the cross-section triangle blade would be sufficient (if not, the measurements of the countersinking shall be increased gradually until this part separates. Caution! The basic cross-section of Pos. 1 and 4 may – as far as possible – not be destroyed!) Afterwards, Pos. 5 must be cut at two areas in the reversed condition and deleted.

Now, the possible broadening of the cracks with marks 12 and/or 13 can be tested. Executing the refurbishment goes necessarily into the jacket plate until the end of the crack. The refilling refurbishment welding must recondition the basic cross-section thickness of Pos. 1 and 4. Furthermore, a fillet weld must be accomplished between Pos. 1 and Pos. 4. at the top around the released edge according to the drawing.

For reinforcing purposes, a total of 11 ribs must be welded afterwards from the interior to the jacket plate (see drawing 29.009.S-2). The new separation plates must, however, be adapted to the ribs, manufactured and welded into according to the drawing (Pos. 6 and 7). Therefore, the left-overs of the interior separation plates must be deleted kerf-free.

After the corrosion protection works only the upper closing plate must be welded into.
