Crazy Frogs, Orbitor and Tageda

Technical Bulletin

ADIPS Bulletin 230726

26 July 2023

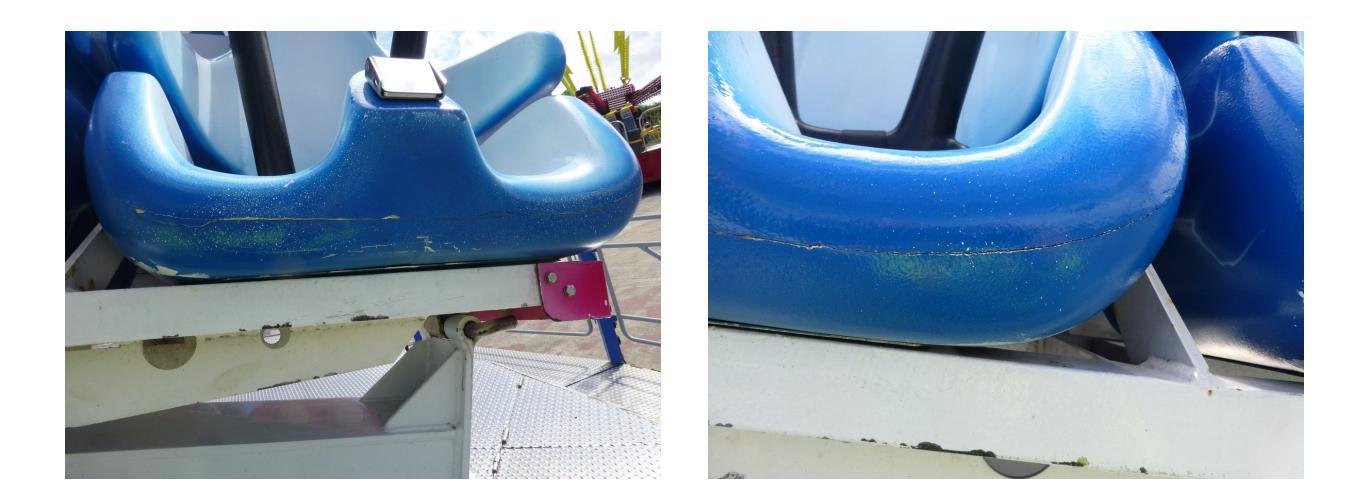
At recent inspection HSE identified significant cracking to the GRP of the passenger seat in several places (see attached pictures). HSE understand that the subframe of the passenger seat is completely encased in foam and GRP and cannot easily removed for inspection.

Initiation (root cause) of the cracks is not clear, but breach of the outer gelcoat surface protection of the GRP will lead to exposure of the fibre underneath, and it these GRP fibres that offer strength to the structure.

Aside from the obvious risk of passengers receiving cuts etc, on the exposed and sharp edges, such damage allows the ingress of water, that could potentially cause corrosion to the steel subframe and accelerate damage to the GRP of the passenger seat.

HSE are concerned that this type of seat arrangement (not just on this type of device) may not be subject to suitable assessment through NDT (visual or otherwise) and that with the ingress of water through damaged outer coating could lead to significant undetected deterioration, and that lack of suitable NDT could also fail to detect cracking and other deformation leading to potential catastrophic failure.

HSE require that these types of passenger seats (along with all other components) are maintained in a good condition and are subject to suitable and sufficient regime of assessment via NDT to ensure that the device remains safe for continued operation.

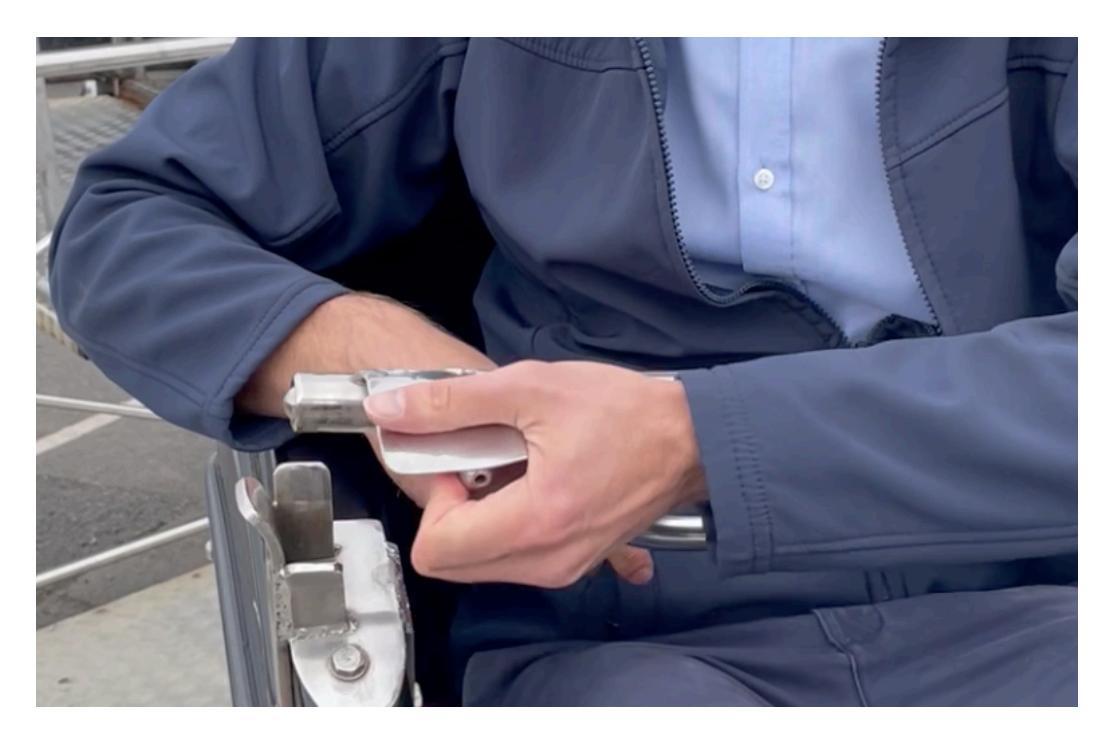
HSE recently identified an issue with the locking mechanism on an Orbitor device, where it was possible for the occupant of the device to open the restraint bar during operation (see attached video).

them from kneeling, standing etc., then it should not be possible for them to open the bar whilst the device is in motion i.e., the restraint should not fail to danger.

HSE require that ride controllers in conjunction with their IBs consider the locking arrangements on these devices (and similar amusement devices) and ensure that where it has been identified by the manufacturer or in the DR that a restraint bar is required, that these are fitted with a positive locking arrangement that is constructed and/or positioned so that they cannot be readily opened by passengers in the car i.e., they should have double feature catches, suitably shrouded catches or catches positioned so that only the ride attendant can open them, or an equally effective design to prevent them being opened by passenger during the ride cycle.
