## TECHNICAL BULLETIN — APRIL 2009

## 357. Sartori Techno Jump Defects

A member of NAFLIC has provided the following information regarding defects that were found on a Sartori Techno Jump ride.

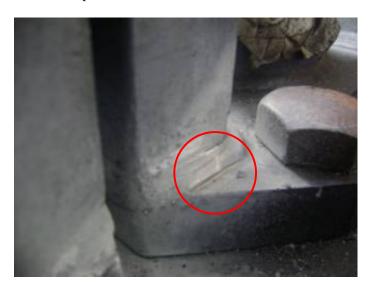
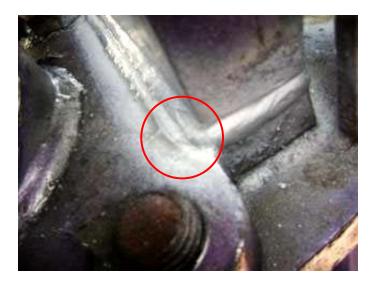
All fourteen (14) Radial Arm Trunnion Brackets exhibited defects to the fillet welds securing both vertical plates to the base plate at the front and rear ends.

While it was possible to detect a number of the defects to the Lifting Cylinder Attachment Brackets visually, the full extent was not determined until the paint, which is quite thick was removed. In the case of the Radial Arm Trunnion Brackets and Centre Hub vertical column no defects were detected visually.

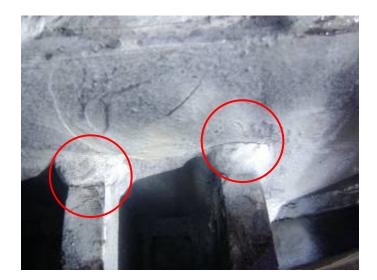
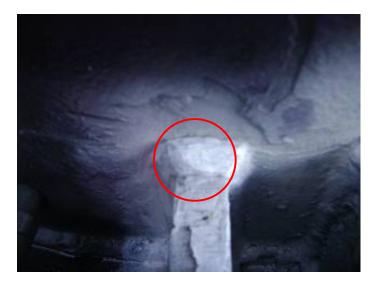
All fourteen (14) Lifting Cylinder Attachment Brackets exhibited defects to the fillet welds securing both vertical plates to the lower flange of the Centre Hub at the upper ends. A majority of the defects were in the top of the weld to the Centre Hub but a number also exhibited defects in the bottom of the weld propagating into the Bracket plate. A small number of welds exhibited both defects.

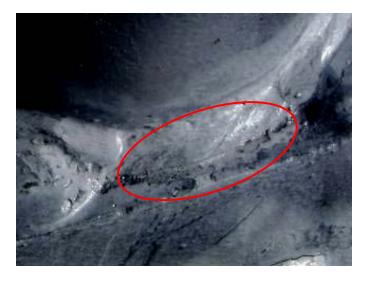
A 50mm long fatigue crack was also detected to the circumferential weld securing the base of one of the Centre Hub Vertical Columns.
