NUMBER: B408R1178-0

## SERVICE BULLETIN

Ride: CHAOS

Subject: Hydraulic System Rework

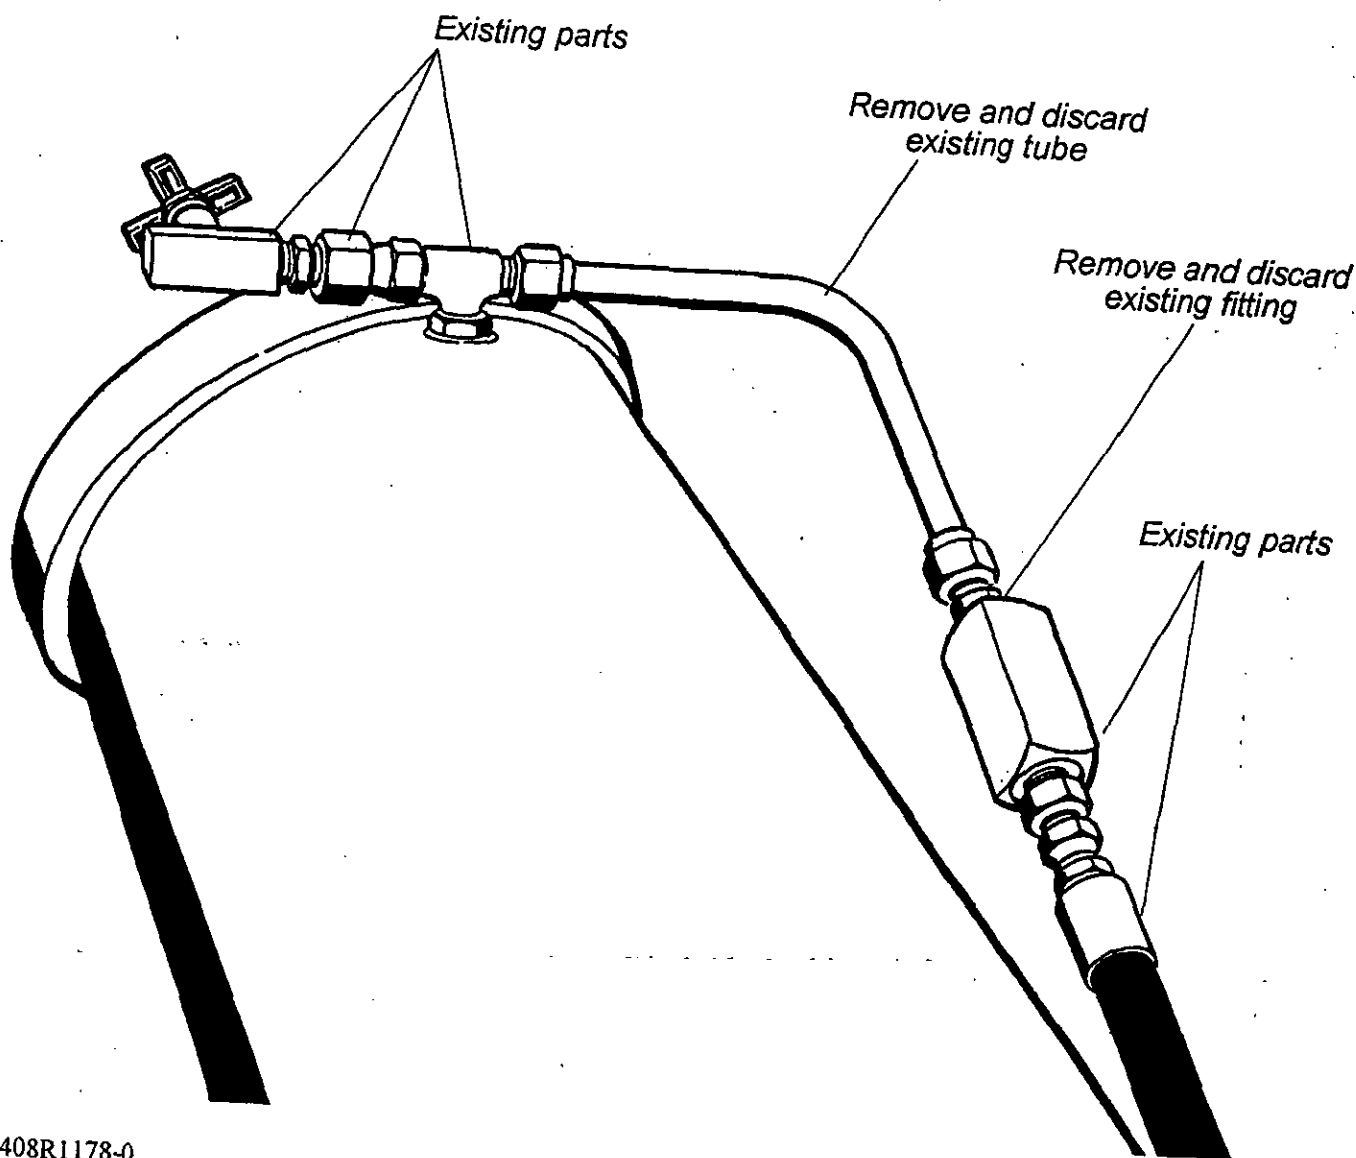
1. Lower the boom completely, stop the hydraulic pump, and shut off the power at the main breakers.
2. Locate the tube at the "T" fitting at the rod end of the boom lift hydraulic cylinder. Remove and discard the tube. Loss of hydraulic fluid will be minimal.

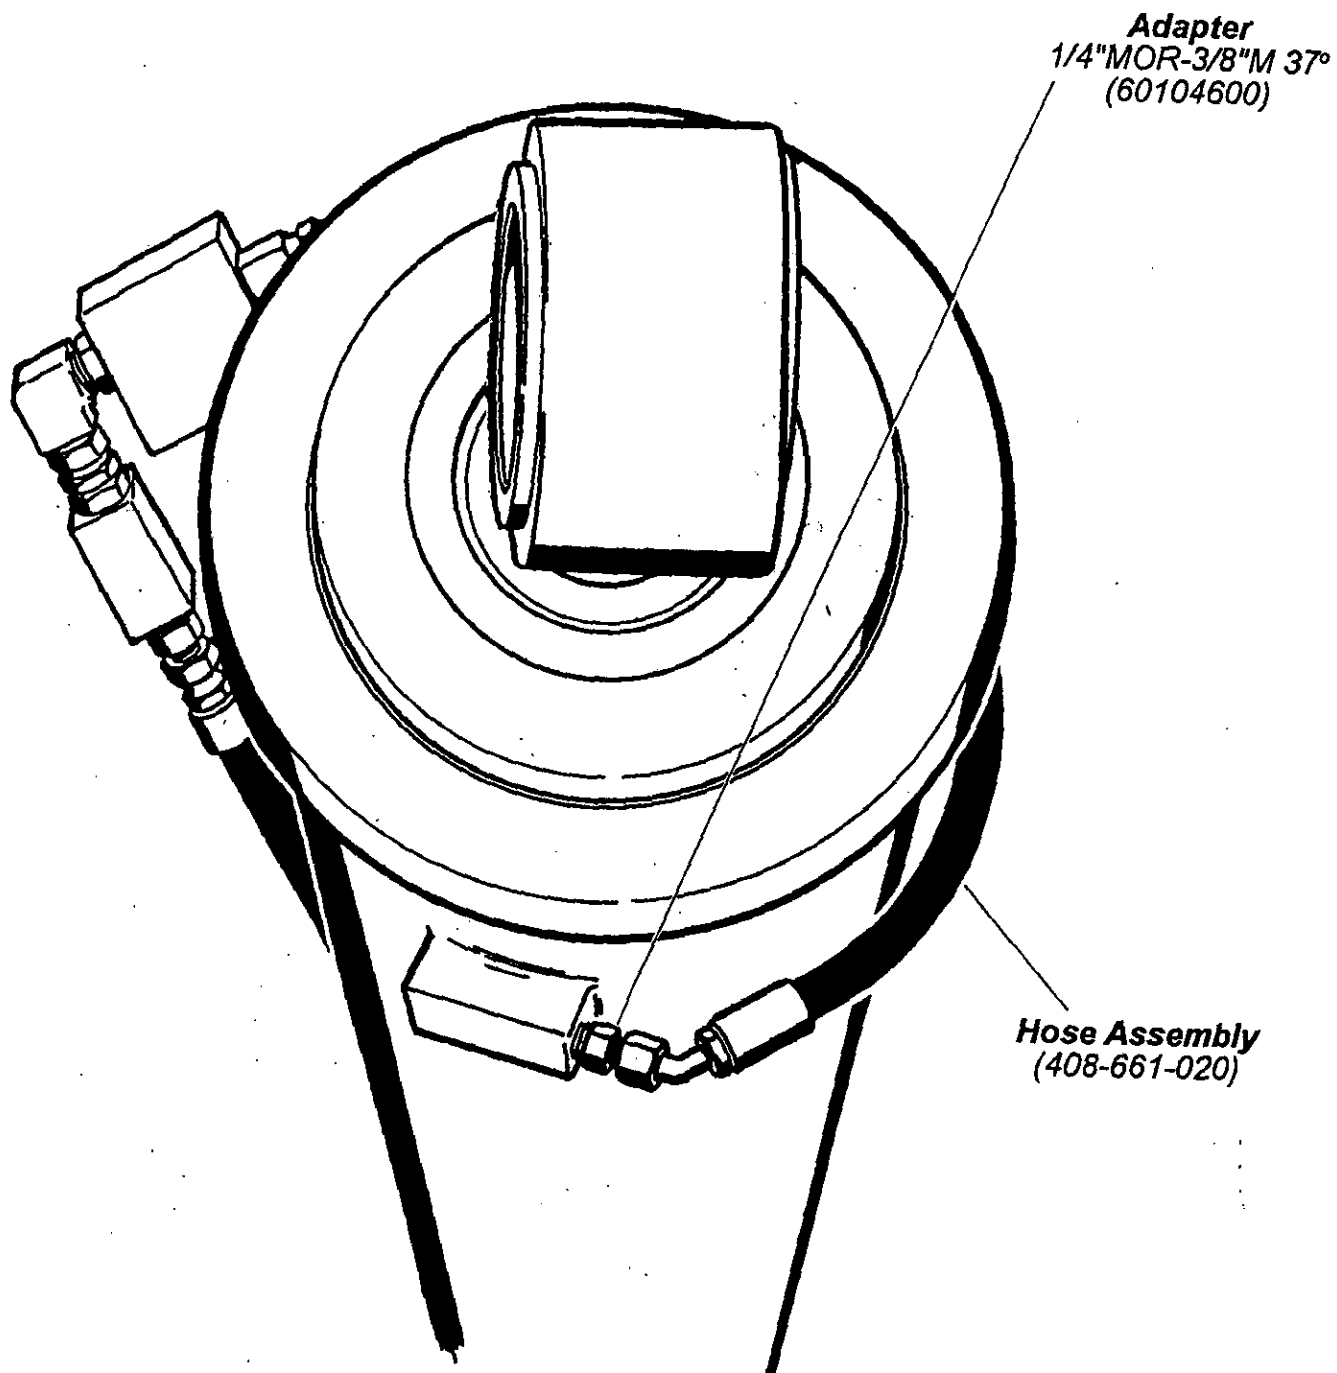
**VIEW OF UNDERSIDE OF BOOM LIFT CYLINDER**

3. Install the parts provided in the kit as shown in the following illustrations.
4. After all parts are installed, operate the ride, then check for leaks at all hoses, tubes and fittings.

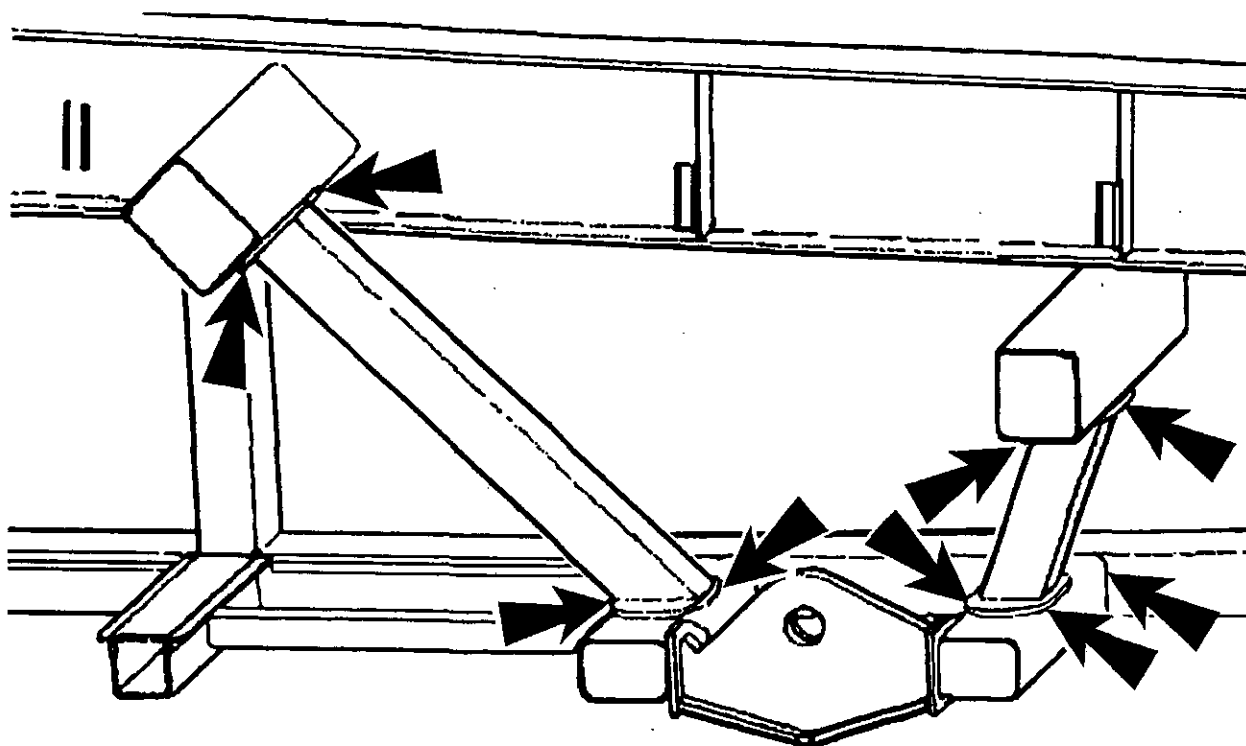
Chance Rides, Inc. has become aware that it is possible for cracks to develop in the structural frame members which supports the main hydraulic lift cylinder on the CHAOS amusement rides noted above.

*INSPECT ALL WELDS IN THE AREAS INDICATED BY ARROWS*

Chance Rides, Inc. requires all owner/operators to perform an annual visual inspection of all support frame members as outlined on the back of this bulletin. If any indications are found, contact Chance Customer Service for a repair procedure.

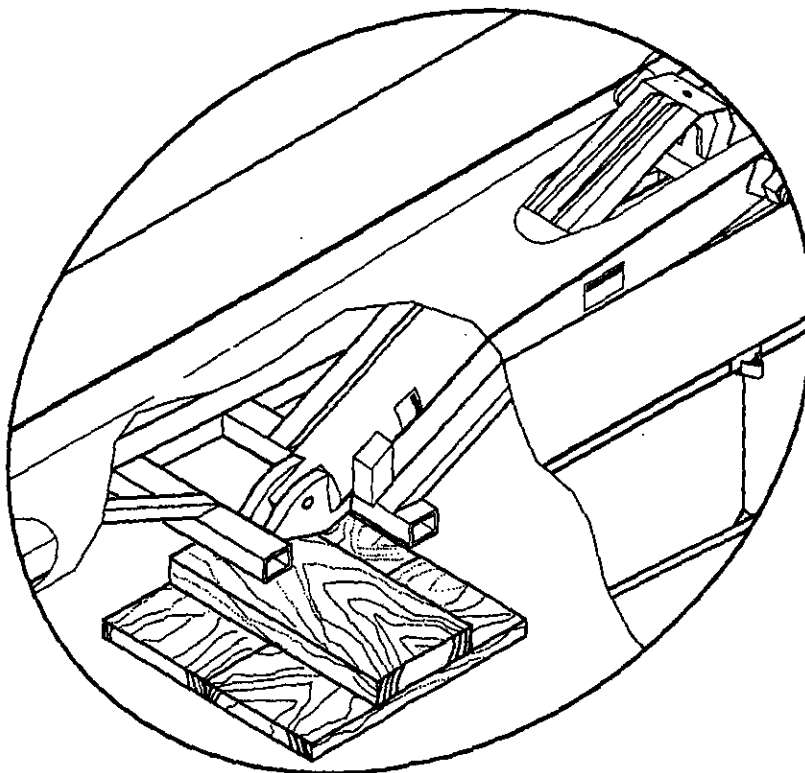
1. Recommended use is a minimum of two blocks stacked on top of each other in a cross block style.
2. Recommended blocking size is 3" x 12" x 48" blocks on the bottom and 3" x 12" x 24" blocks on top.
3. Install blocks centered under lowest point of boom lift cylinder mounting ears.
4. Shim blocks as required to bring blocking within 1/8 to 1/4 inch of the boom lift cylinder mounting ears.

Chance Rides, Inc. has become aware that the boom lift cylinder on the above noted CHAOS amusement rides needs to be supported with blocking while the ride is being operated. Failure to block under the ride's boom lift cylinder can cause undue stresses to the trailer frame in the cylinder pivot point area. These stresses can result in the cracking of structural members of the trailer frame in the area where the boom lift cylinder pins.

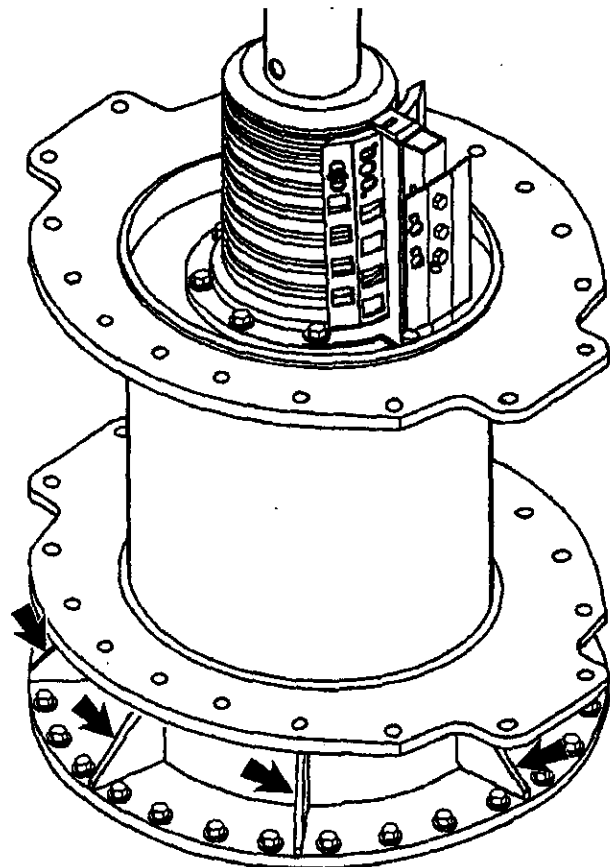
1. Visually inspect the seven existing gussets and the weld area around each gusset as shown.
2. If any cracks are found, contact Chance Rides, Inc. Customer Service Department for a repair procedure. If no cracks are found, install Kit number K408R1203-0.

Chance Rides, Inc. has become aware that cracks can form in and around the gussets on the hub of the above noted CHAOS amusement rides.

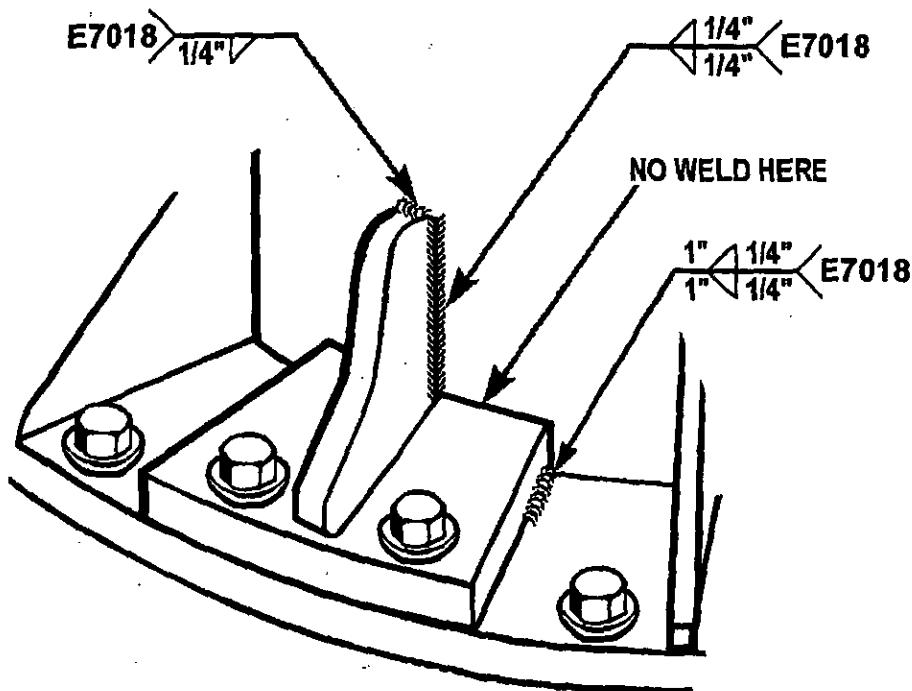
5. Weld the gussets in place using E-7018 welding rod. Weld only in the areas shown below.

6. Material surface to be welded must be above 70°F before welding. To avoid heat distortion of the hub, welds must be performed in the sequence shown on the following page.

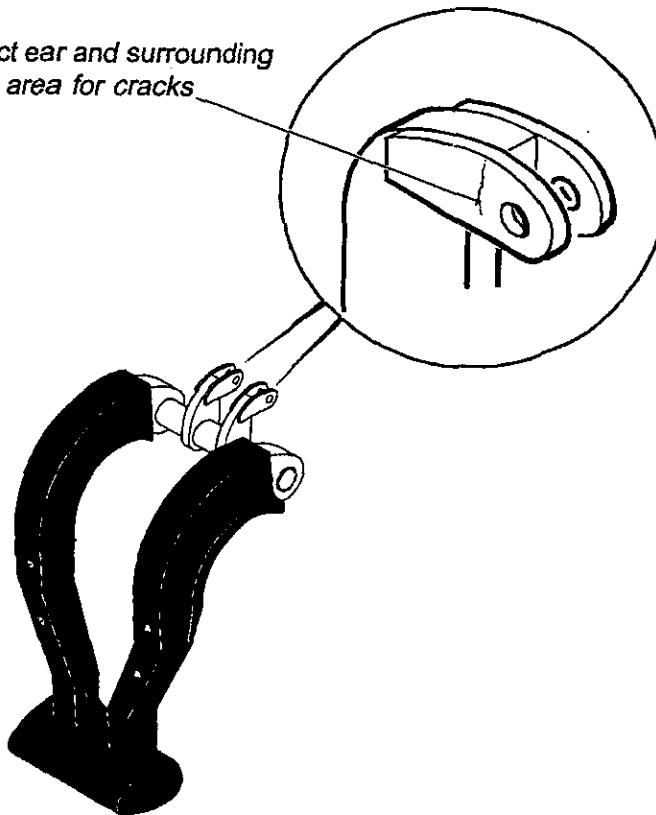
Visually inspect both primary restraint bars on all vehicles (36 total) as shown. If any cracks are found, contact the Chance Customer Service Department immediately. **DO NOT ATTEMPT TO REPAIR THE CRACK.**

Inspect ear and surrounding  
area for cracks

Chance Rides, Inc. has become aware that cracks can form in and around the ears on the back of the primary restraint bars on the CHAOS amusement ride.

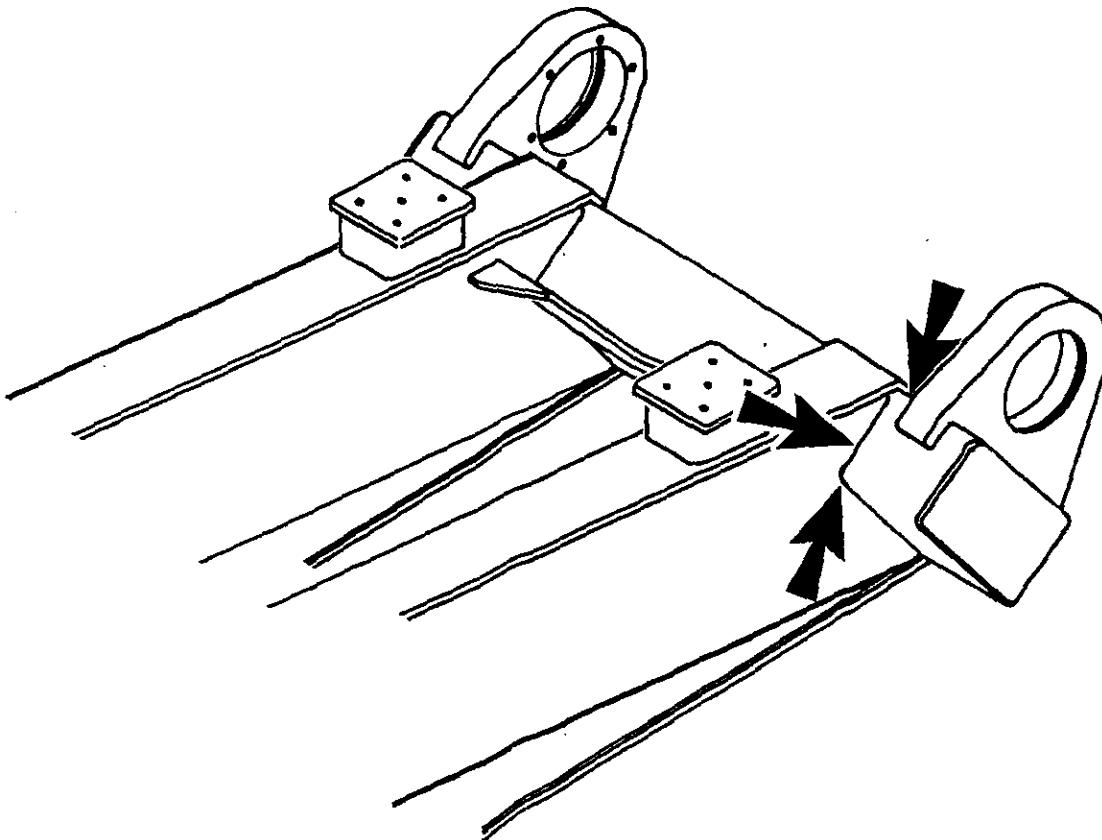
2. If any cracks are found, contact the CHANCE Customer Service Department.

Chance Rides, Inc. has become aware that cracks can form in and around the tilt head mounts on the boom of the above noted CHAOS amusement rides.

Perform the inspection described on the next page of this bulletin. If any indications are found, contact the CHANCE Customer Service Department immediately for instructions on further action to be taken. DO NOT ATTEMPT TO WELD OR OTHERWISE REPAIR THE BOOM, EXCEPT AS SPECIFICALLY INSTRUCTED BY CHANCE RIDES, INC.

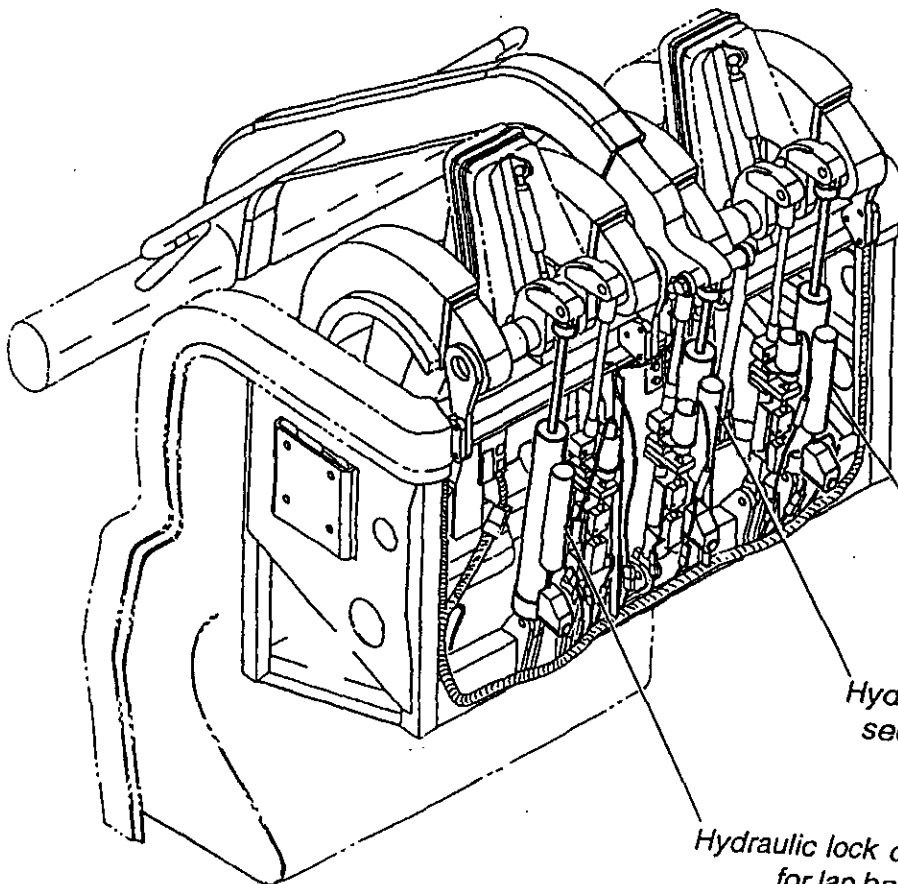
Hydraulic lock cylinder  
for lap bar

**IMPORTANT:** Note the location at which each cylinder is installed. Pay particular attention to the cylinder for the secondary restraint bar (center position).

Chance Rides, Inc. has become aware of a manufacturing defect which can affect the reliability and/or service life of the hydraulic lock cylinders. Although the defect has been corrected by the manufacturer, some defective cylinders have been shipped on new products and as replacement parts.

All owners of the above noted amusement rides are required to inspect all hydraulic lock cylinders per the instructions on the following page of this bulletin. If any defective cylinders are found, order and install part number 22162104 in the appropriate quantity to replace all defective cylinders.

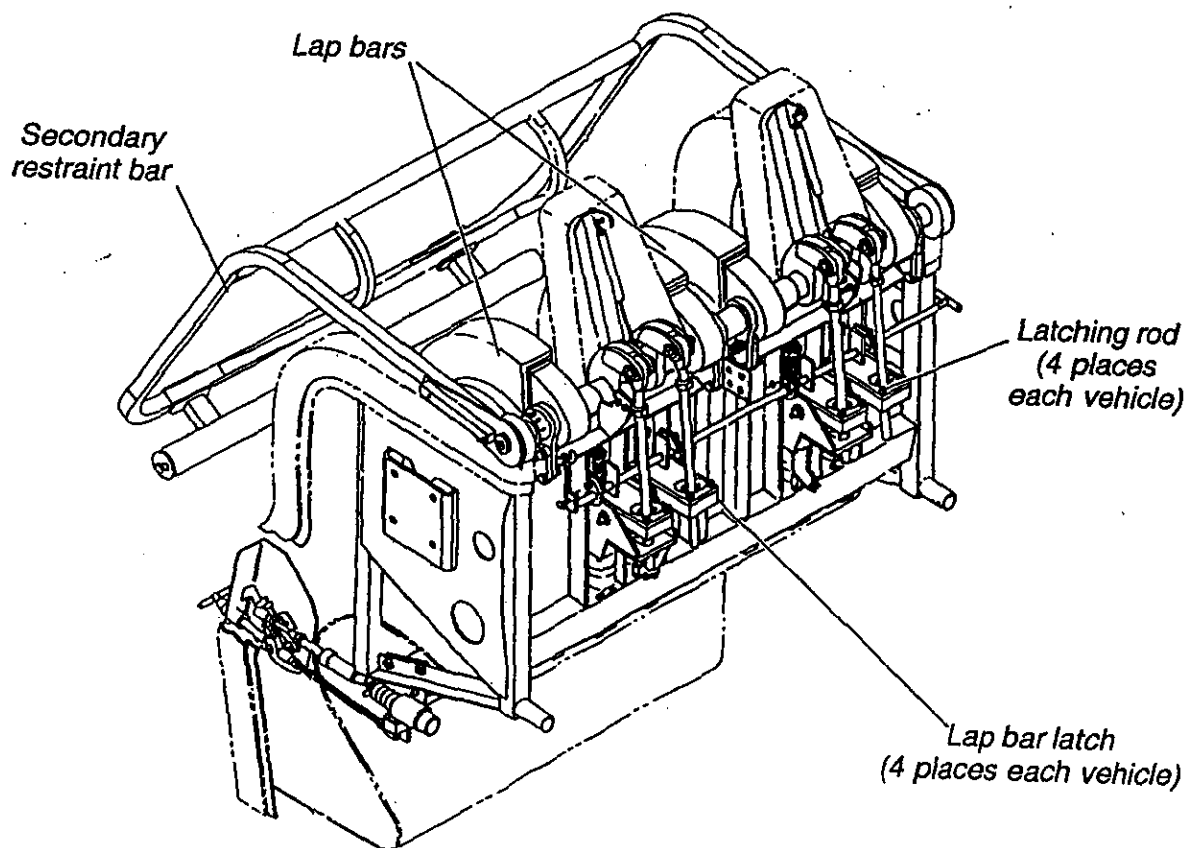
The components are identified in the illustration below.

Inspect the lap bar lock components as described on the following pages of this bulletin. Replace any components that are worn or damaged.

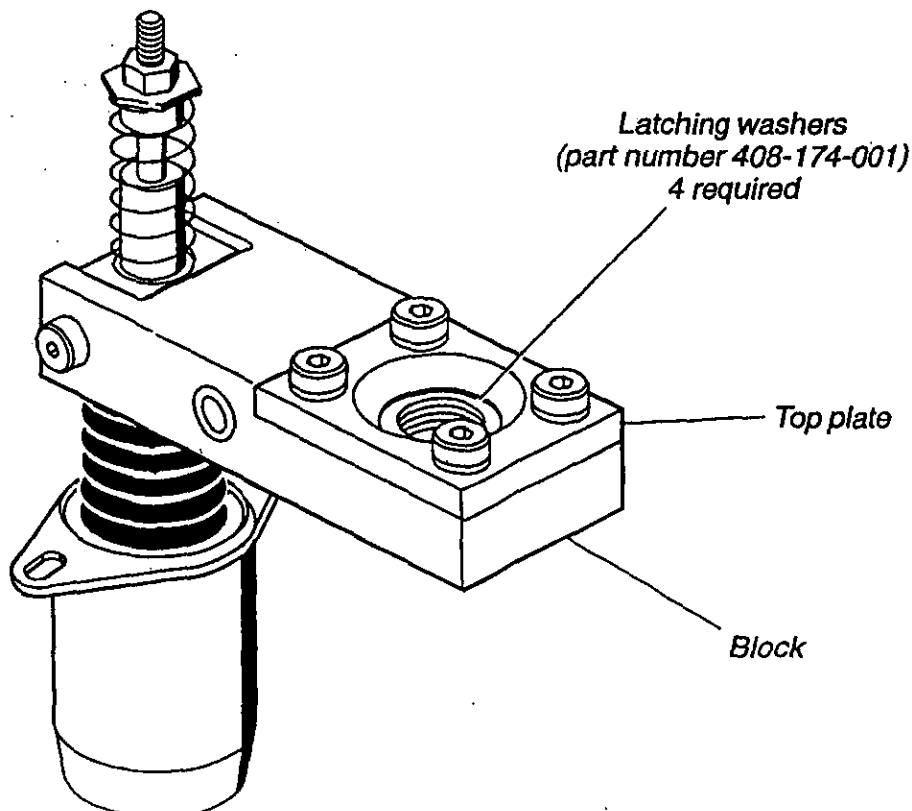
- The inside diameter of the four latching washers must not show signs of chamfering. The inside edges must be square, with no elongation of the holes.
- If the holes in the top plate or block show signs of contact with the latching rod, this indicates wear of the latching washers.
- All parts must be clean and free of lubricants or any other residue. When assembled, the washers must move freely in the block.

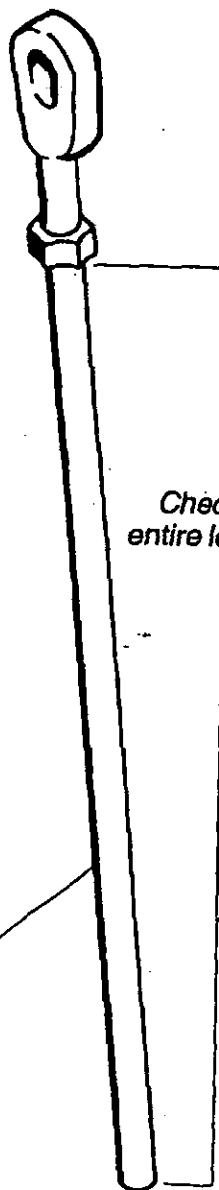
2. Inspect the latching rods. The entire length of the rod must be clean, smooth and free of corrosion or other damage

*Check condition along  
entire length of latching rod*

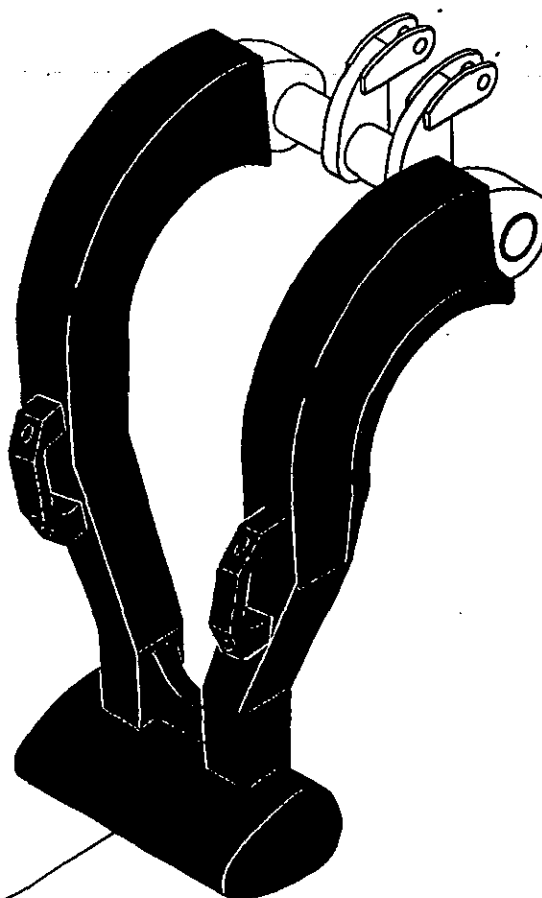
3. Inspect the lap bar padding where it contacts the secondary restraint bar. If the padding has a groove matching the contact area of the secondary restraint bar, this indicates the latching washers are worn. The lap bar padding must be in good condition.

*Inspect padding in this  
area for grooves matching  
the contact area with the  
secondary restraint bar*

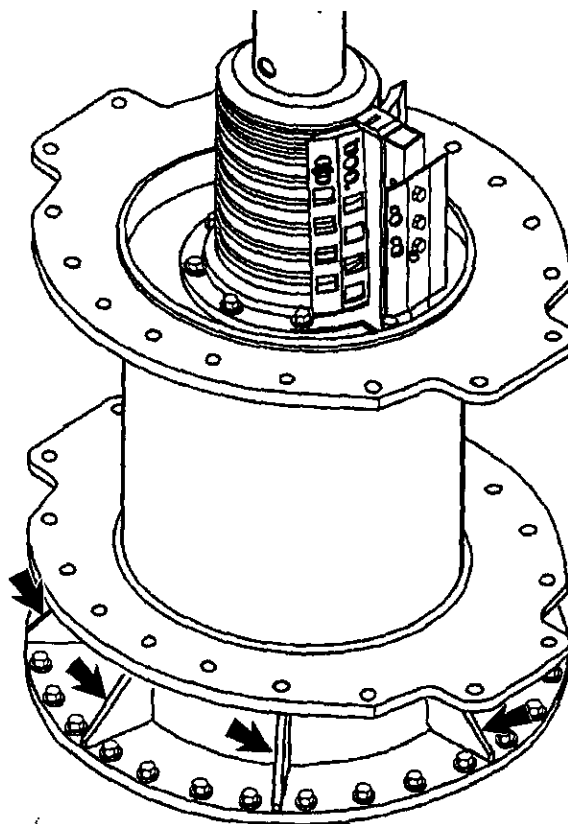
1. Visually inspect the seven existing gussets and the weld area around each gusset as shown.
2. If any cracks are found, contact Chance Rides, Inc. Customer Service Department for a repair procedure. If no cracks are found, install Kit number K408R1203-0.

Chance Rides, Inc. has become aware that cracks can form in and around the gussets on the hub of the above noted CHAOS amusement rides.

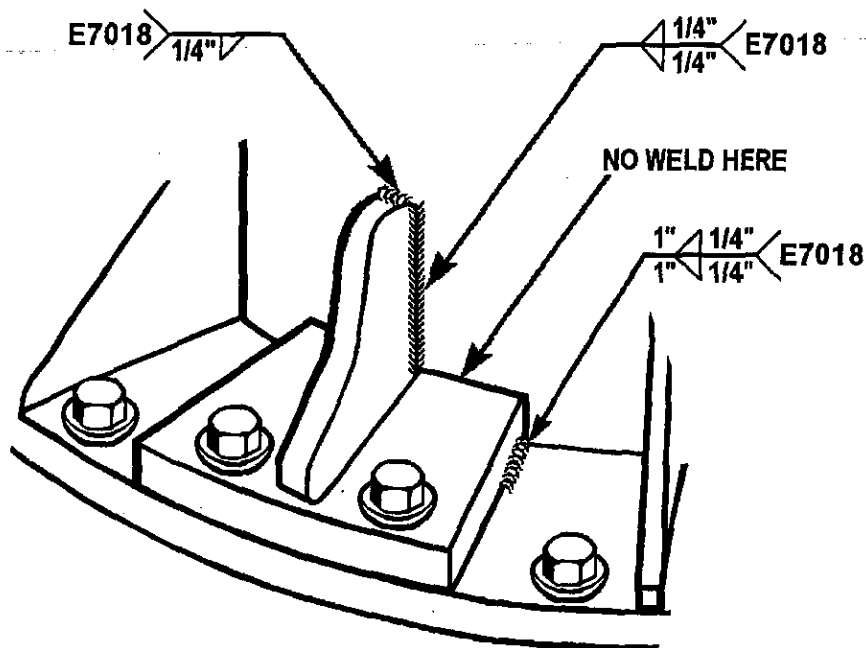
5. Weld the gussets in place using E-7018 welding rod. Weld only in the areas shown below.

6. Material surface to be welded must be above 70° F before welding. To avoid heat distortion of the hub, welds must be performed in the sequence shown on the following page.

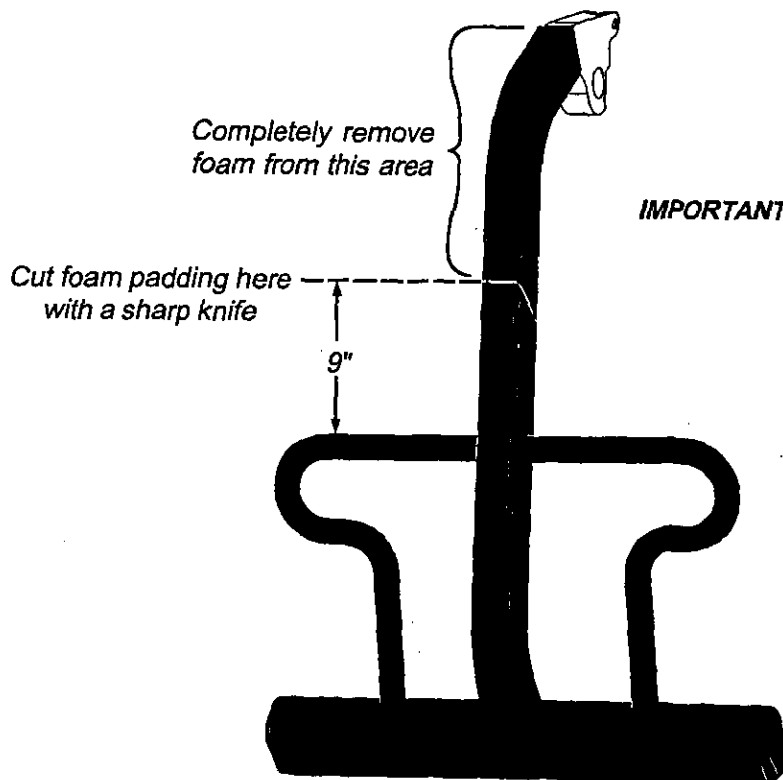
1. Use a sharp knife to carefully cut the foam padding as shown on all 18 secondary restraint bars.

**IMPORTANT:** When cutting the foam, be careful not to score the aluminum tube inside the foam. This will severely weaken the tube.

Chance Rides, Inc. has become aware of a single occurrence where a crack developed in the curved area of the secondary restraint bars of the CHAOS amusement ride. A break in the secondary restraint bar can possibly result in personal injury to the operator, passengers, and/or bystanders.

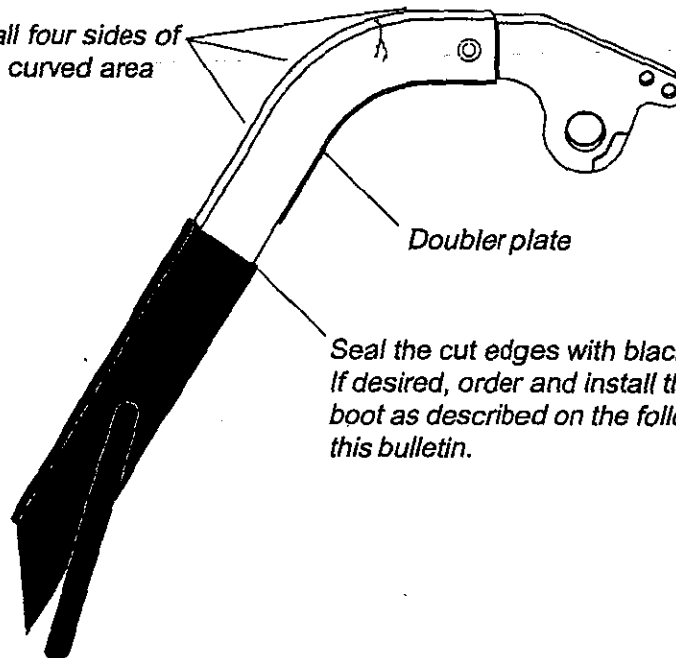
*Inspect all four sides of  
tube in curved area*

*Seal the cut edges with black RTV sealant.  
If desired, order and install the inspection  
boot as described on the following page of  
this bulletin.*

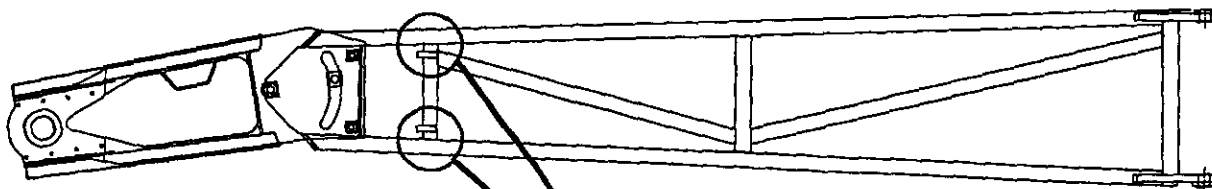
Visually inspect every sweep, paying particular attention to the areas indicated in the following illustration. Look for indications in the steel tubes, and check the welded joints for indications in the welds and the parent metal. If any indication is found, **DO NOT OPERATE THE RIDE**. Contact the Customer Service Department at Chance Rides Manufacturing, Inc. for specific instructions on further action to be taken.

*Pay particular attention to this area on both the top and bottom tubes of each sweep.*

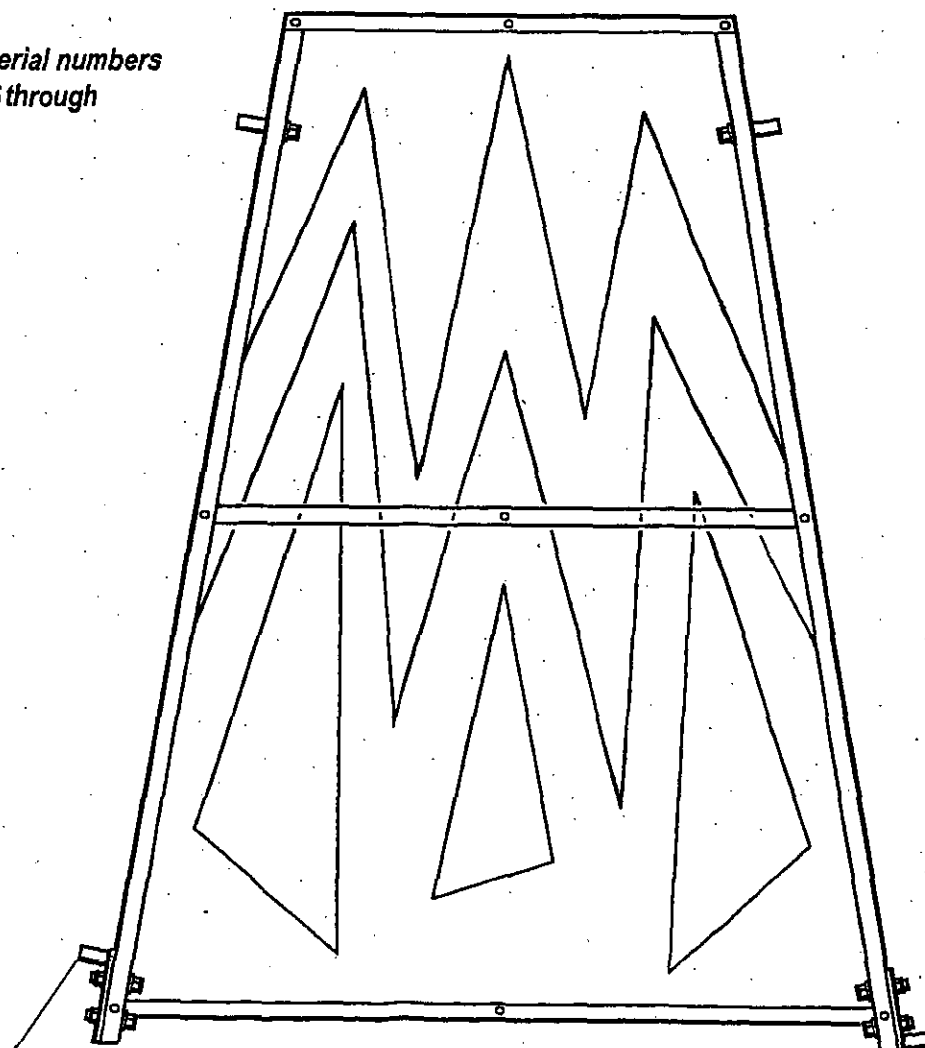
*For ride serial numbers  
408-00196 through  
408-04399*

*Remove guide pin weldments from both  
sides of sweep insert panel. Turn 180° as  
shown and mount with existing fasteners.*

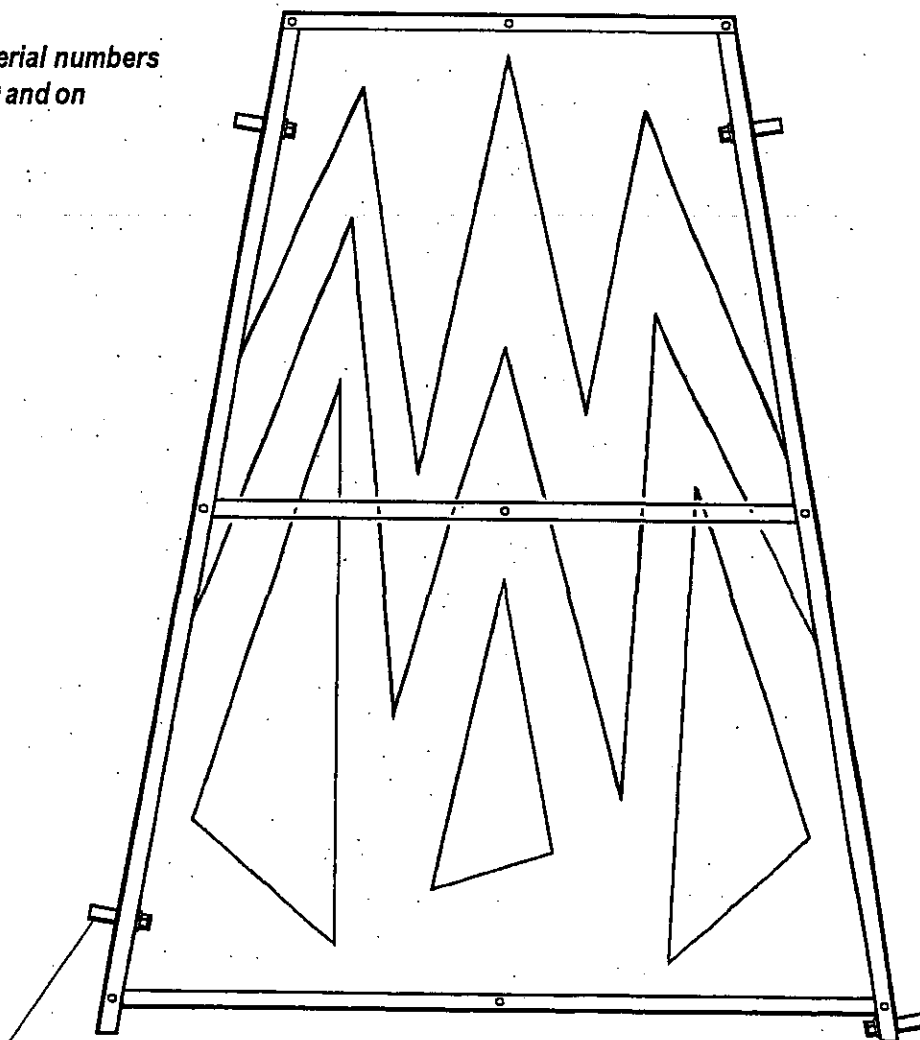
**For ride serial numbers  
408-04499 and on**

Remove guide pins from both sides of sweep insert panel. Locate new holes 3" in from existing holes (toward hub). Drill 0.28" diameter holes through both sides of tube and install guide pins with existing fasteners.

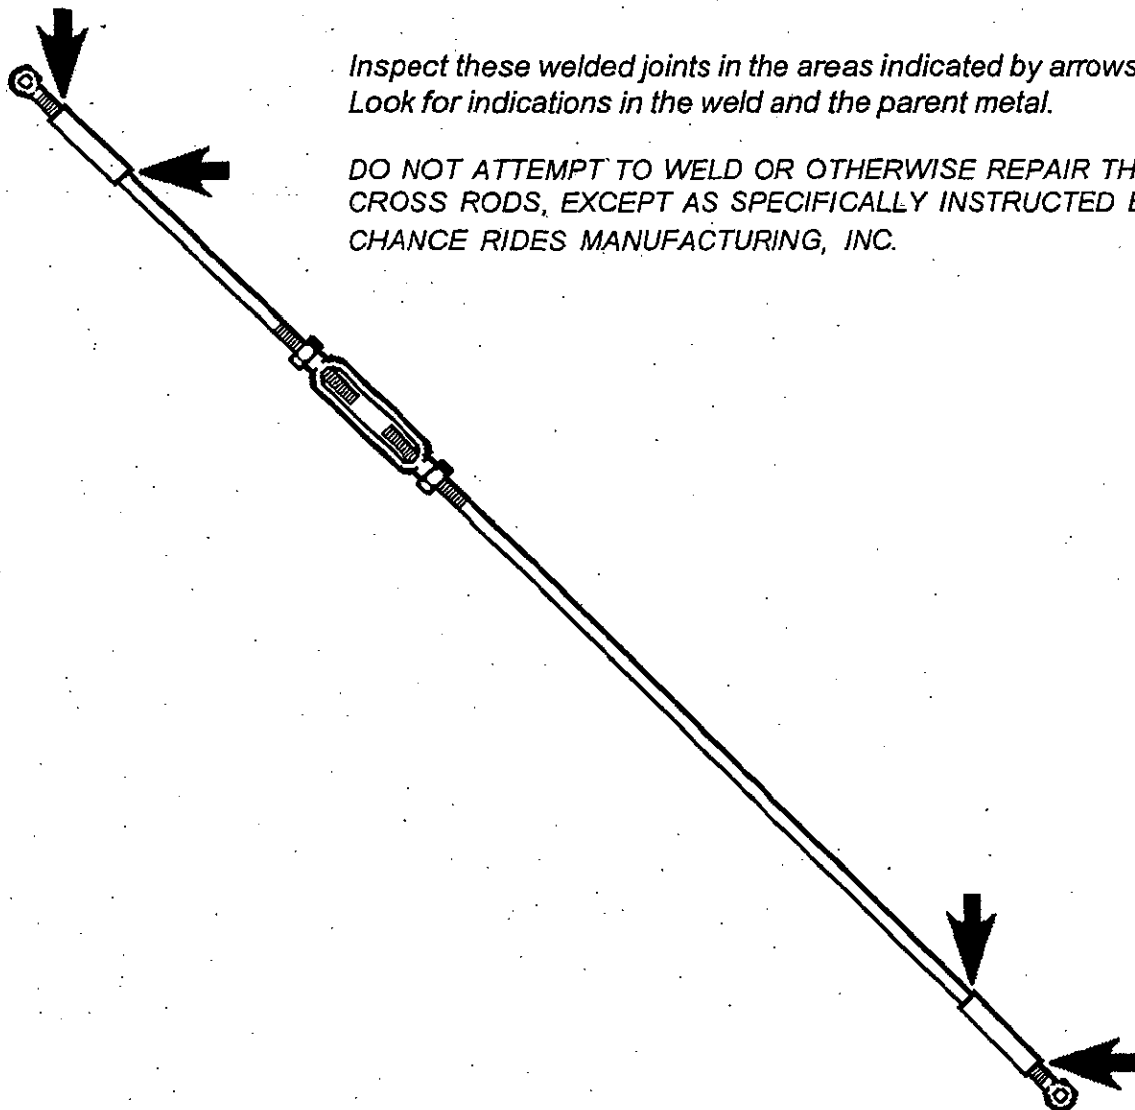
*Inspect these welded joints in the areas indicated by arrows.  
Look for indications in the weld and the parent metal.*

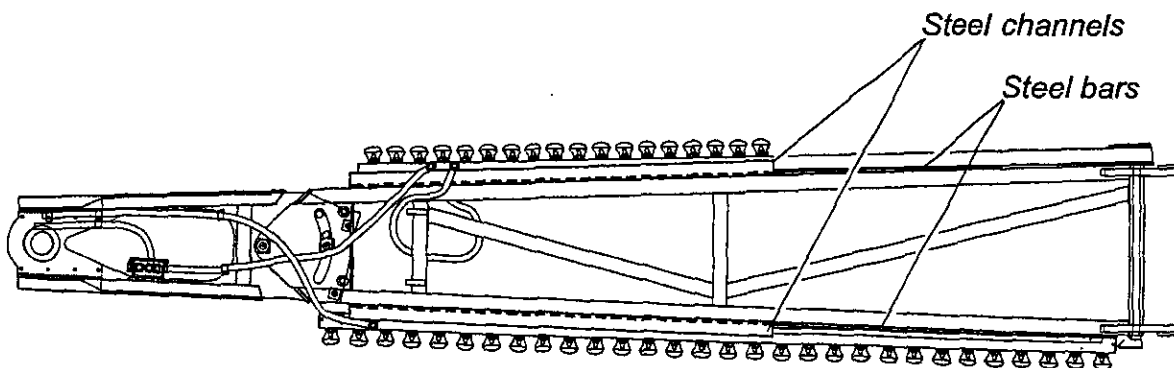
*Installation of the Sweep Reinforcement Kit (K408CRM115-0) can be visually verified by the channels and bars welded to the upper and lower tubes of every sweep as shown.*

*On rides with the Sweep Reinforcement Kit installed, perform the inspection described in this bulletin ANNUALLY.*

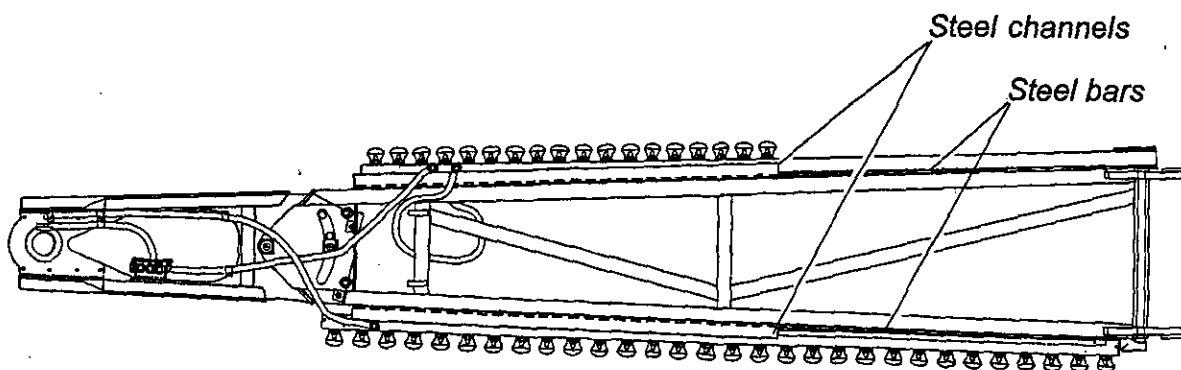
*Installation of the Sweep Reinforcement Kit (number K408CRM115-0) can be visually verified by the channels and bars welded to the upper and lower tubes of every sweep as shown.*

*On rides with the Sweep Reinforcement Kit installed, perform the inspection described in this bulletin ANNUALLY.*

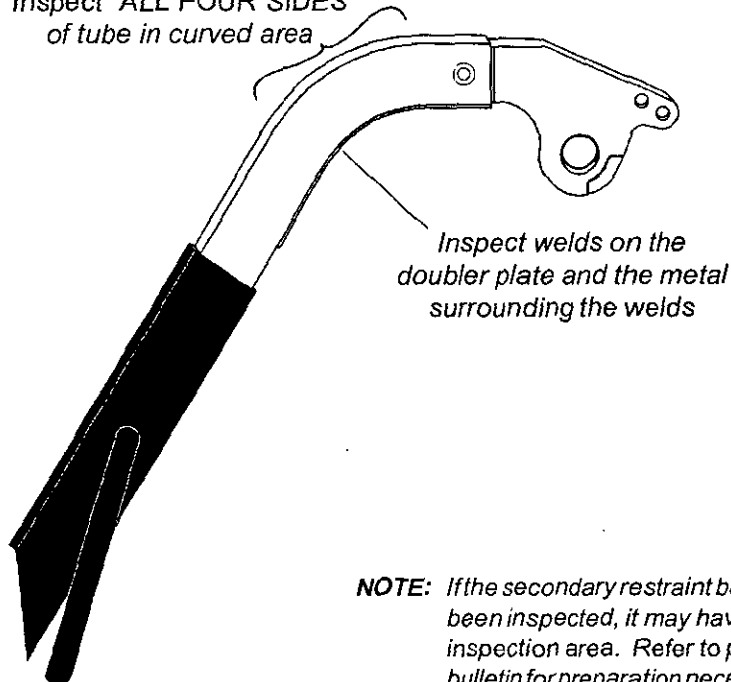
*Inspect ALL FOUR SIDES  
of tube in curved area*

**NOTE:** If the secondary restraint bar has not previously been inspected, it may have foam covering the inspection area. Refer to pages 4 and 5 of this bulletin for preparation necessary to gain access to the inspection area.

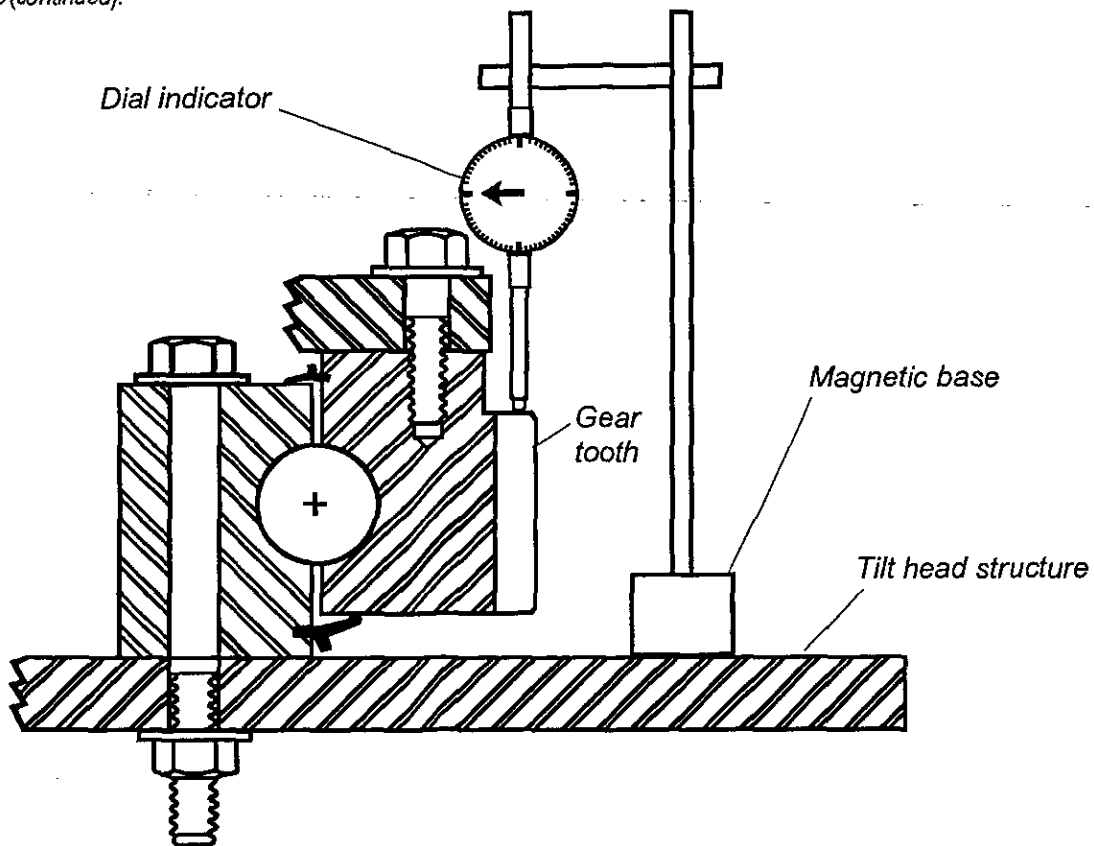
**Detail of Dial Indicator Set-Up to Measure Main Bearing Clearance**  
(Typical three locations equally spaced around the bearing)

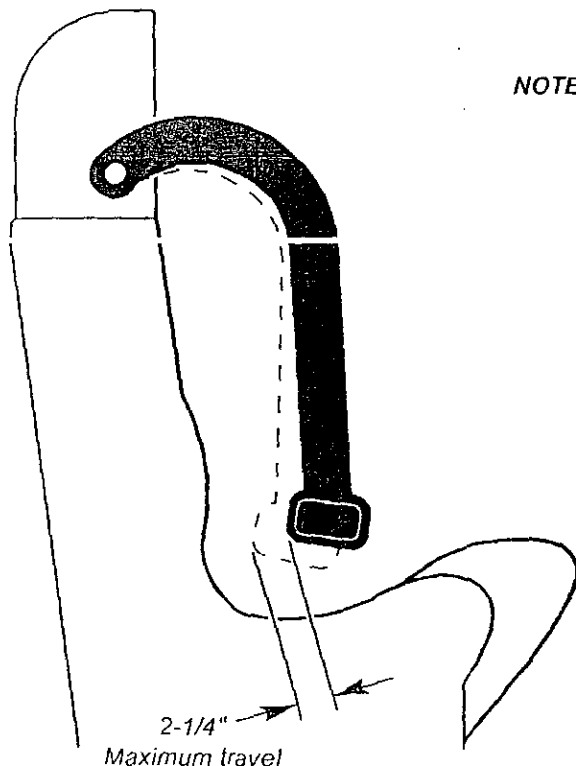
**NOTE:** Excessive travel before the mechanical lock engages is usually the result of one or more of these conditions: wear or damage to the mechanical lock components, worn rod end bearings, worn restraint bar pivot bushings, or loose fasteners.
