NUMBER: B391R1144-0

SERVICE BULLETIN

Ride: FALLING STAR

Subject: Drive Sprocket/NDT

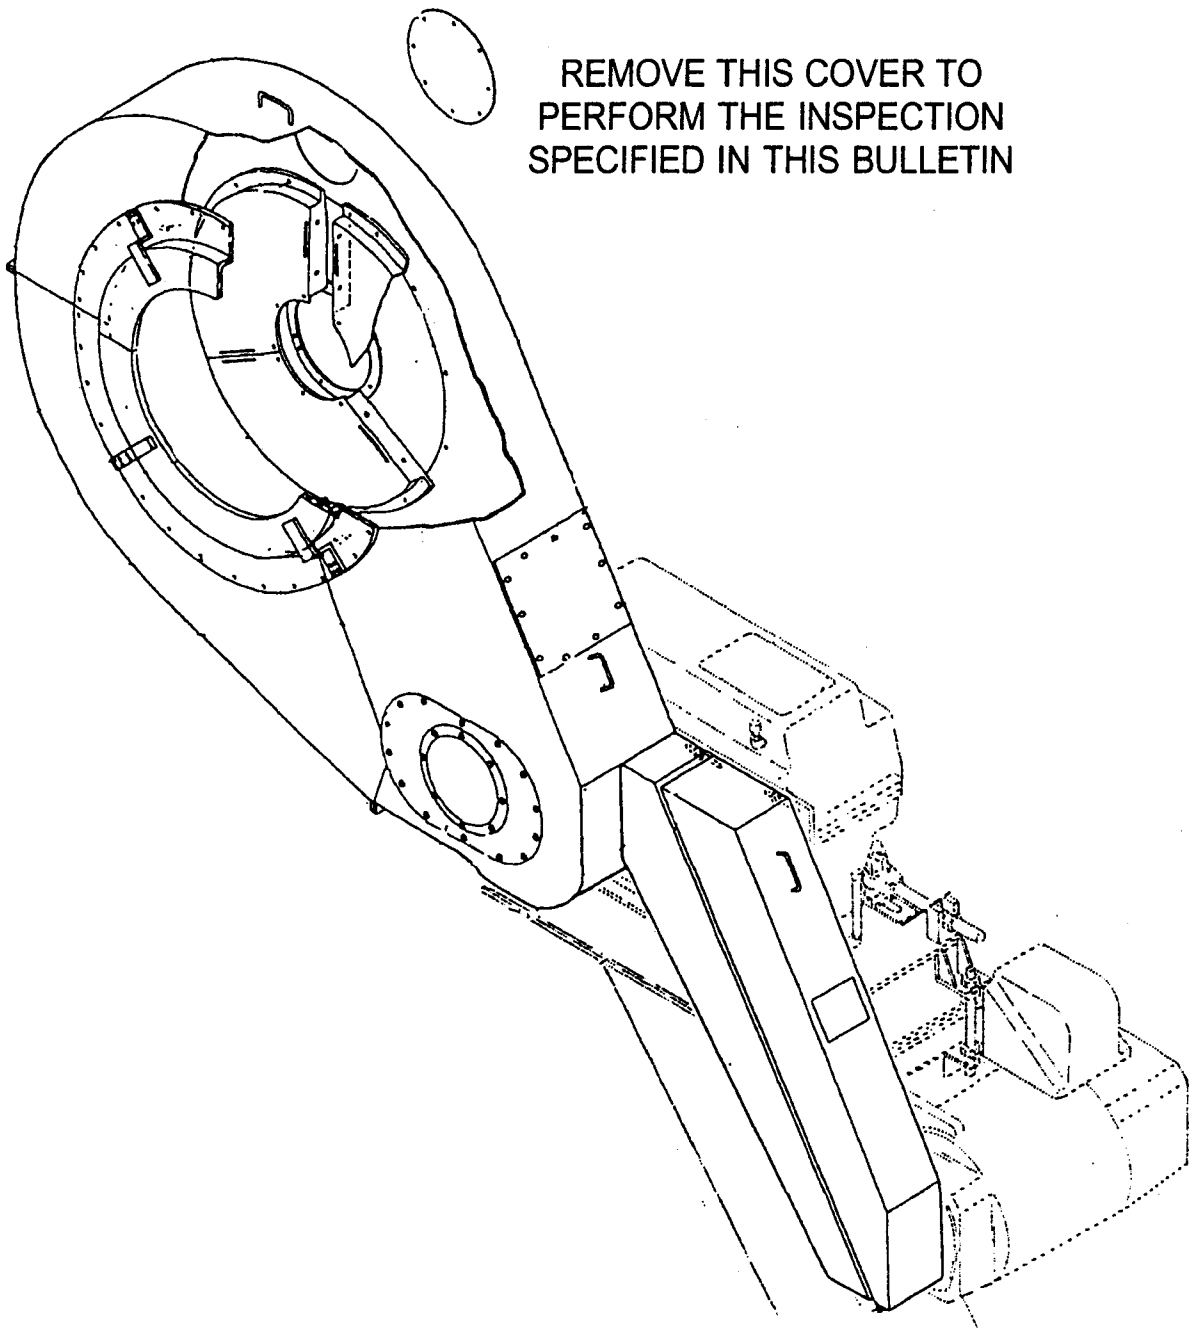
REMOVE THIS COVER TO
PERFORM THE INSPECTION
SPECIFIED IN THIS BULLETIN

1. PRE-CLEAN:
 - * Clean the weld radius area of the drive sprocket as shown in the illustrations in this bulletin to remove oils and other contaminants.
2. MAGNETIZATION PROCESS:
 - * Using an A.C. yoke with articulating legs, position yoke over weld so flux field is 90° to weld as shown in illustration.
 - * Use continuous method for applying particles and current.
3. INSPECTION:
 - * Thoroughly inspect all weld areas for linear indications.
 - * If any linear indications are found, **do not operate the ride**, contact the Chance Rides, Inc. Customer Service Department.
 - * Fill out test report with results and send a copy to Chance Rides, Inc.
4. POST-CLEAN:
 - * Remove magnetic particles from weld area.

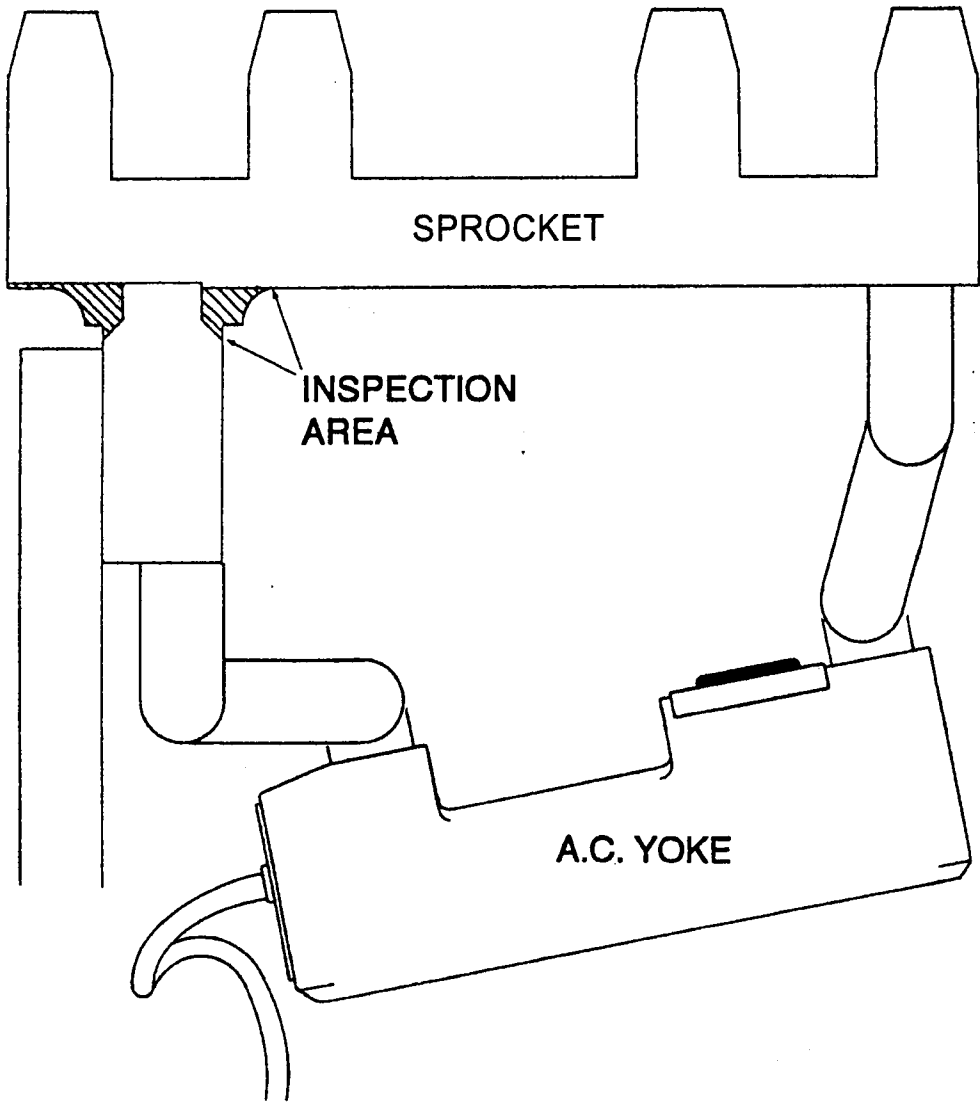
Chance Rides, Inc. has become aware that cracks can develop in the large chain drive sprocket on the FALLING STAR amusement ride. The cracks have appeared on the back side of the sprocket in the radius where the horizontal part of the sprocket is welded to the vertical part of the sprocket.
