NUMBER: B391R1145-0

SERVICE BULLETIN

Ride: FALLING STAR

Subject: Gearbox Inspection

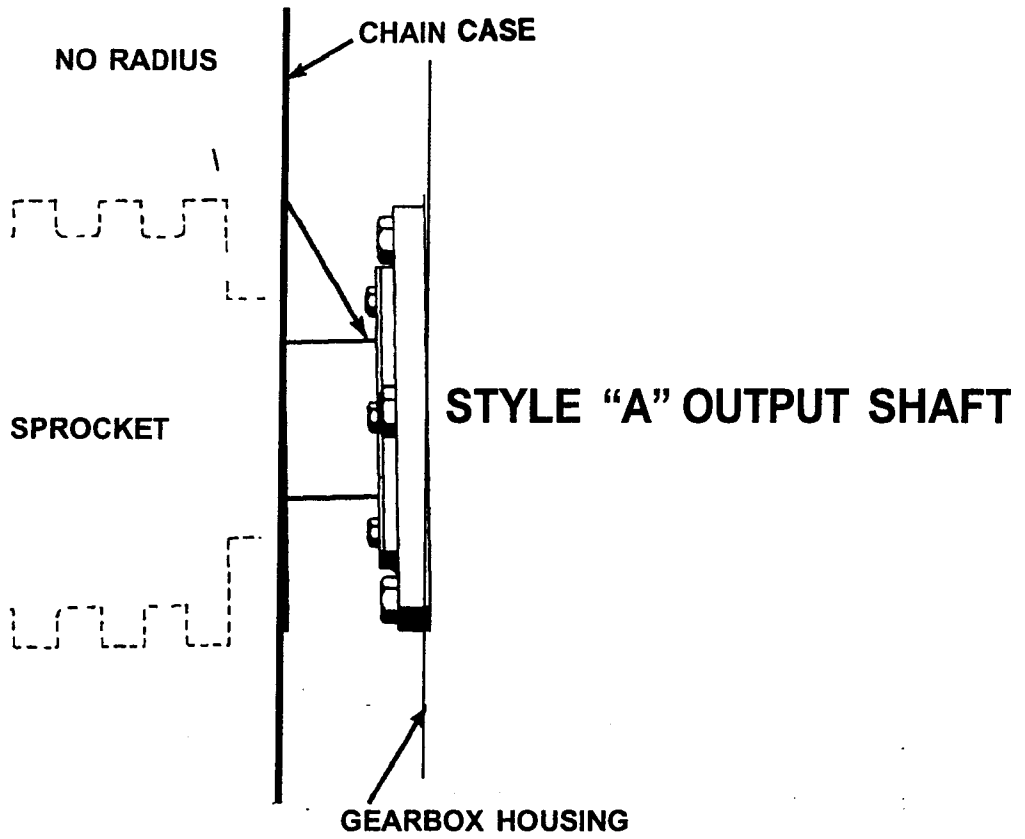
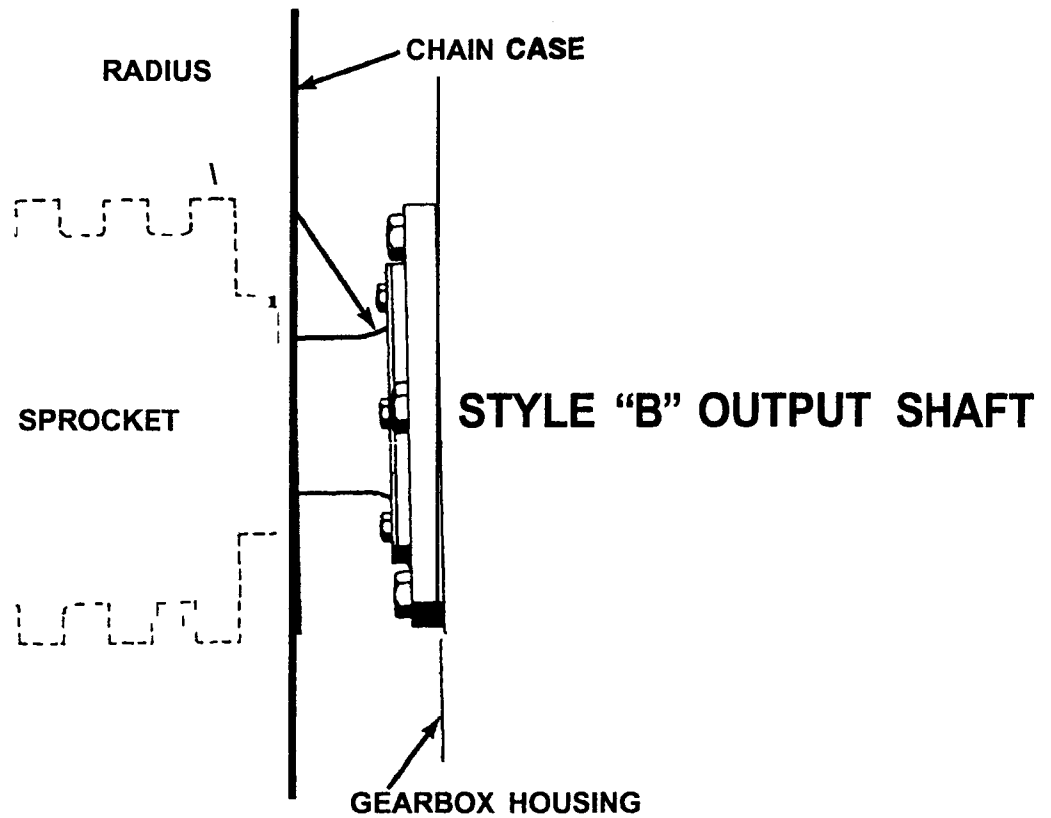
1. Remove inspection plate from top of gearbox.
2. Slowly rotate gears while visually inspecting gears for pitting, broken teeth, and/or uneven wear.
3. Identify large output shaft style, see illustration.

**INSPECT THIS
SHAFT TO IDENTIFY
STYLE "A" OR STYLE "B"**

NAMEPLATE

**REMOVE THIS COVER
TO INSPECT GEARS**

In an effort to better serve all FALLING STAR owners Chance Rides Inc. requires all FALLING STAR owners to complete and return the attached Certificate Of Compliance, within fifteen (15) days from receipt of this bulletin, including the gearbox serial number and output shaft style.
