NUMBER: B400R1046-A

SERVICE BULLETIN

Ride: GIANT GONDOLA WHEEL

Subject: Gondola Door Adjustment

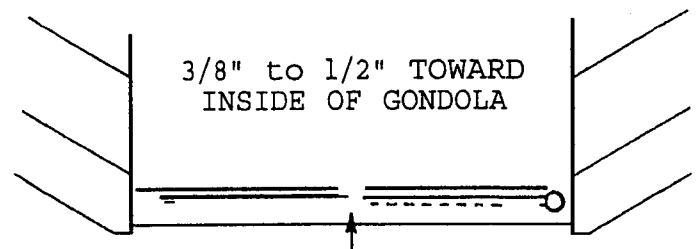
RIDE SERIAL NUMBERS 400-001-88 THROUGH 400-012-89

With the doors closed, and the cam pin against the stop bolt, check the alignment of the door panels. The doors must be angled slightly toward the center of the gondola as shown, not flush with each other.

If adjustment of the doors is required, follow the procedure on the reverse side of this bulletin.

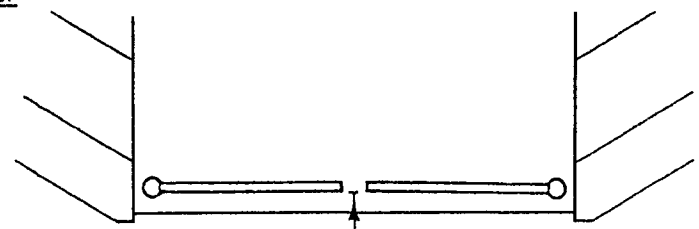
RIDE SERIAL NUMBERS 400-013-89 AND ON

With the doors closed, and the cam pin against the stop bolt, check the alignment of the door panels. The doors must be flush with each other.

If adjustment of the doors is required, follow the procedure on the reverse side of this bulletin.

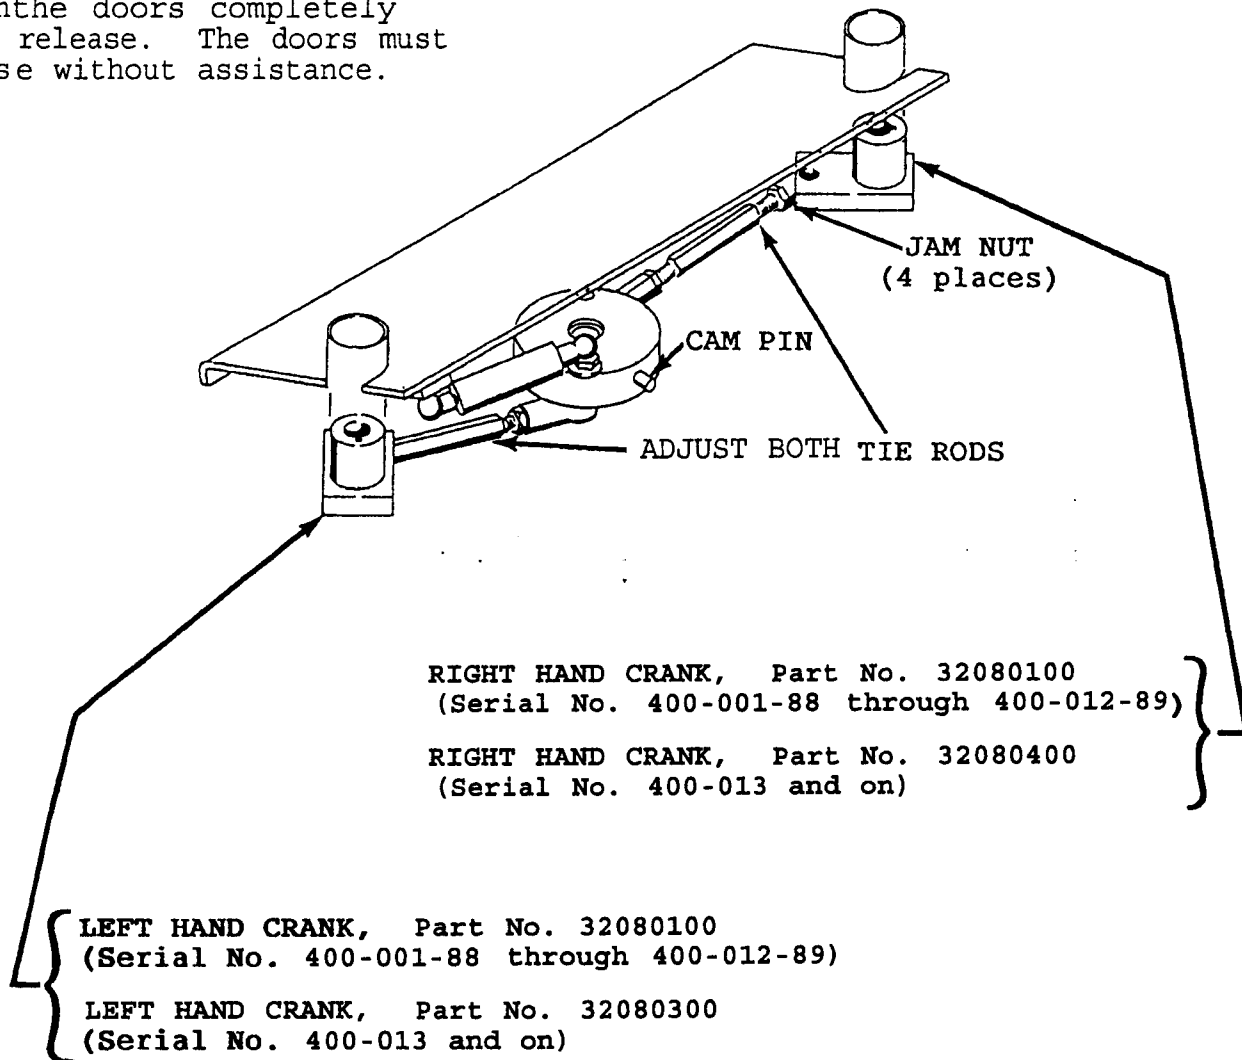
Adjustment

If adjustment of the doors is required, remove the access panel and adjust the length of the tie rods. Loosen jam nuts and turn the rod to shorten or lengthen both tie rods as required. Tighten jam nuts and replace the access panel.

Open the doors completely and release. The doors must close without assistance.
