Bulletin No:	B414CRM131-0
Release Date:	July 30, 2004
Effective Date:	July 30, 2004
Supersedes:	N/A
Completion Date:	N/A
Page:	1 of 3
1.0321

SERVICE BULLETIN

INVERTER (Portable Model)

Inspection of Main Bearing Capscrews

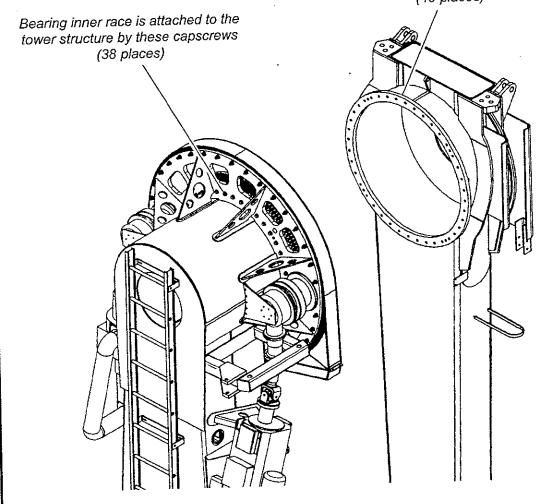
1. Locate the 40 capscrews which secure the main bearing to the arm. These capscrews are installed in through-holes in the outer bearing race and are secured by nuts on the outside of the flange as shown in the illustration.

NOTE: The heads of these capscrews are not accessible when the ride is assembled. Check the capscrews at the nuts, which are accessible from the back side of the flange.

Bearing outer race is attached to the main arm structure on this flange. Nuts are accessible from back side of the flange (40 places)

- 2. Locate the 38 capscrews which secure the main bearing to the tower structure. These capscrews are installed into tapped holes in the inner bearing race.
- 3. Use a torque wrench to check all capscrews and nuts. SET THE TORQUE WRENCH TO ONLY 140 FT-LBS TO CHECK THE FASTENERS. This permits the fastener to be checked, but prevents damage to the LocTite.

4. The fasteners must not turn when checked as instructed. If any fastener turns, it indicates a damaged or loose fastener. The fastener must be removed and replaced with a new part. Apply LocTite 271 (red) to the threads using the manufacturer's instructions. Tighten to the correct assembly torque of 160 ft-lbs.
