Chance Service Bulletins for Inverter Overview

Inspection of Secondary Restraint Bar (T-Bar) Locking Mechanism

Inspection, Replacement and Operation of Hydraulic Lock Cylinders

Vehicle Frame Inspection and Rework

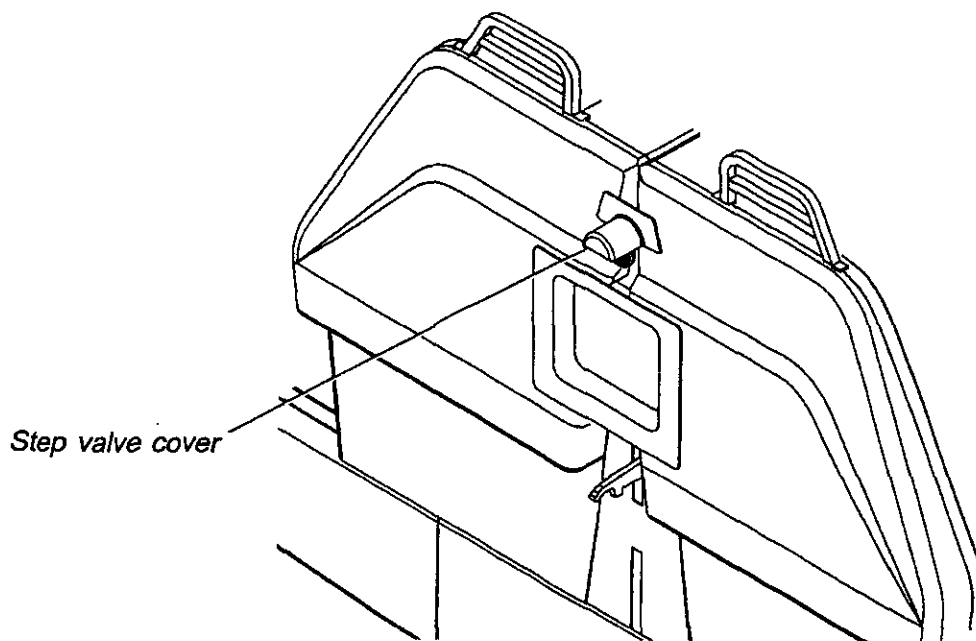
Chance Rides, Inc. has become aware that the step valve on the INVERTER amusement ride can be accidentally actuated by the operator or passengers as they are loaded and unloaded, causing the step to raise. Unexpected movement of the step can cause injury to persons in its path.

Chance Rides, Inc. has developed a cover which requires deliberate action by the operator to actuate the step valve. All owner/operators of the above noted INVERTER amusement rides are required to install the Step Valve Cover Kit, part number K414R1218-0, using the instructions on the following page of this bulletin. The kit includes all parts necessary to rework one vehicle. For DOUBLE INVERTER rides, order two kits.

**Installation Instructions - Step Valve Cover**

1. Locate the cover so that it is centered over the step valve knob.
2. Drill through the cover and the fiberglass panels using a 3/16" drill. Maintain 3/8" margin on all edges.
3. Secure the cover to the vehicle using the four pop rivets provided.

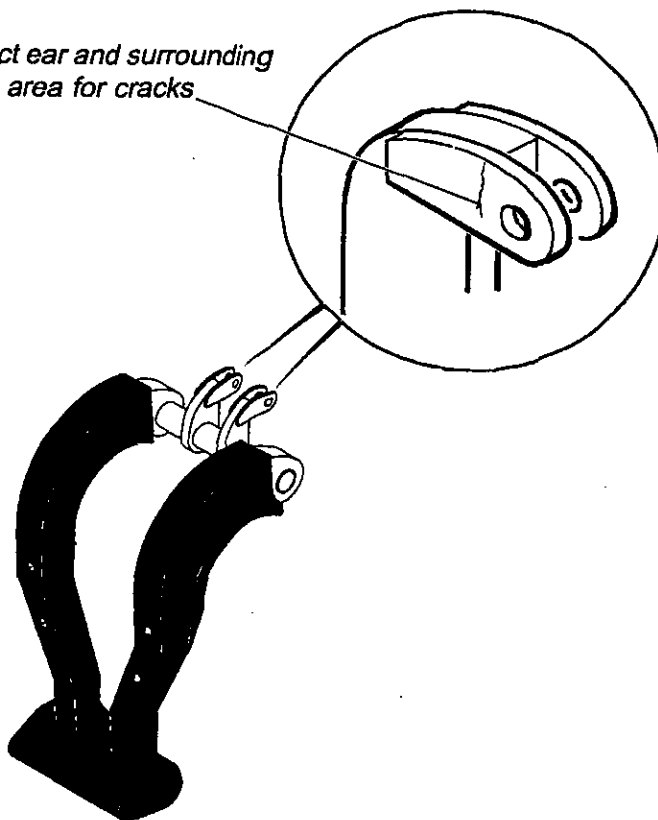
Chance Rides, Inc. has become aware that cracks can form in and around the ears on the back of the primary restraint bars on the INVERTER amusement ride.

*Inspect ear and surrounding
area for cracks*

Visually inspect all primary restraint bars (24 total) as shown. If any cracks are found, contact the Chance Customer Service Department immediately. DO NOT ATTEMPT TO REPAIR THE CRACK.

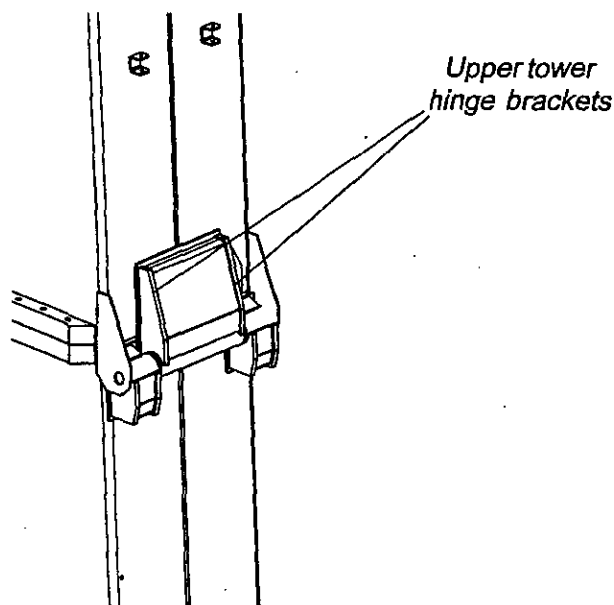
Chance Rides, Inc. has become aware that cracks can develop in the tower hinge area of the above noted INVERTER amusement rides. The areas where the cracks can occur are the welded joints for the upper tower hinge bracket. If these welds break, the tower can fall during the set-up or tear-down procedure, when the tower is being raised or lowered. This can possibly result in personal injury to set-up personnel and/or bystanders. A kit has been developed to reinforce the tower hinge brackets.

If indications are found in the hinge brackets or surrounding area, contact the Chance Customer Service Department for specific repair instructions. **DO NOT ATTEMPT TO SET-UP OR TEAR-DOWN THE RIDE IF CRACKS ARE FOUND IN THE HINGE AREA.**

If no indications are found, order and install the Tower Hinge Bracket Rework Kit, number K414R1223-0. This kit includes all necessary parts to rework one complete ride, with complete instructions for installation. **DO NOT INSTALL THIS KIT IF THERE ARE CRACKS IN THE TOWER HINGE AREA UNTIL REPAIRS SPECIFIED BY THE MANUFACTURER ARE MADE.**

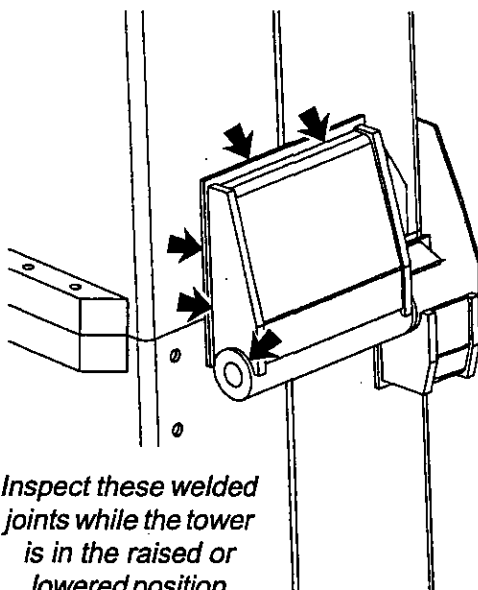
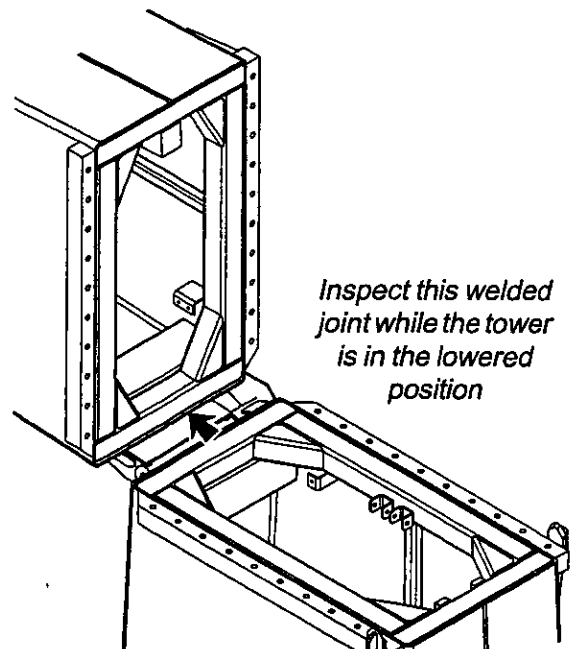
1. Visually inspect the welds in the area where the tower hinge brackets attach to the tower as shown.
2. If cracks are found, contact the Chance Customer Service Department for specific repair instructions prior to installation of the rework kit. **DO NOT ATTEMPT TO SET-UP OR TEAR-DOWN THE RIDE IF CRACKS ARE FOUND IN THE HINGE AREA.**
3. If no cracks are found, order and install the Upper Tower Hinge Bracket Rework Kit (K414R1223-0) using the instructions provided with the kit.

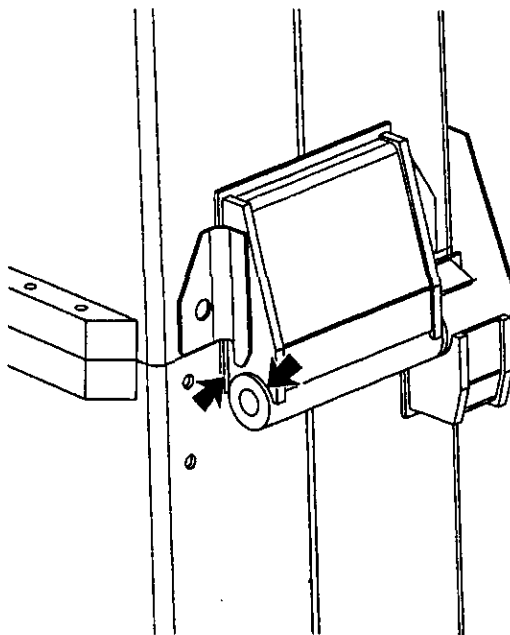
1. Visually inspect the welds in the tower hinge areas shown.
2. If cracks are found, contact the Chance Customer Service Department immediately. **DO NOT ATTEMPT TO SET-UP OR TEAR-DOWN THE RIDE IF CRACKS ARE FOUND IN THE HINGE AREA.**

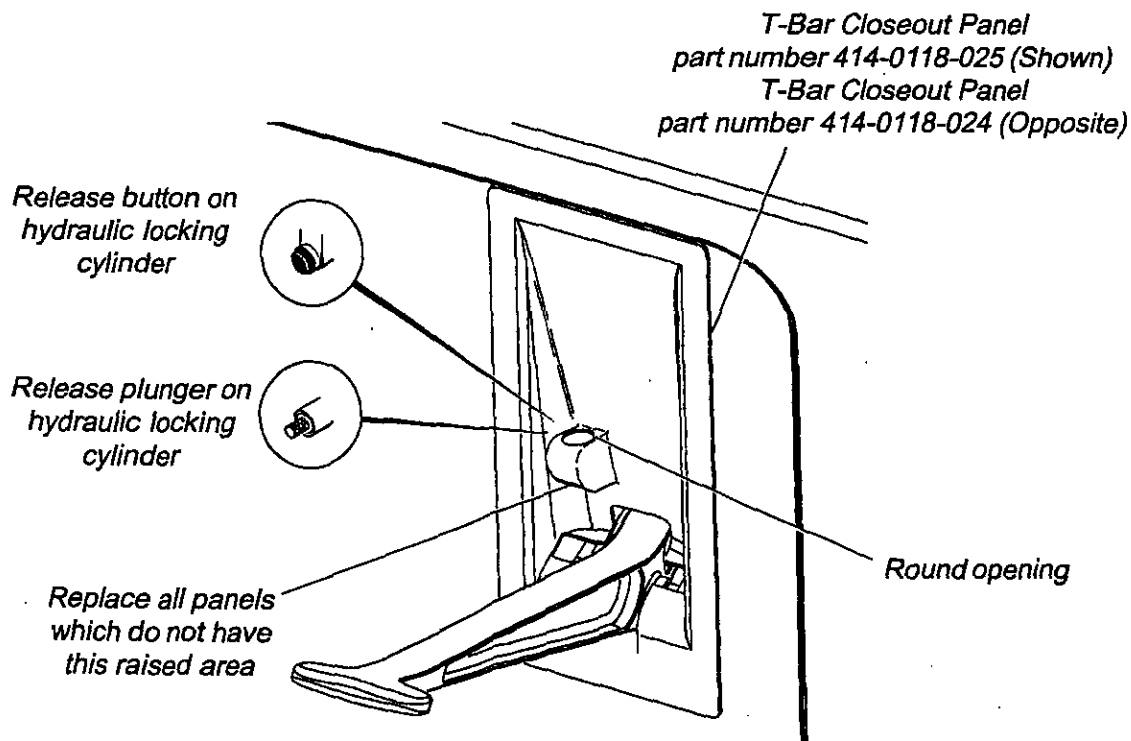
Inspect all T-bar closeout panels (8 right hand panels and 8 left hand panels) for raised area over manual release on hydraulic locking cylinder. Replace all panels which do not have this raised area.

NOTE: For hydraulic locking cylinders with release plunger, the closeout panel must have openings in both the top and bottom of the raised area. Replace the panels with the parts shown below as required, or rework by cutting a 1-1/8" diameter hole in the bottom of the raised area.

Chance Rides, Inc. requires all owner/operators of the above noted INVERTER amusement rides to inspect all T-bar closeout panels and, if required, replace with the new design panels. Refer to the illustration on the following page of this bulletin.

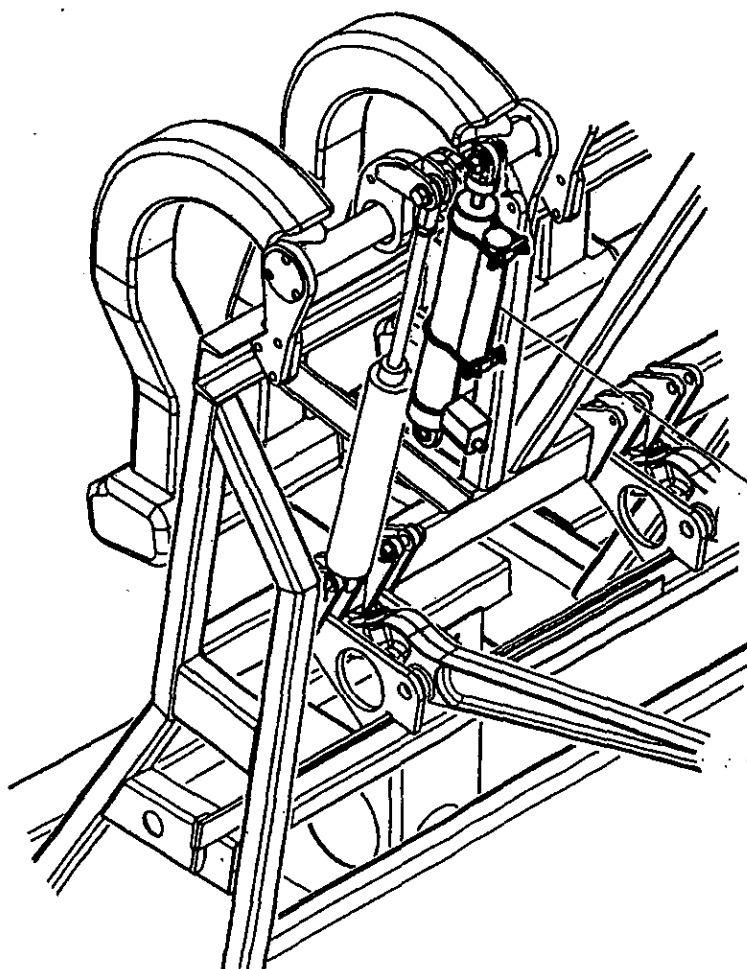
Inspect the hydraulic lock cylinders for all seats (24 total). Identify the cylinders based on the distinguishing characteristics detailed on the next page.

Hydraulic lock cylinder
for primary restraint bar
(lap bar)

All owners of the above noted amusement rides are required to inspect all hydraulic lock cylinders per the instructions on the following page of this bulletin. If any defective cylinders are found, order and install part number 22162104 in the appropriate quantity to replace all defective cylinders.

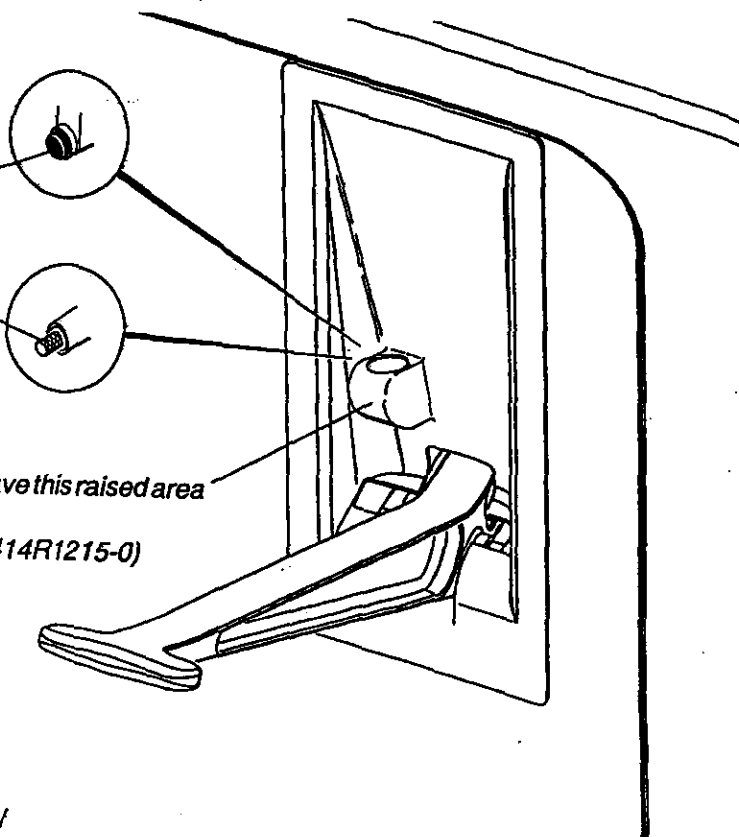
- push the black release button
- or -
- pull the red release plunger

NOTE: All closeout panels must have this raised area
over the manual release.
(refer to Service Bulletin B414R1215-0)

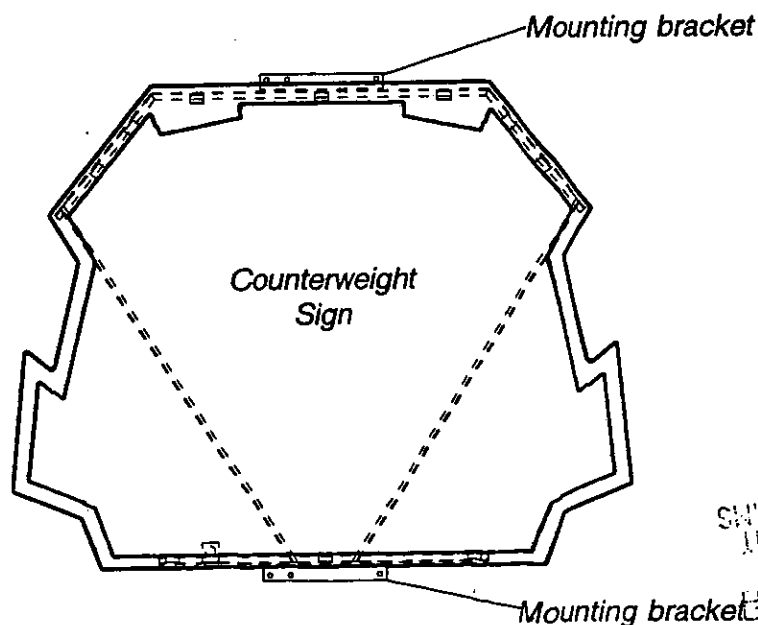
Chance Rides, Inc. has become aware that cracks can develop in the counterweight sign frame on the above noted INVERTER amusement rides. The area where the cracks can occur is the welded joints for the mounting brackets. If these weld break, the sign can fall, possibly resulting in personal injury to the operator, passengers and/or bystanders.

Two rework kits have been designed:

- For ride serial numbers 414-00699 through 414-01499 and 414-005P99, a kit has been developed to reinforce the aluminum sign frame. The kit, part number K414R1221-1 includes steel doubler plates which attach to the existing frame.
- For ride serial numbers 414-00399 through 414-00599, a kit has been developed to replace the aluminum sign frame with a steel frame. The kit, part number K414R1221-2 includes a complete steel sign frame.

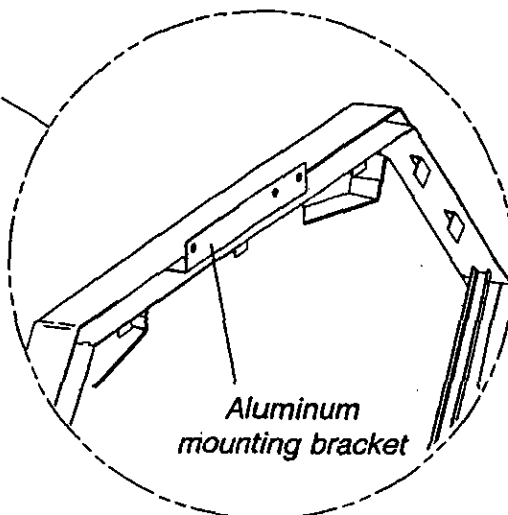
1. Visually inspect the aluminum mounting brackets and welds in the area where the mounting brackets attach to the frame. Use an inspection mirror or similar tool to view the area under the fiberglass sign.
2. If cracks are found or if the mounting holes in the bracket are excessively worn, contact the Chance Customer Service Department for specific repair instructions prior to installation of the rework kit.
3. If no cracks are found, order and install the Counterweight Sign Rework Kit (K414R1221-1) using the instructions provided with the kit.

Aluminum
 mounting bracket

Side view of counterweight sign
 (Ride serial numbers 414-00699 through
 414-01499 and 414-005P99)

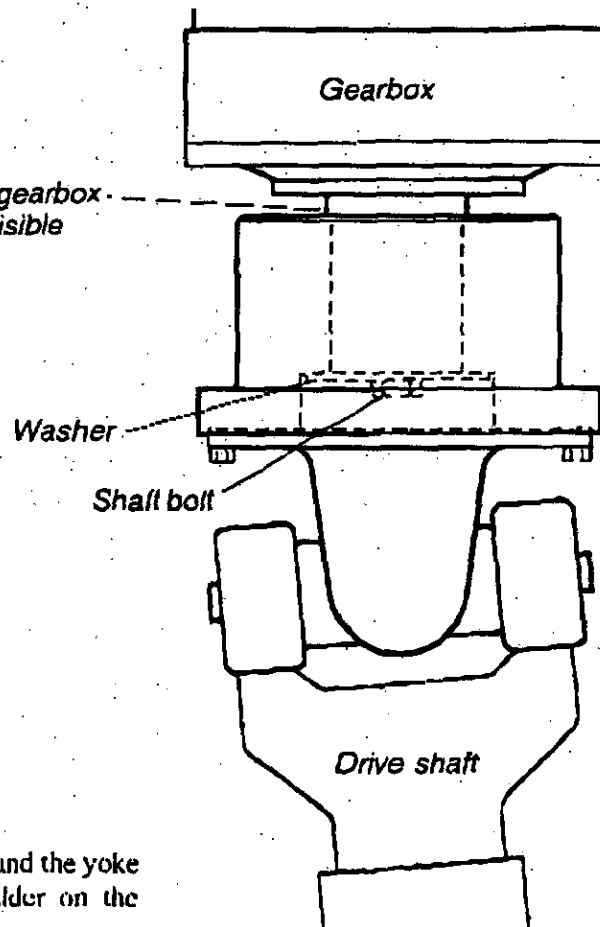
Correct
Shoulder on gearbox
shaft is not visible

This condition indicates the shaft bolt is tight and the yoke adapter is properly seated against the shoulder on the gearbox shaft.

Repeat this inspection at monthly intervals.

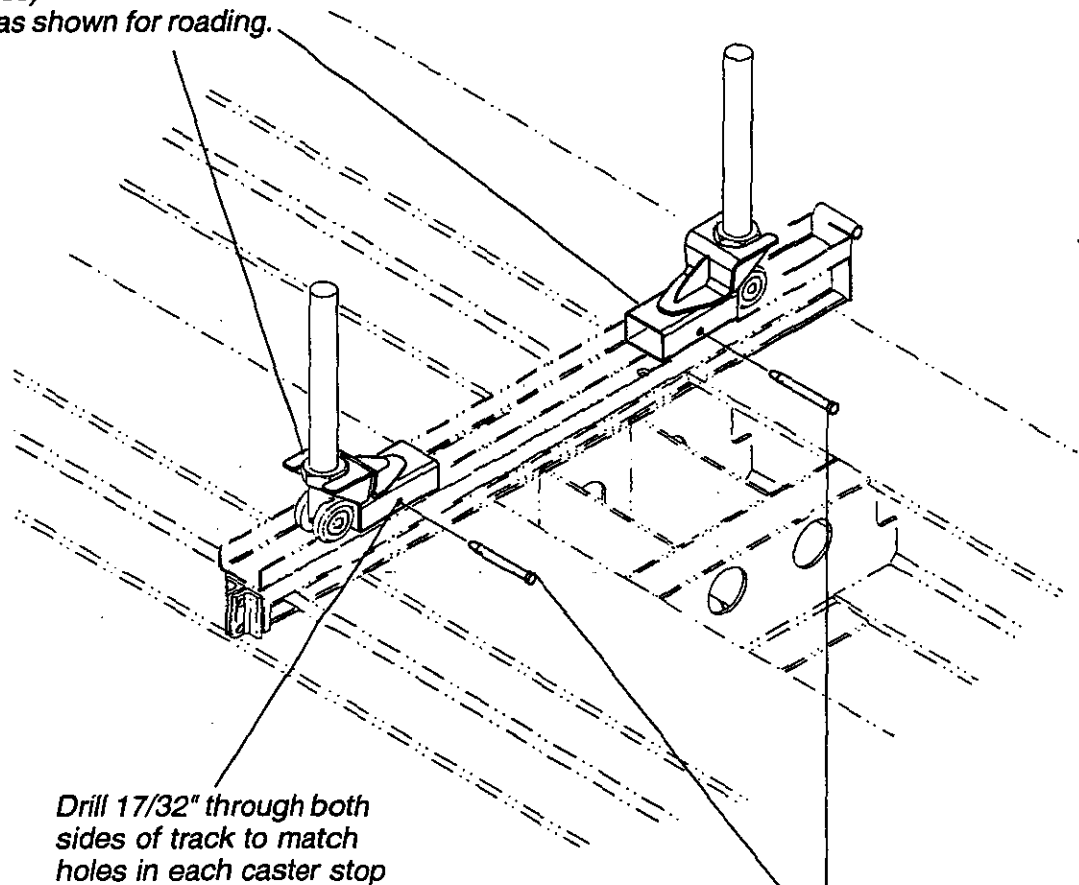
Install as shown for roading.

Drill 17/32" through both
sides of track to match
holes in each caster stopSecure with pin and
hairpin provided

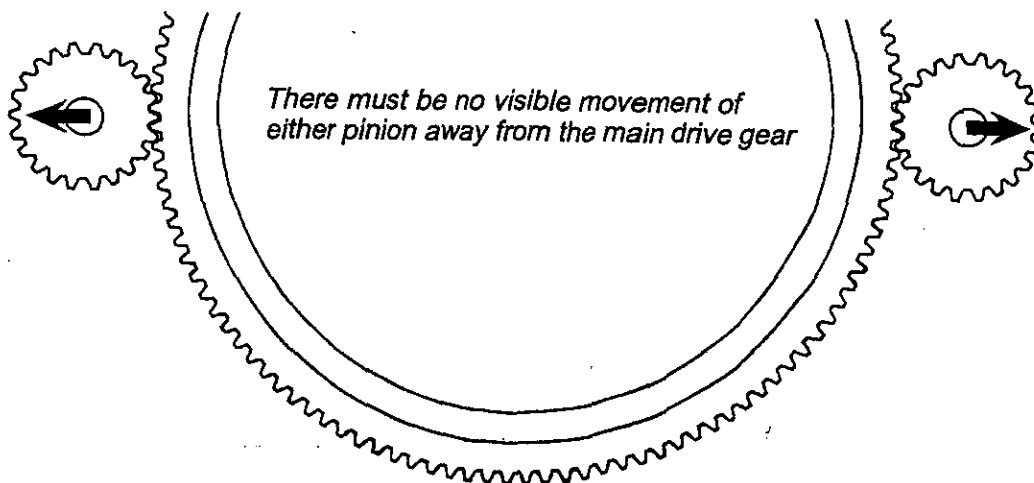
Observe the movement of the pinions in relation to the main drive gear. The pinions must only rotate. Any movement away from the main gear indicates a problem in the gearbox.

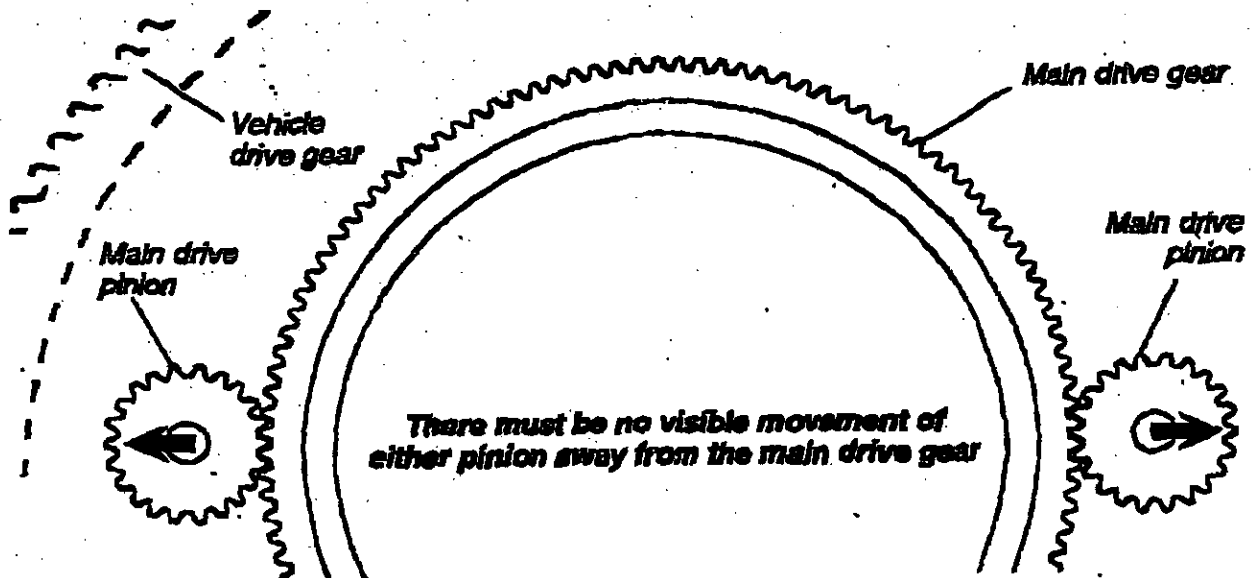
Observe the movement of the main drive pinions in relation to the main drive gear. The pinions must only rotate. Any movement away from the main gear indicates a problem in the gearbox.

- DAILY** - Inspect both main drive gearboxes and all four vehicle drive gearboxes. If any gearbox exhibits oil leakage or excessively noisy operation, it is likely that failure of that gearbox has occurred.

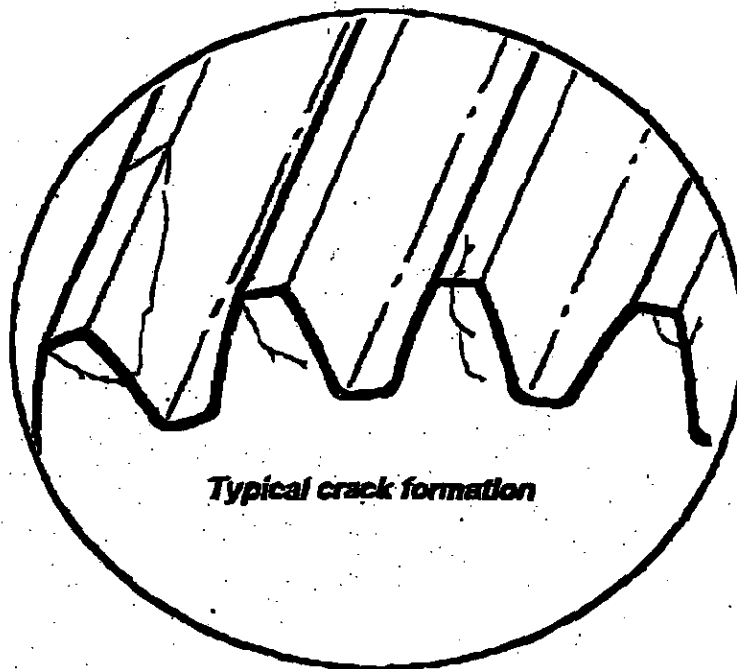
4. **WEEKLY** - Carefully inspect the teeth on the main drive gear. Look for broken, chipped or cracked gear teeth. If necessary, wipe away the grease to see the teeth clearly. The gear is accessible for inspection through holes in the structure and in the gear guard. If necessary, remove the gear guard.

Typical crack formation

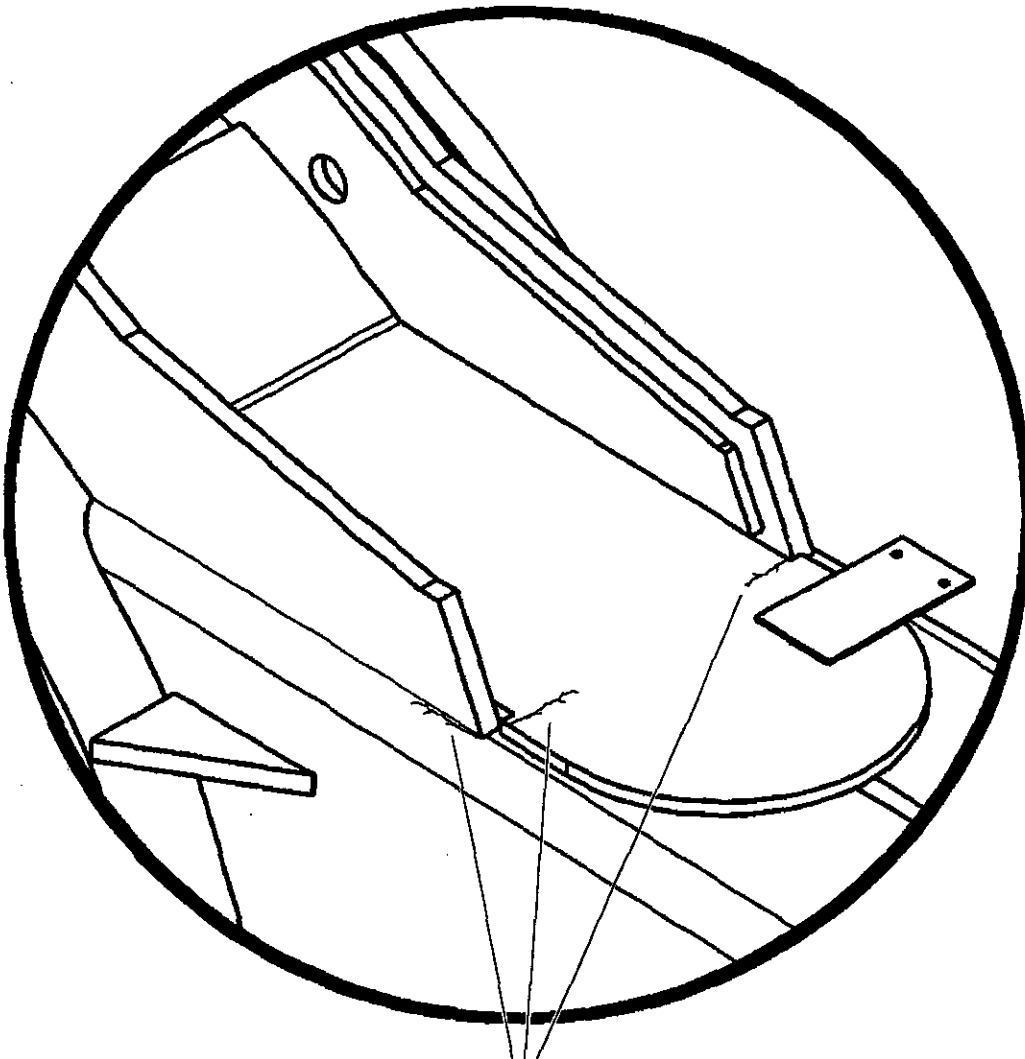
Inspect all four corners for cracks in these areas

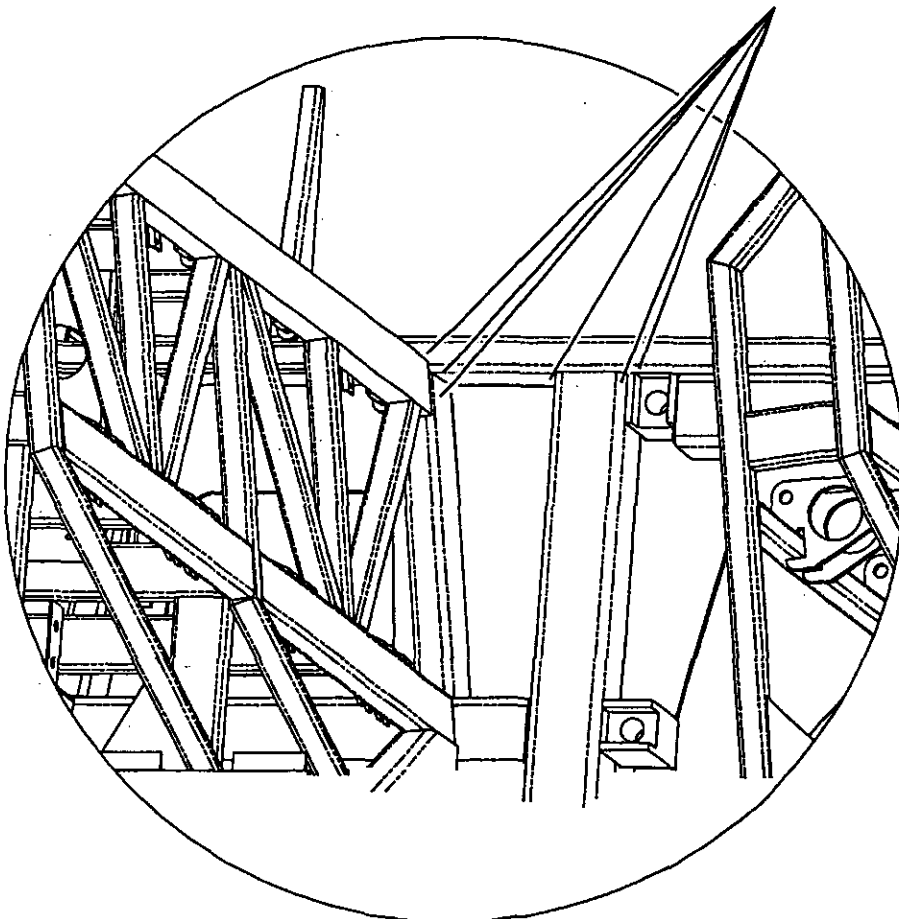
Inspect for cracks in these areas on both sides of the vehicle mounting plate. Carefully inspect all sides of each joint, looking for indications in the welds and the parent metal.

NOTE: For clarity, fiberglass seats and back panel are not shown in some views.

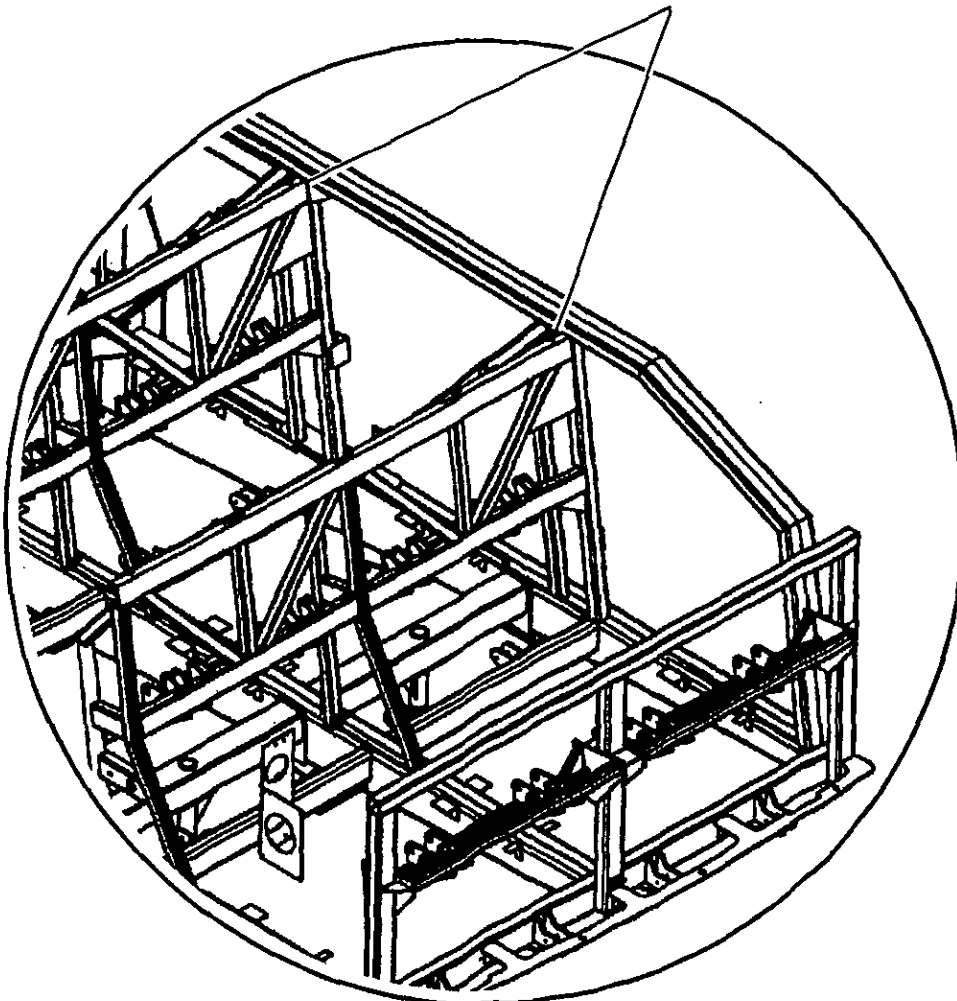
*Inspect the welded joints on
these channels at both ends
of vehicle*

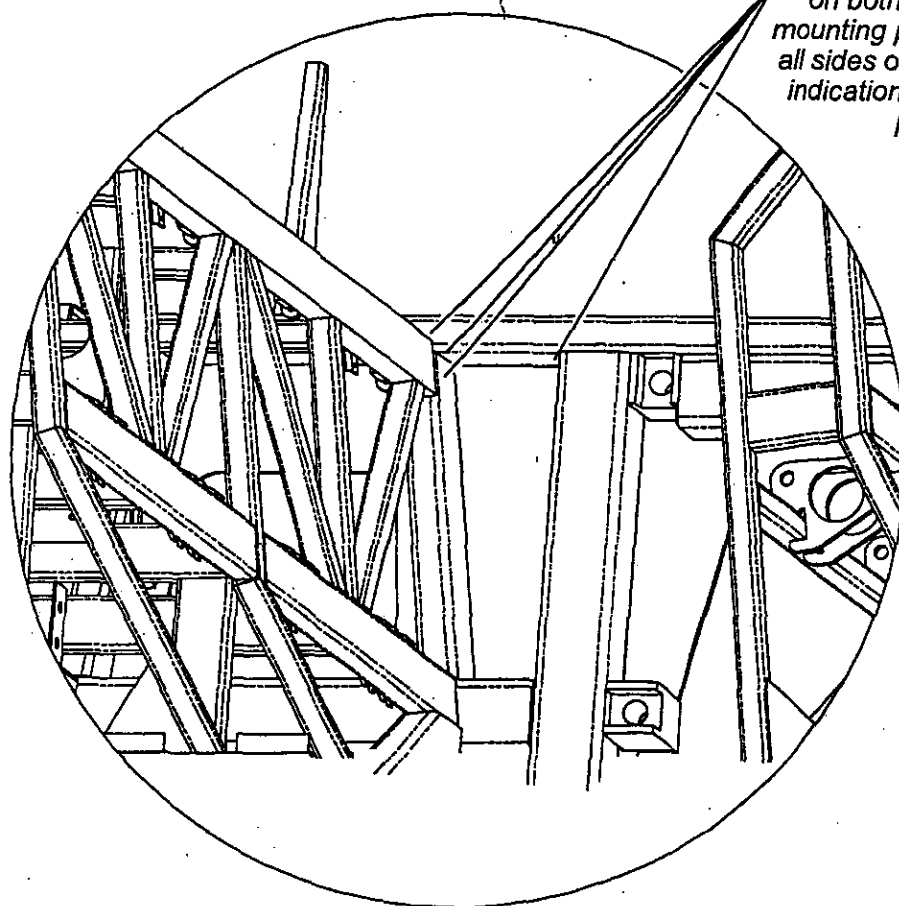
Inspect for cracks in these areas on both sides of the vehicle mounting plate. Carefully inspect all sides of each joint, looking for indications in the welds and the parent metal.

NOTE: For clarity, fiberglass seats and back panel are not shown in some views.

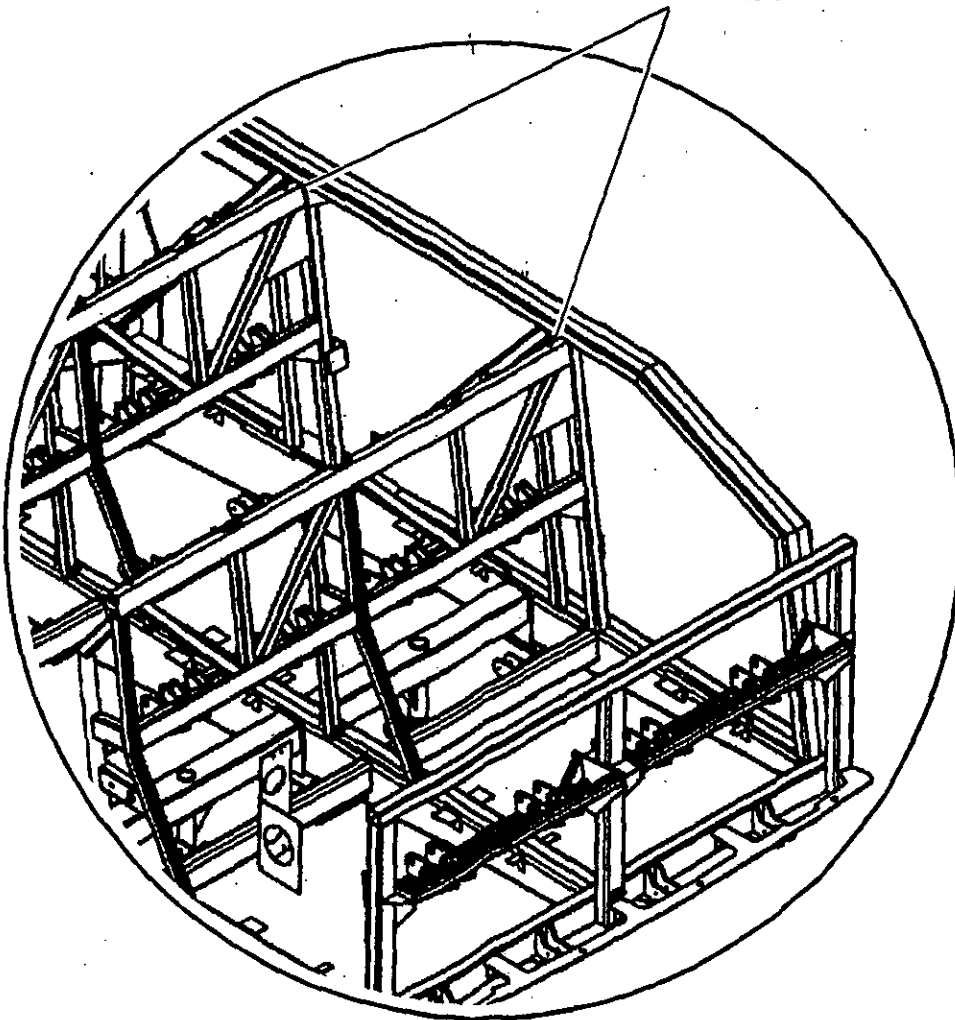
*Inspect the welded joints on
these channels at both ends
of vehicle*

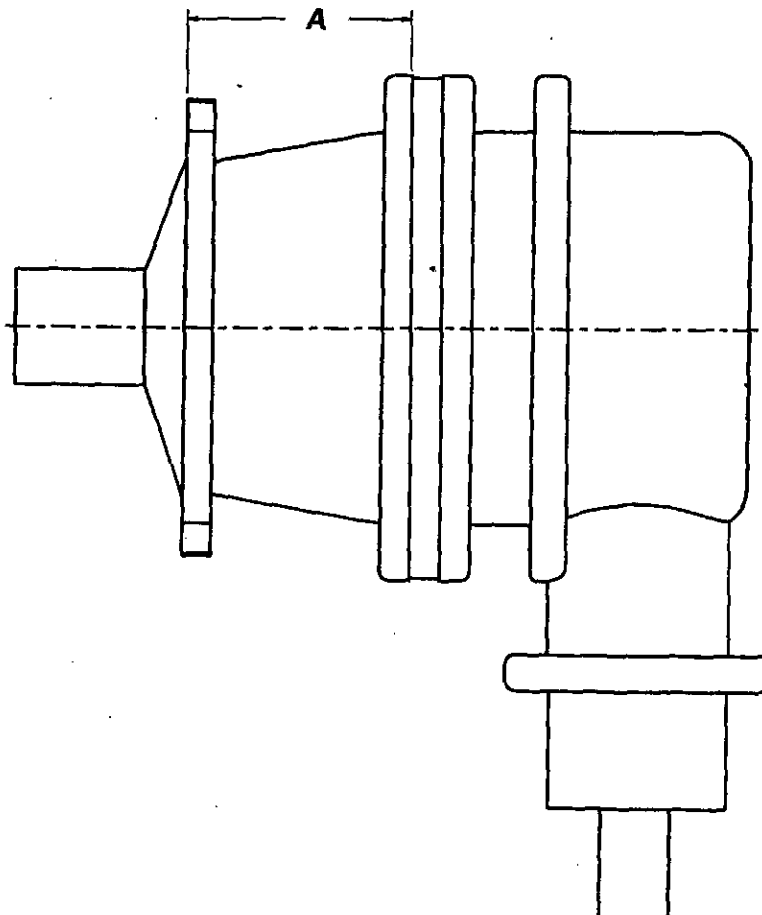
Identify BOTH main drive gearboxes to determine how this bulletin affects your specific ride. The gearboxes can be identified by measuring the distance between the flanges (Dimension "A") on the output section as shown in the following illustration.

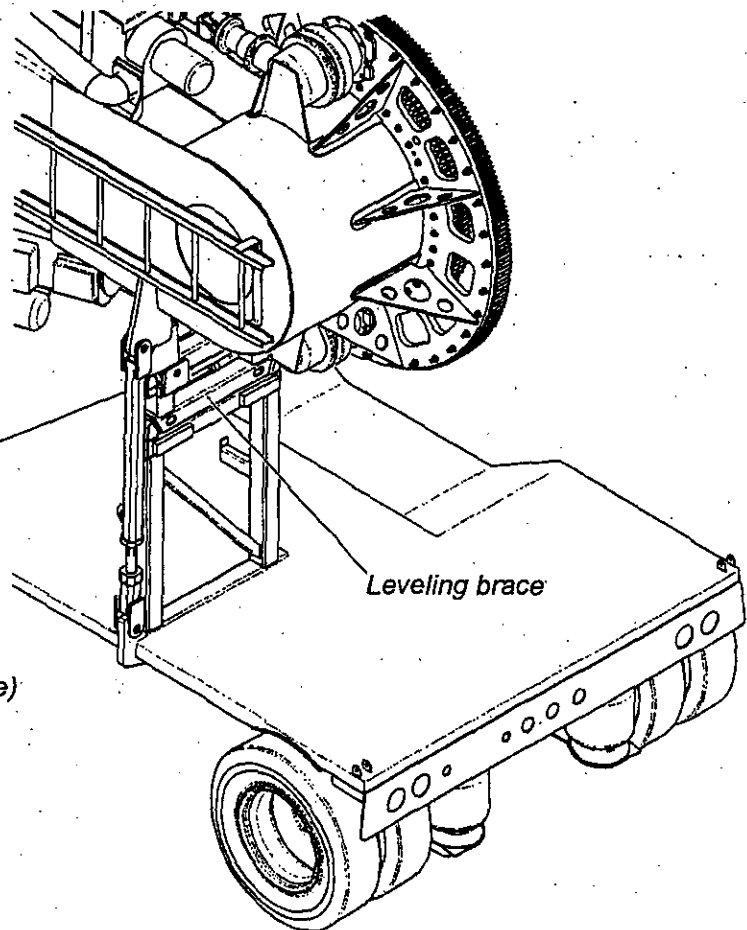
*The leveling strut
must be installed and
tightened before swinging
the counterweight arm into
the operating position
(See "Set-Up and Tear-Down
Procedure" on the following page)*

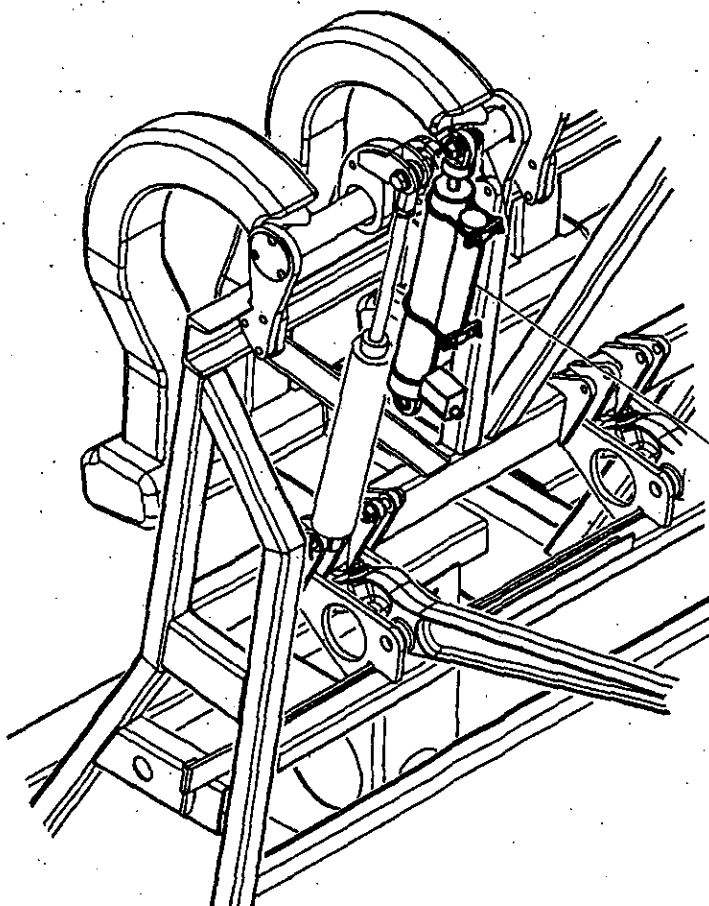
Inspect the hydraulic lock cylinders for all seats (24 total). Identify the cylinders based on the distinguishing characteristics detailed on the next page.

Hydraulic lock cylinder
for primary restraint bar
(lap bar)

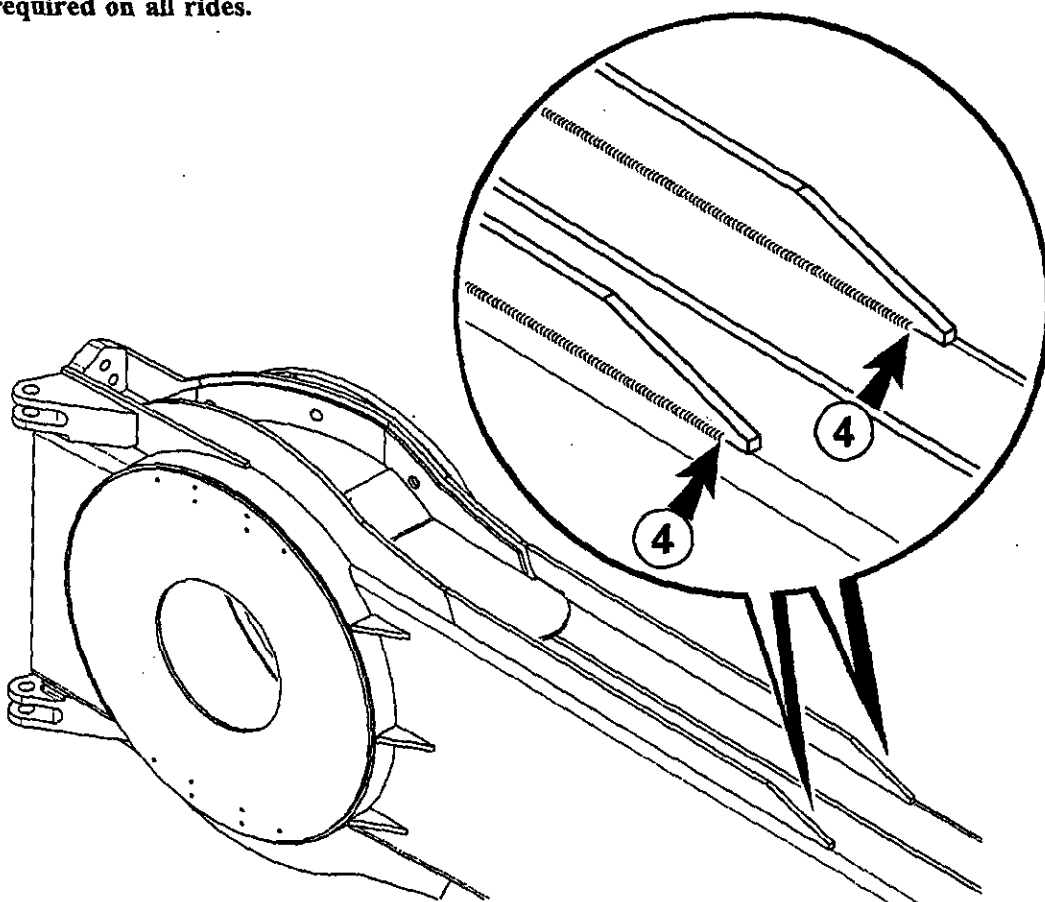
Area 4 (Main Arm) - Vehicle arm gussets extension ends. This inspection point applies only to portable model rides equipped with the gusset extensions shown. These gusset extensions are not required on all rides.

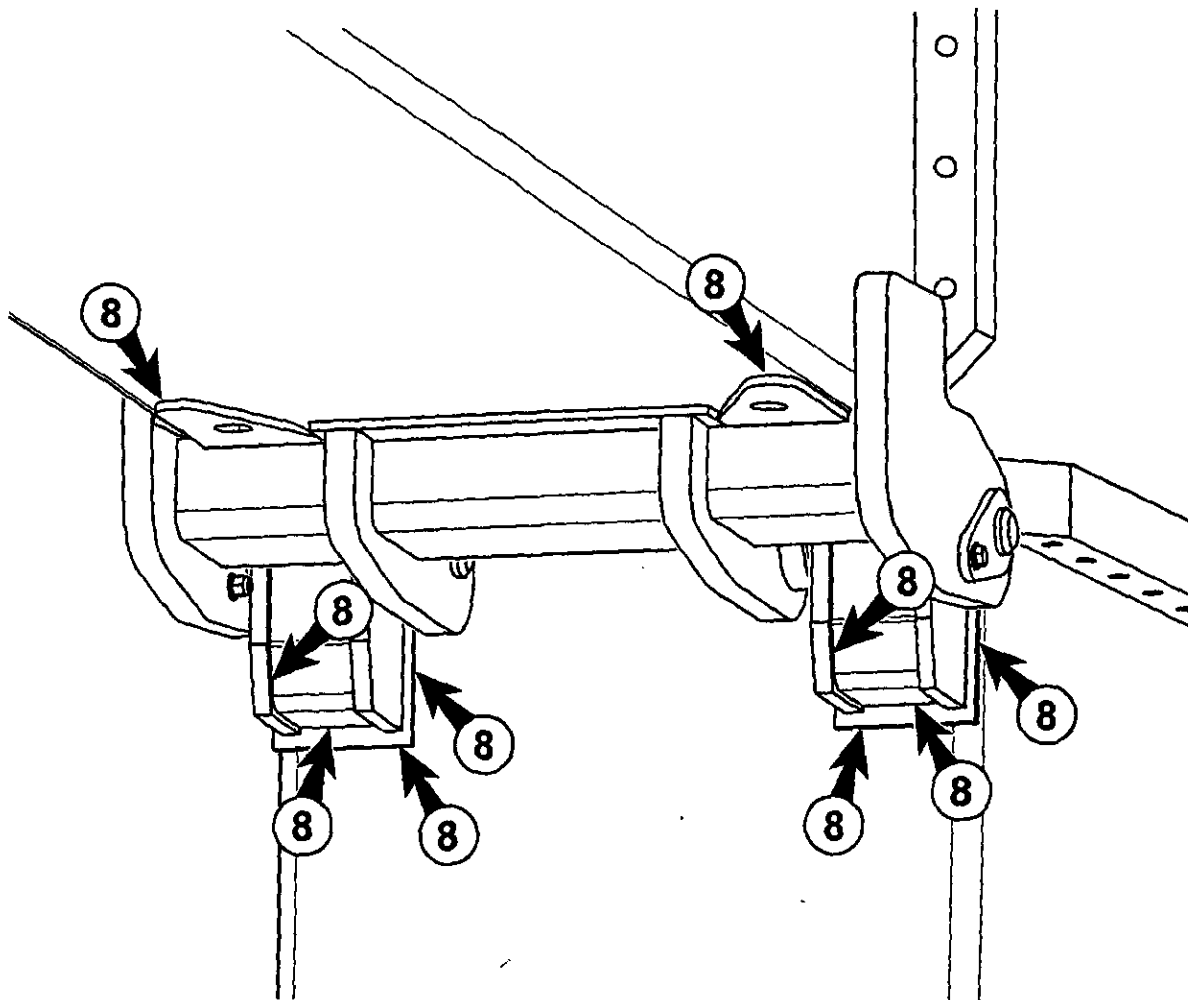
Area 8 (Tower Hinge) - Welds and parent metal around hinge blocks, brackets, pivot ears and doubler plates. This inspection point applies only to portable model rides.

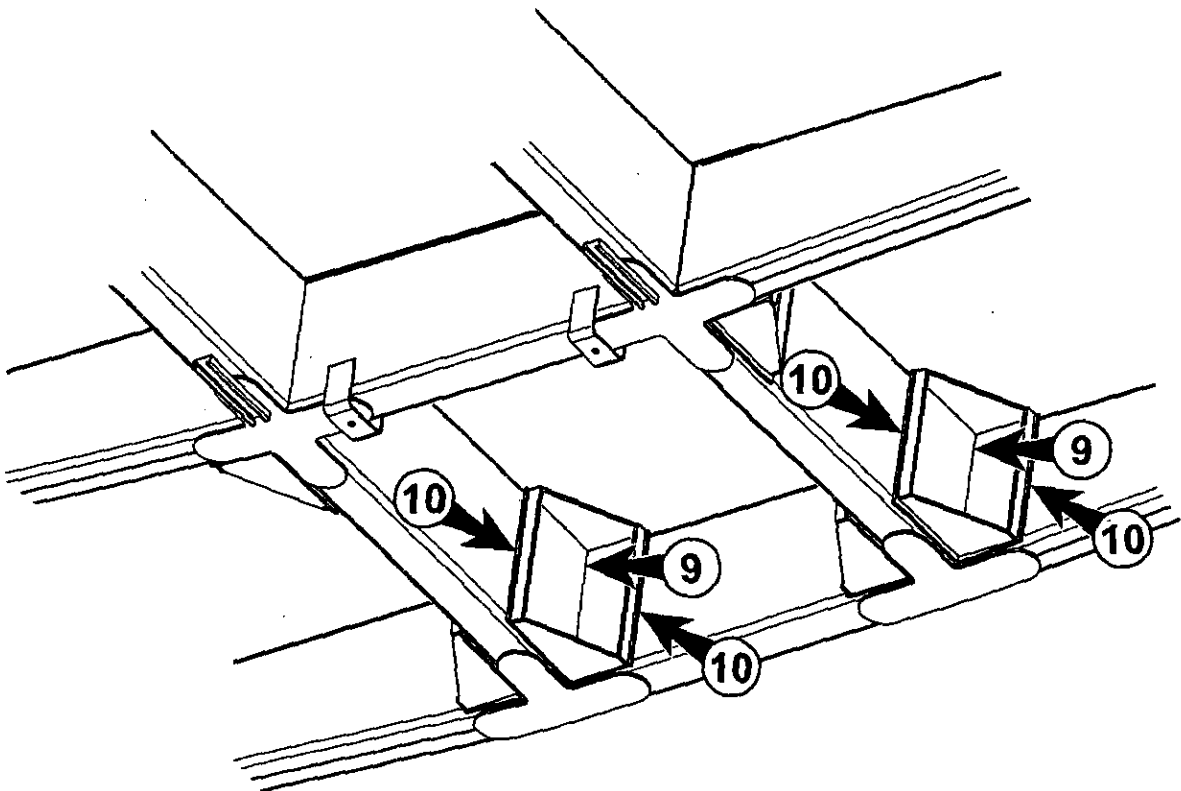
Area 10 (Vehicle Frame) - 4" x 12" lateral tube (fillet welds and gusset welds)

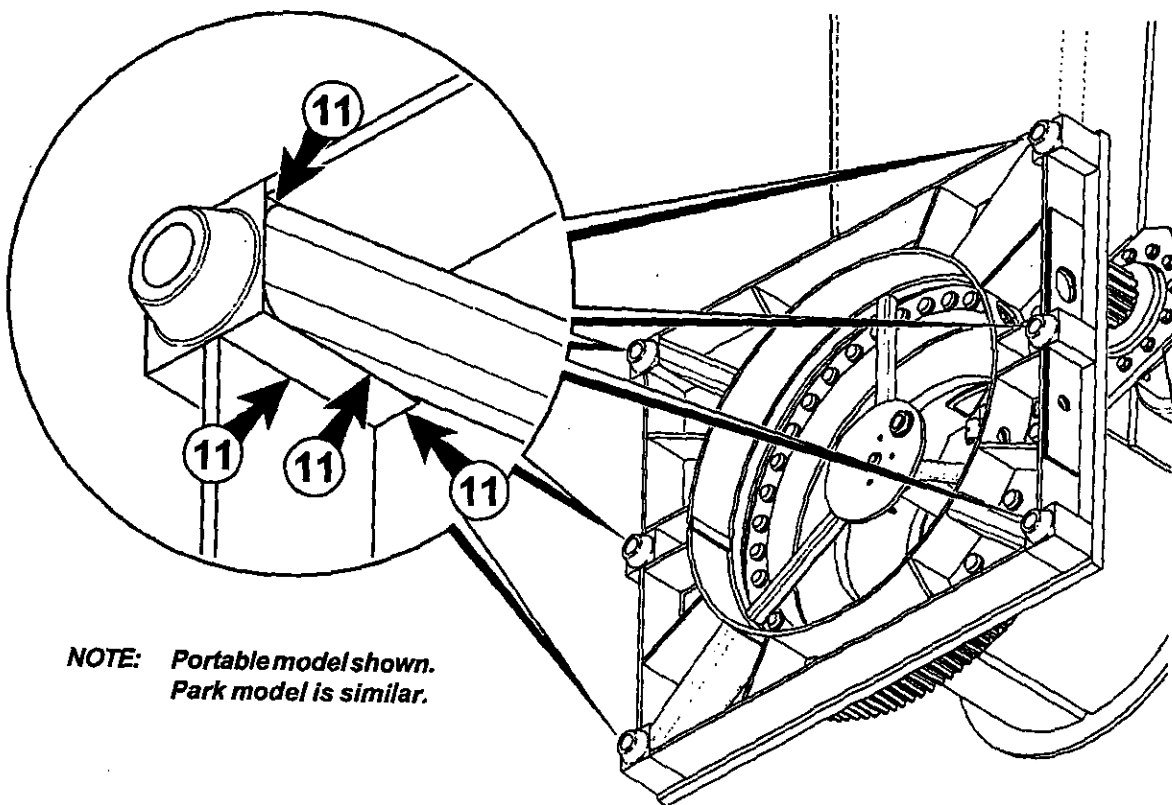
Area 11 (Vehicle Arm Adapter Box) - Welds around vehicle mounting blocks

NOTE: Portable model shown.
Park model is similar.

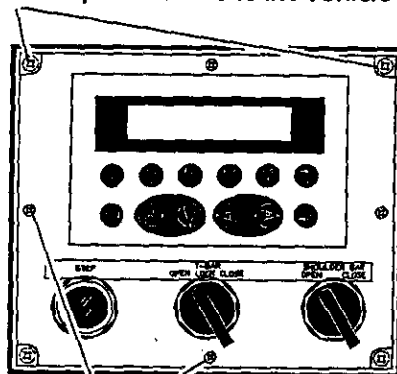
The corner screws secure the control panel frame to the vehicle

These screws secure the panel to the frame
