Chance Service Bulletins for Inverter Overview

Inspection of Secondary Restraint Bar (T-Bar) Locking Mechanism

Inspection, Replacement and Operation of Hydraulic Lock Cylinders

Vehicle Frame Inspection and Rework

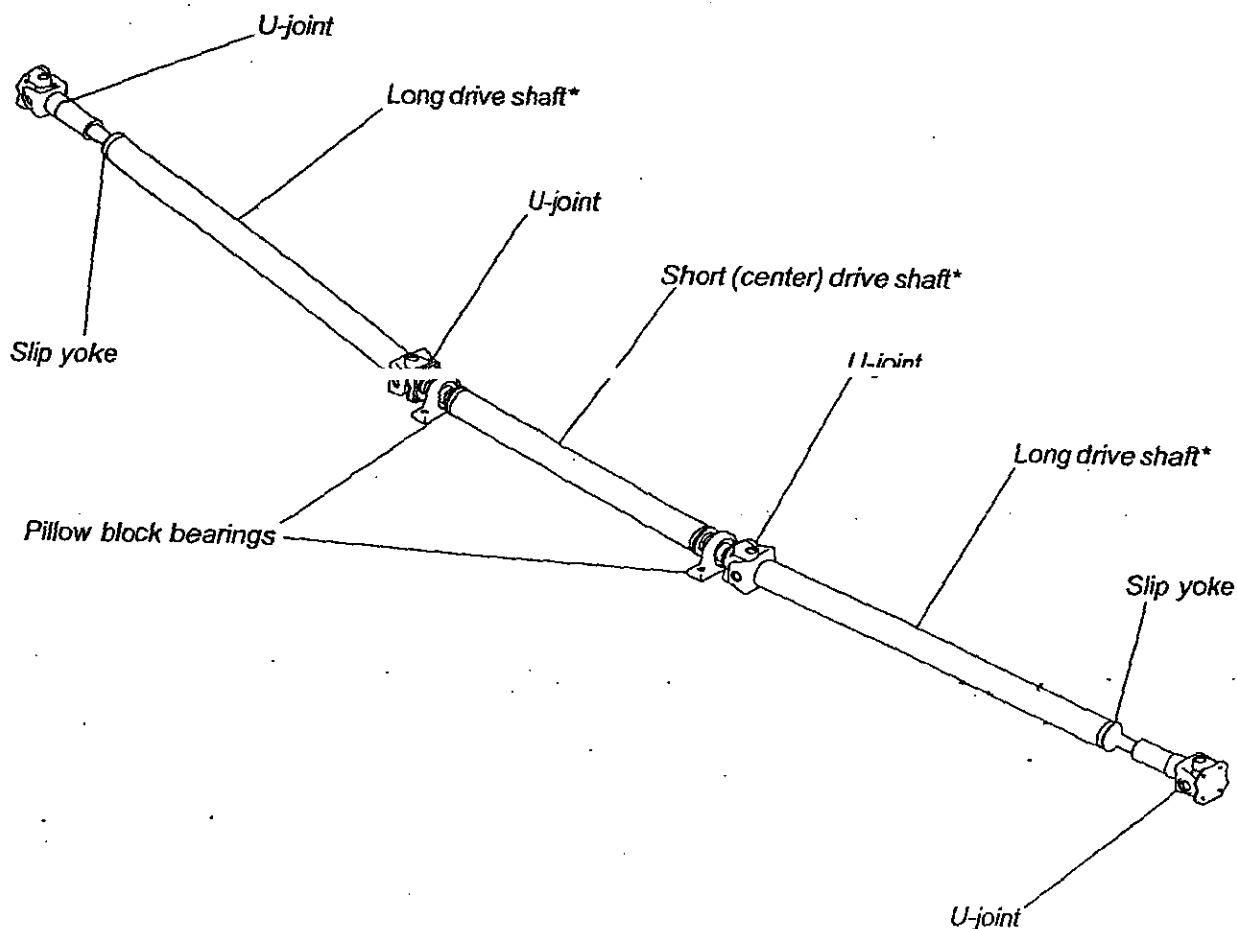
Drive Shaft Component Identification

* These components are not serviced separately
