Service Bulletin

Original Ride Manufacturer: Vekoma Manufacturing B.V. Vekoma International B.V.	Affected Production Dates: Between 1983 and 24-08-2001
Ride Name: Boomerang	Affected Serial Nos: See table 1.
Model No: N.A.	374-1
Abstract of issue: Evacuation procedure when the train stopped on lift #2.	
Reason for release: Additional information regarding evacuation procedures. Only when chain guide is covered.	
Action to be taken: As described in this document.

Bulletin No.: 1-SB-004-220507
 Release Date: 22-05-2007
 Effective Date: 22-05-2007
 Supersedes:
 0504-0903-0201-1-110106
 Completion Date: Immediately

SAFETY ALERT MESSAGE

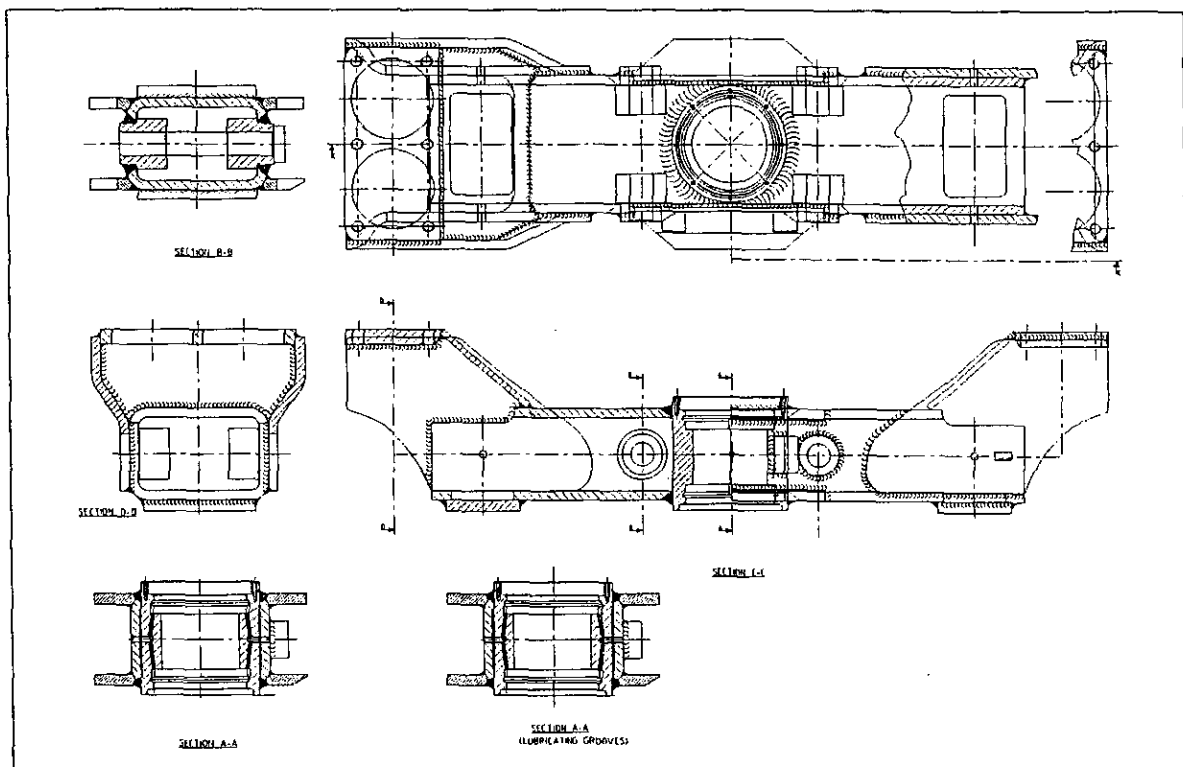
figure 1: Welded joints to be checked

- 1 Visually inspect **all welds** of the axle.

- 1 Check **all welds** of all main axles and rear axle for indications of cracks.

After 3 years of operation it is strongly recommended to increase the inspection from yearly to every 6 months.

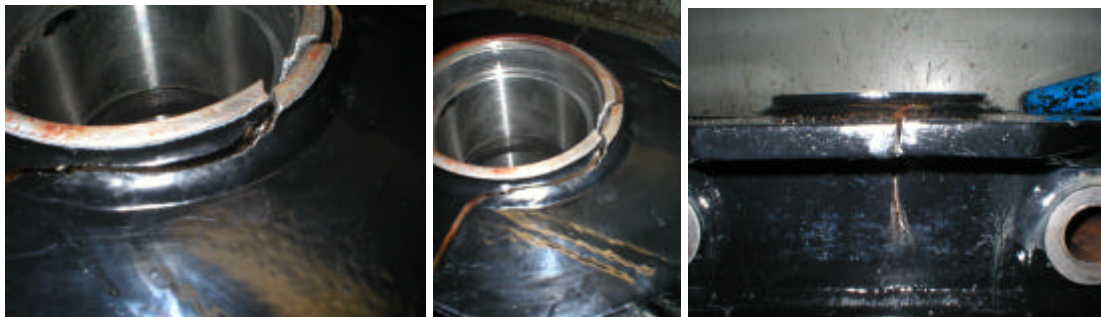
During the ride a strange noise was heard. Inspection immediately after the ride learned that one main axle was broken during or just before start of the ride. No passengers were hurt due to this incident.

See pictures below:

The line of the break originated from a crack in the center of the main axle. This crack, due to fatigue and, based on the rust patterns, was already in place for a considerable amount of time. The owner has applied powder paint to preserve the main axle. As a result of this flexible paint cracks could not be discovered in an early stage.

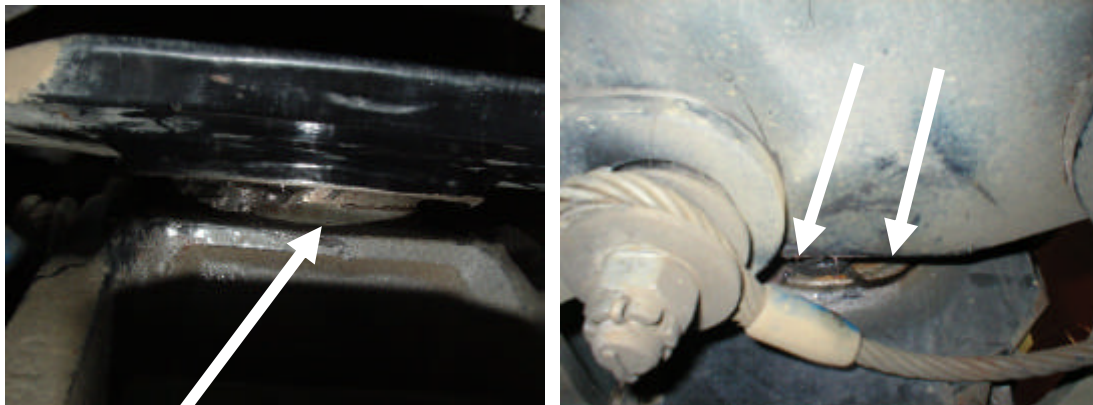
- The picture below shows that the weld itself is visual for inspection.

- Carefully weekly visual inspection as described in the manual to all welds on the axles, with special attention to welds as indicated with arrows on the pictures above and on the drawing below.
- Make sure that the actual paint is brittle, so the paint will crack when the surface below cracks.
- Make sure that the surface is clean and preferable painted in a lighter paint. This makes it easier to see indications.
- When there is any doubt, an additional NDT (UT and ET, or MT) inspection will be needed.
- We strongly recommend performing a major NDT (UT and ET, or MT) examination on these parts during the next winter stop.
- If there are any indications, please contact Vekoma Rides Parts & Services.
Tel.: +31 475 409 222
