# SERVICE BULLETIN

Effective Serial Numbers: AS NOTED  
Ride: AS NOTED Subject: SKID CONTROL VALVE REPLACEMENT

Subject: SWEEP EARS

Subject: Vehicle Frame Pivot  
Inspection and Repair

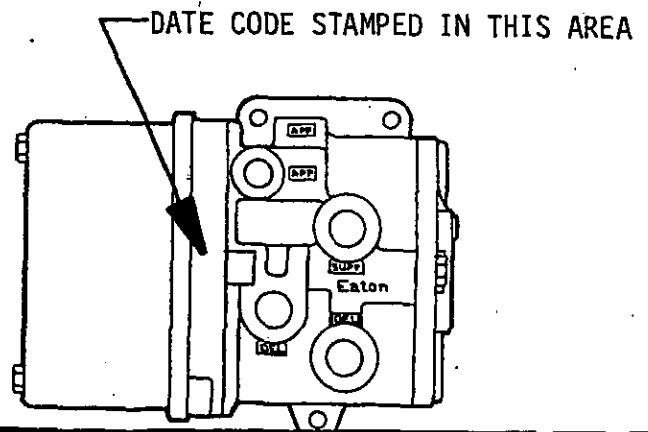
DATE CODE EXPLANATION

Chance Manufacturing Co. is requiring ride owners to check the date codes on the skid control valves. Date codes are stamped into the top cover on the same side as the valve air delivery ports. Valves with date codes 274-74 through 244-77 must be replaced. Ride owners will be billed for the new valve and the amount will be credited to their account upon receipt of the old valve.

YEAR PRODUCED  
274-74  
DAY OF YEAR PRODUCED

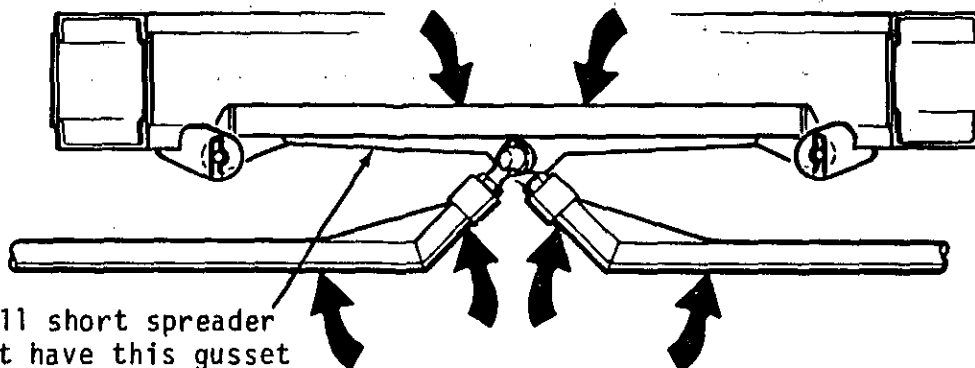
Inspect for cracks in the areas indicated by arrows in the following illustration. Also check the spreader bar mounting points for worn bushings or pins. If wear or damage is found in any of these areas, contact the CHANCE CUSTOMER SERVICE DEPARTMENT immediately.

NOTE: All short spreader bars must have this gusset

IMPORTANT: Do not attempt to repair spreader bars in the field. Any spreader bar which has been welded, drilled or otherwise repaired must be discarded and replaced with a new part.

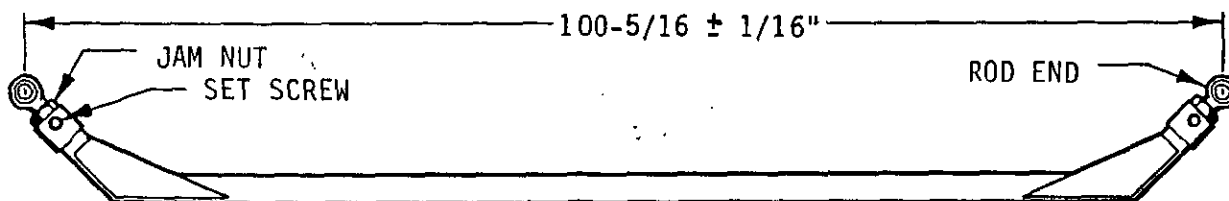
1. Remove all long spreader bars.
2. Loosen ALL jam nuts and set screws.

3. Measure the length between the rod ends, center to center, on all long spreader bars. This measurement must be  $100-5/16 \pm 1/16$  inches. Adjust the length by turning the rod ends.

IMPORTANT: Both rod ends must be threaded into the sockets an equal number of turns. Always adjust both rod ends equally within one-half turn.

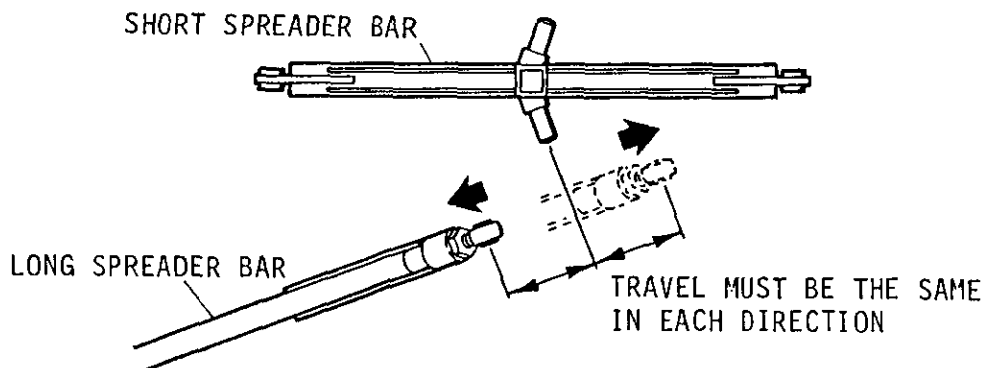
5. Remove one end of the long spreader bar which is  $180^{\circ}$  from the master sweep (driving sweep).
6. Rotate the ride counterclockwise one complete revolution by hand using two or three men.

As the ride turns, measure the distance the disconnected rod end travels in relation to the pin on the short spreader bar. This distance of travel must be the same each direction from the pin.

7. If the travel is equal in both directions, install the spreader bar and tighten all jam nuts and set screws.

If the travel is not equal in both directions, adjust the length of each long spreader bar (either longer or shorter) by turning the rod ends. ALL SPREADER BARS MUST BE THE SAME LENGTH. If one spreader bar is adjusted to a longer length, ALL spreader must be lengthened by the same amount.

Repeat STEPS 6 and 7 until the travel is equal.

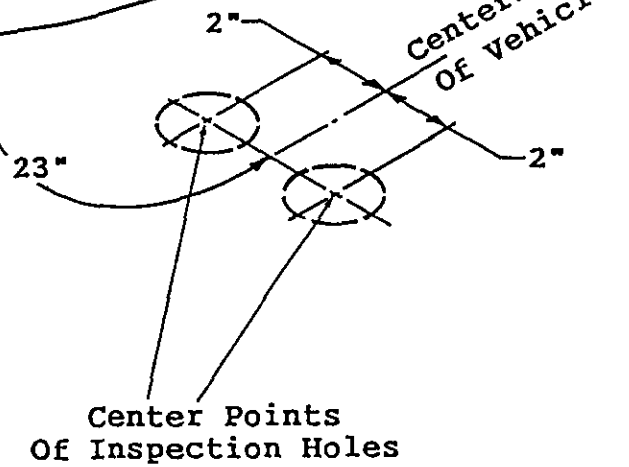
VIEW LOOKING  
DOWN THROUGH  
ACCESS OPENING

5. Thoroughly clean the area and use a light to inspect the vehicle frame for cracks as shown. Use a mirror as required to see all sides of all parts. Inspect the top and both sides of the frame from inside the vehicle. Inspect the bottom and both sides of the frame through the holes in the fiberglass.
6. Check the operation of the frame pivot bearings. Look for excessive looseness or other signs of wear or damage to the bearings and/or frame.
7. Move the upper frame from side to side. Look for wear marks near the opening in the vehicle body, or excessive side-to-side movement, which indicates wear or damage to the bearings and/or frame.

CHECK FOR  
SIDE-TO-SIDE  
MOVEMENT

CHECK FOR  
WEAR MARKS

If cracks or any unusual condition exist on any of the frames, contact the CHANCE CUSTOMER SERVICE DEPARTMENT immediately. DO NOT OPERATE THE RIDE.

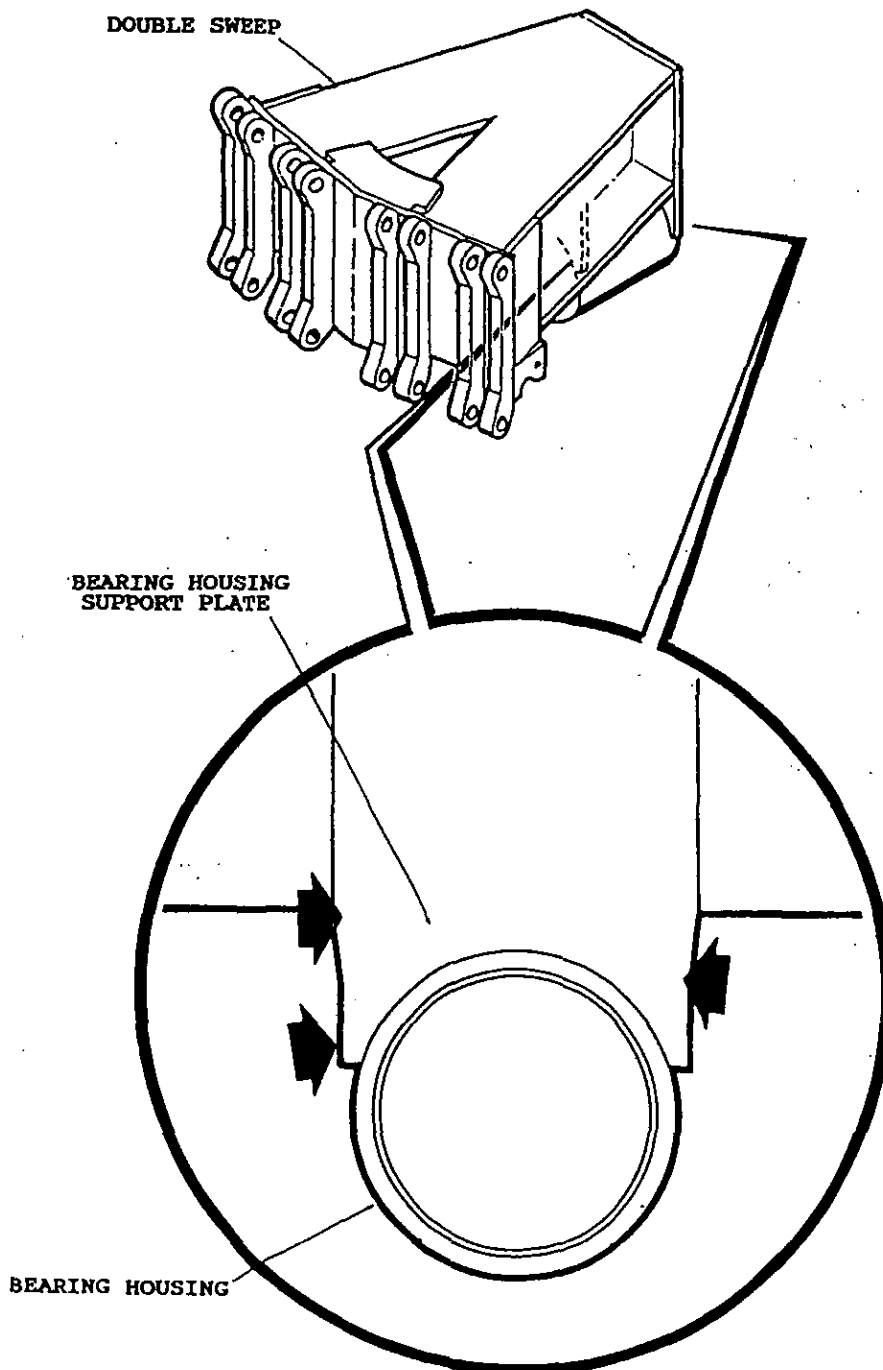
Chance Rides, Inc. requires all owners of FLYING BOBS amusement rides to inspect the double sweeps for cracks around the bearing housing support plates. Inspection must be done as shown in the illustration on this bulletin. If the plate cracks, failure of the part could occur, resulting in possible injury to passengers.

1. Thoroughly clean all areas to be inspected. All areas must be free of grease and other foreign materials which could hamper inspection.
2. Visually inspect all areas as indicated on the illustration below.
3. This inspection must be done every 30 days or at each set up, whichever occurs first.

If any cracks are found, contact the Chance Rides Customer Service Department. DO NOT ATTEMPT TO REPAIR OR WELD. DO NOT OPERATE the ride until the Chance Rides, Inc. approved repair rework kit number K337R1090-0 has been properly installed. If no cracks are found during inspection, the kit is not required.
