# SERVICE BULLETIN

Ride: TRABANT

Subject: REPLACEMENT OF FLOOR CLEVIS  
FOR LIFT CYLINDERS

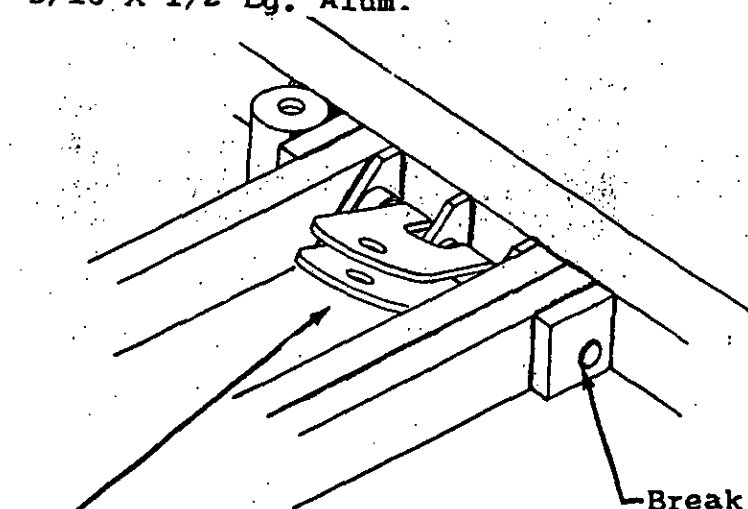
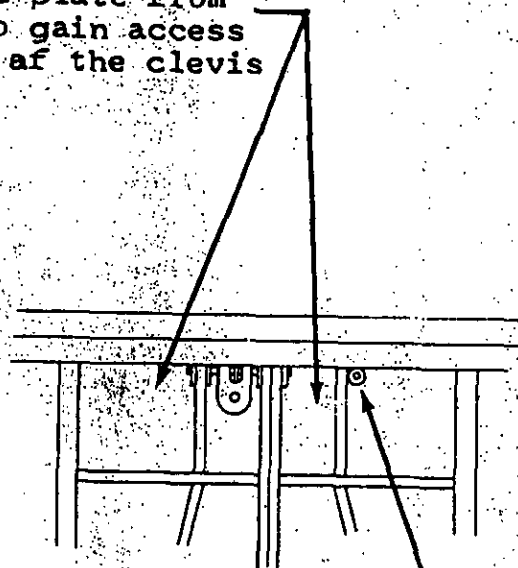
Remove tread plate from this area to gain access to the ends of the clevis pin

Heat plate and bend if necessary to gain clearance for new clevis

Break welds loose on both ends of pin

Relocate Floor Stand Support Socket to this location.

Remove the tread plate on each side of the clevis by drilling out the rivets. Use a #9 drill bit.

After removing the tread plate, the ends of the pin and the socket for the floor support stand will be visible.

Using the "Arc Air", blow the welds loose on the floor support socket and on the ends of the clevis pin.

Knock the pin loose and install new pin and clevis, securing pin with 1/8 x 1" long cotter pin on both ends.

In order to obtain enough clearance for the new clevis, it may be necessary to bend the plate which is welded to the support tubes. To accomplish this, heat the plate with an acetylene torch and strike it several blows with a hammer.

Relocate socket as shown in drawing.

Complete procedure by pop riveting tread plate to structure.

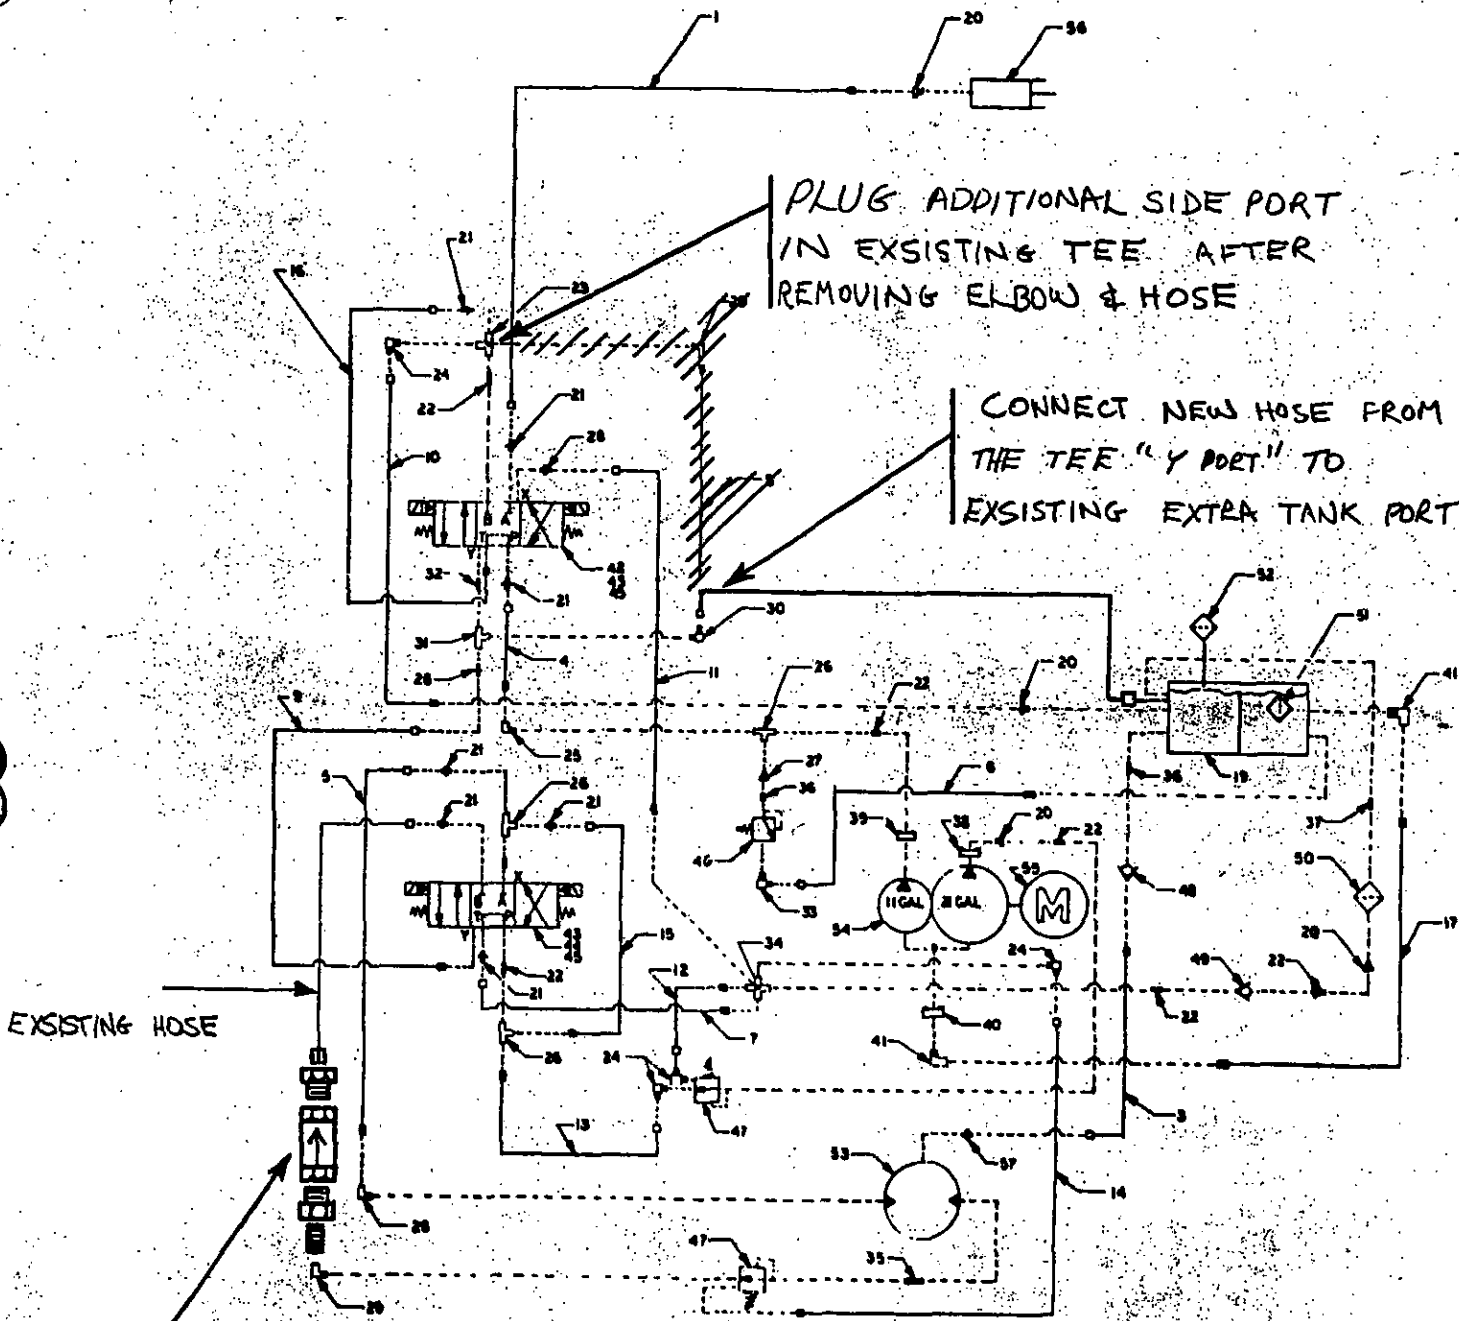
PLUG ADDITIONAL SIDE PORT  
IN EXISTING TEE AFTER  
REMOVING ELBOW & HOSE

CONNECT NEW HOSE FROM  
THE TEE "Y PORT" TO  
EXISTING EXTRA TANK PORT

EXISTING HOSE

ADD NEW CHECK  
VALVE, BUSHINGS &  
CLOSE NIPPLE BETWEEN  
HOSE & ST. ELBOW

To stop Barrel Creeping, a Check Valve can be added in the return line from the motor. This will equalize pressure on both sides of the motor.

Remove the Drive Tire to facilitate access to bottom side of Hydraulic Motor and Relief Valve.

Remove Hose going from the Relief Valve to B Port of the Directional Valve.

Screw the Check Valve with nipple and bushings into the St. Elbow on the bottom side of the Relief Valve.

Be sure Check is installed with Arrow pointing away from Relief Valve.

Re-connect Hose from Check Valve to B Port of the Directional Control Valve.

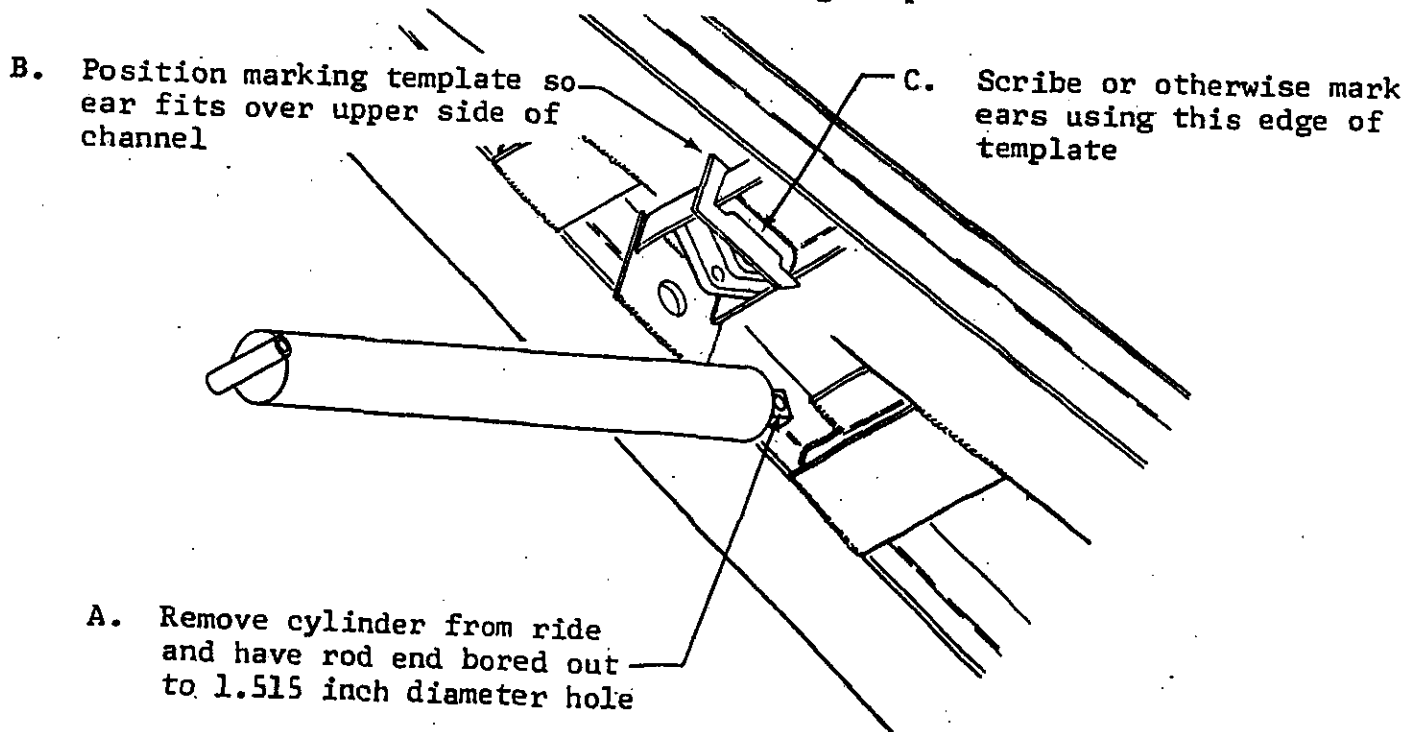
Figure 1

Position cutting template so the small ear fits over the upper side of the channel.

Scribe or use a magic marker or soap stone, etc., to mark a line along each ear following the inside edge of the cutting template.

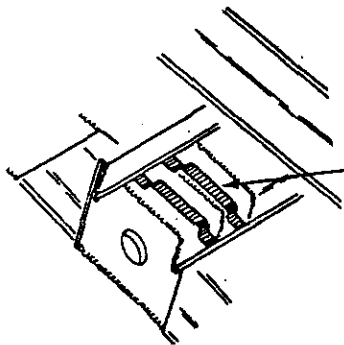
Figure 2

Torch old ears off along line, should look approximately like this when complete

5. With a cutting torch, cut off each ear as close as possible to the line that you have marked on them.

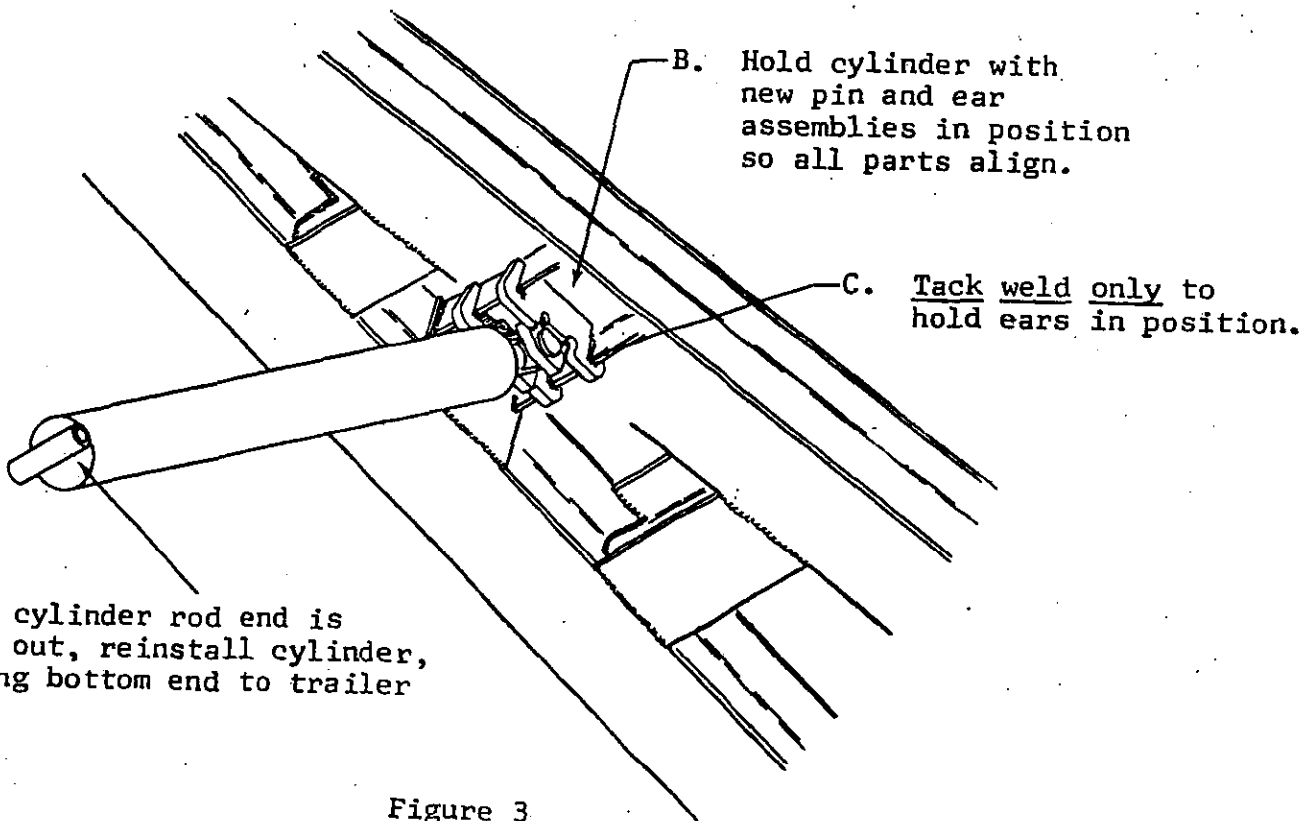
Figure 3

A. After cylinder rod end is bored out, reinstall cylinder, pinning bottom end to trailer

6. Place each new ear assembly up against the old ear and channel to see that each one fits flat against the inside of the channel and flat against remaining portion of old ear.

If new ear assemblies do not fit, torch or grind a small amount off the old ears.

7. Pin bottom end of lift cylinder.
8. Insert new pin through cylinder rod end and new ears.
9. Hold or block cylinder so new ears are in proper position and tack weld ears in place.

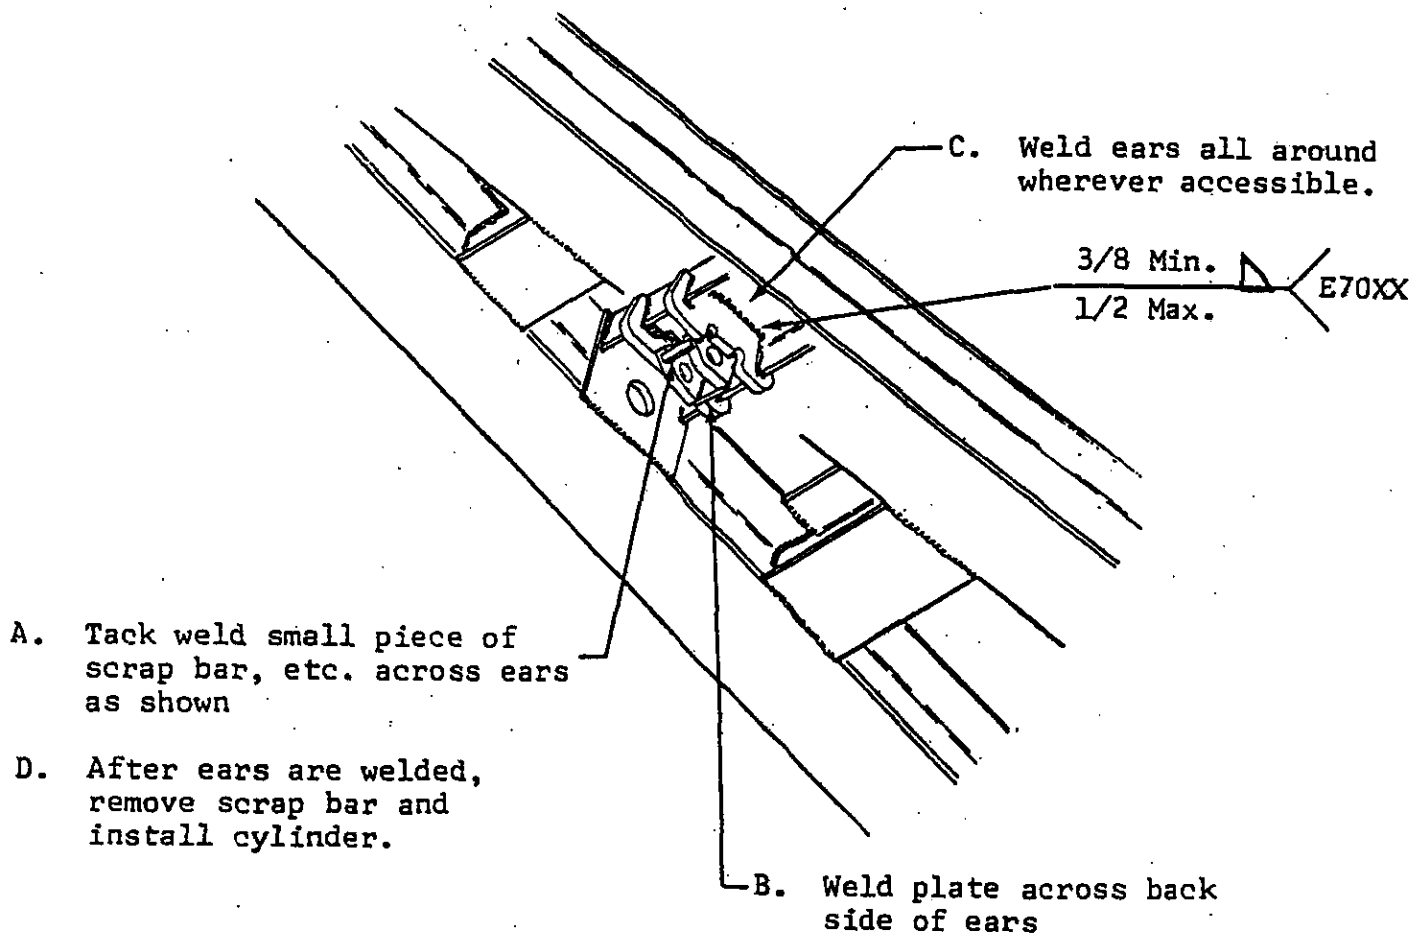
Figure 4

REMOVE CYLINDER AND PIN

10. Remove pin and let cylinder drop down so it is not in the way.
11. Weld ear assemblies in place as shown in Figure 4.
12. Secure cylinder with new pin and cotter pin.

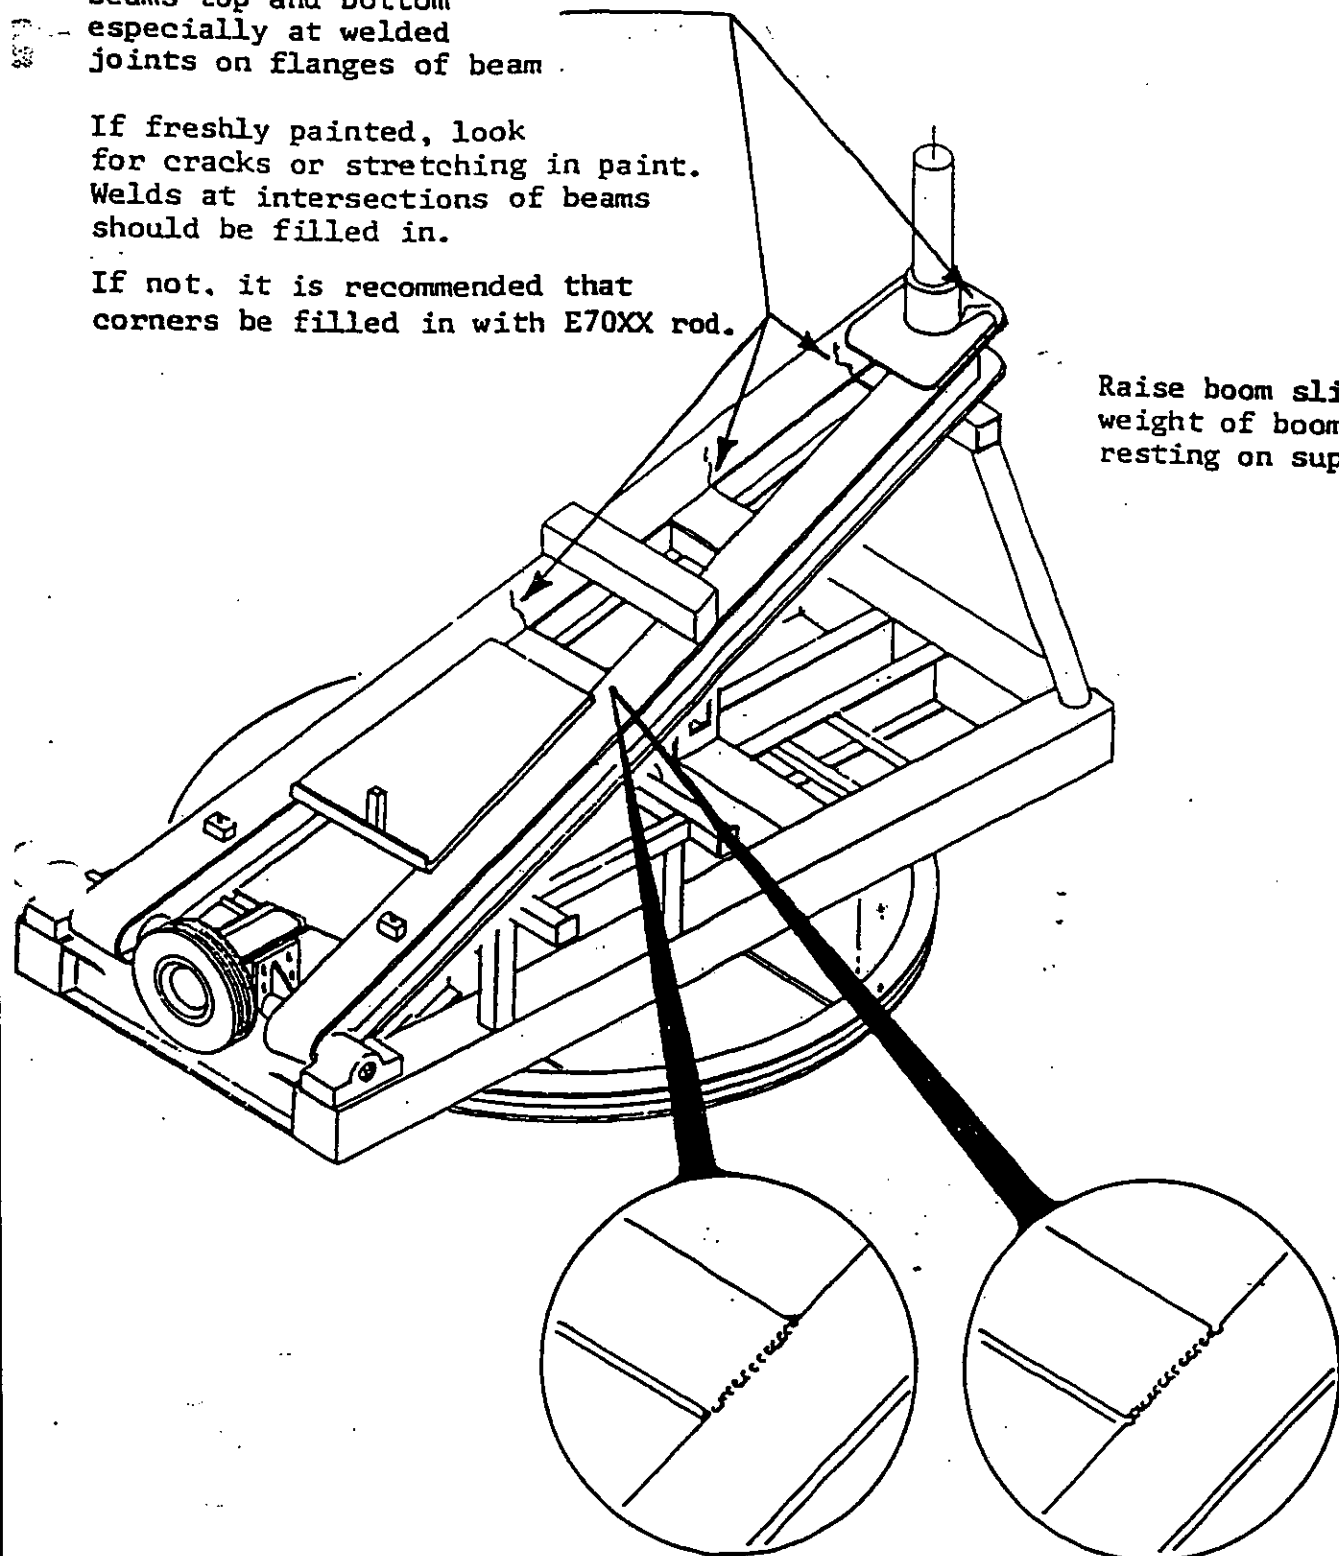
Inspect for cracks along beams top and bottom especially at welded joints on flanges of beam.

If freshly painted, look for cracks or stretching in paint. Welds at intersections of beams should be filled in.

Desired weld joint

Undesirable weld joint

If not, it is recommended that corners be filled in with E70XX rod.

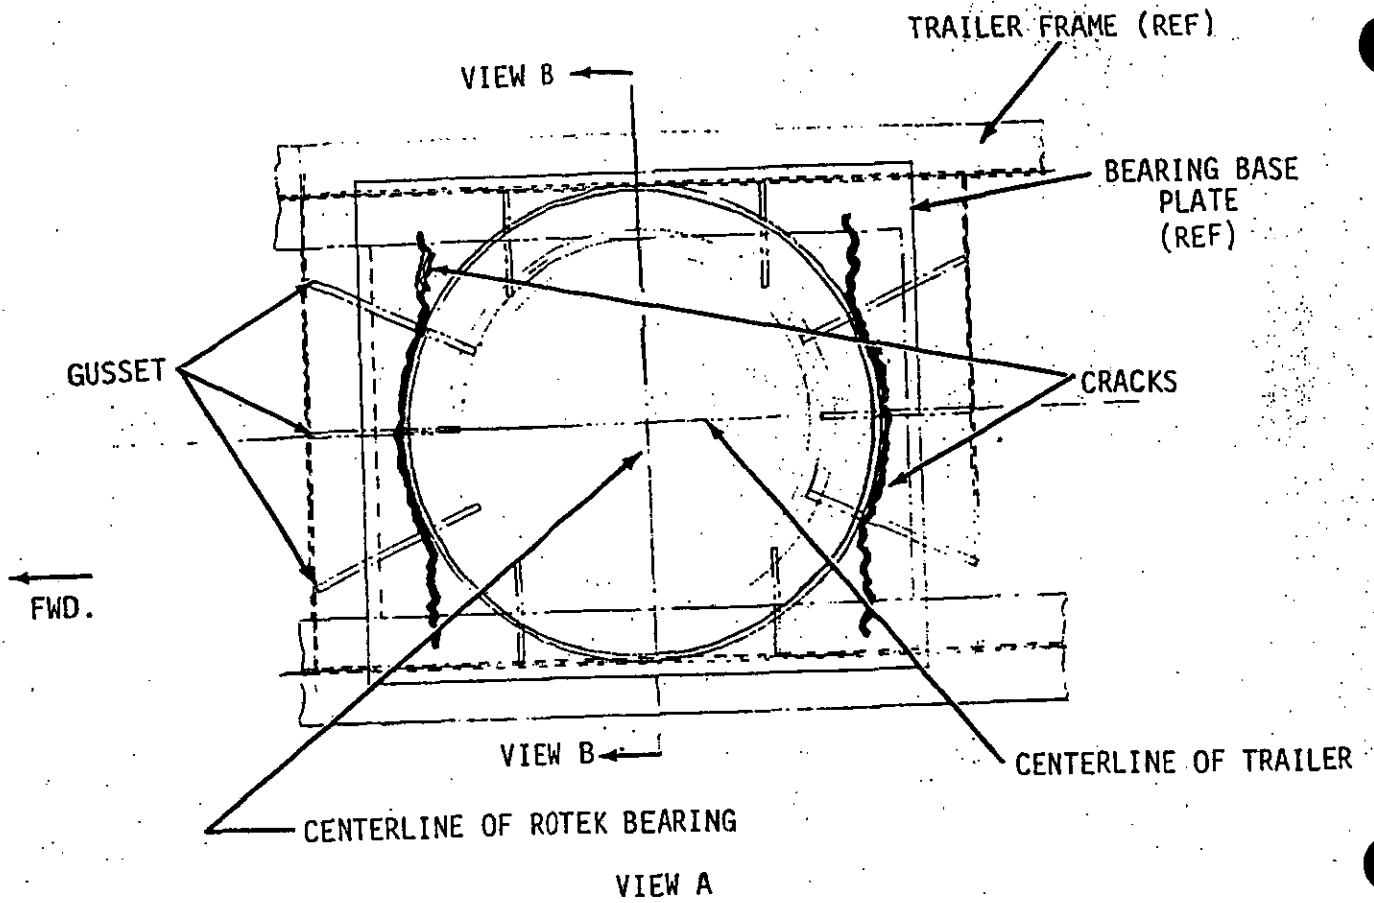
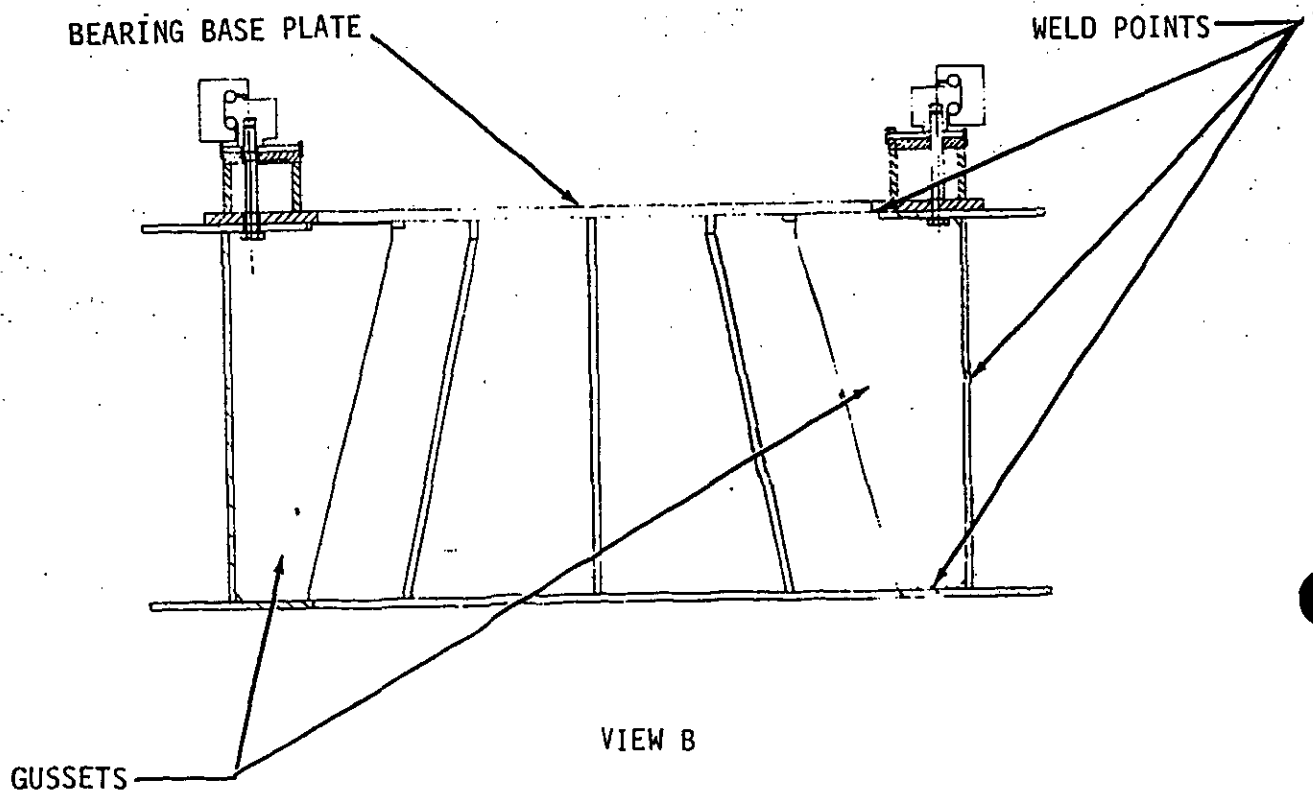
There is a possibility that cracks may form laterally on the bearing base plate in the positions indicated in VIEW A below or along seams where gussets are welded to the trailer frame or bottom of the bearing base plate as shown in VIEW B.

NOTE: To facilitate finding lateral cracks in the bearing base plate, rock the upper wheel assembly parallel to the center line of the trailer while observing the areas indicated in VIEWS A AND B. If cracks exist, they will be accentuated by the rocking motion.

Early units have six reinforcement gussets and later units have ten reinforcement gussets.

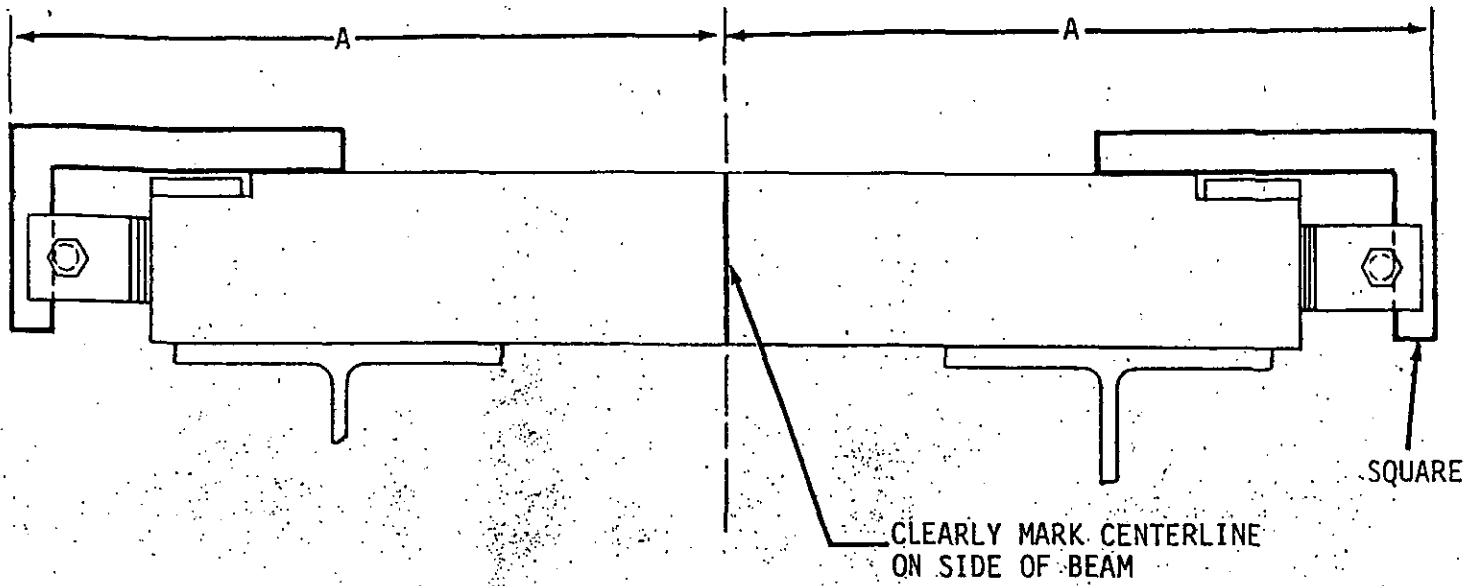
FIGURE A

With the ride set up remove the floor lift cylinders from the clevises. Replace the bolts in the clevises and lay a square at each end of the crossmember, tight against the bolts. Measure the distance between the two squares to find the centerline as shown in FIGURE A. Clearly mark the centerline on the side of the crossmember. Remove and discard the clevises, nuts and bearings. Cut the crossmember as shown in FIGURE B and grind the cuts smooth. Do not remove the lower wall of the crossmember.

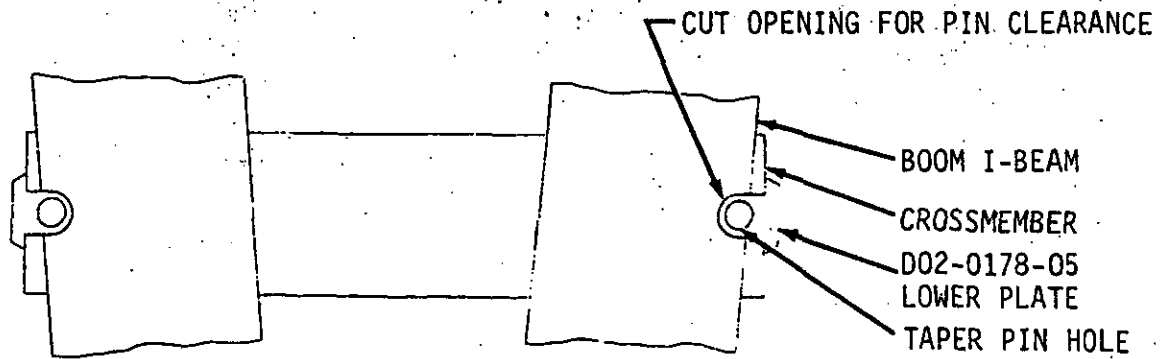
VIEW FROM UNDER BOOM  
FIGURE C

Use the centerline mark to center the D02-0178-05 lower plate in the crossmember. Mark the taper pin holes on the crossmember and remove the lower plate. Cut the crossmember and the I-beams for pin clearance as shown in FIGURE C. Grind cuts smooth.

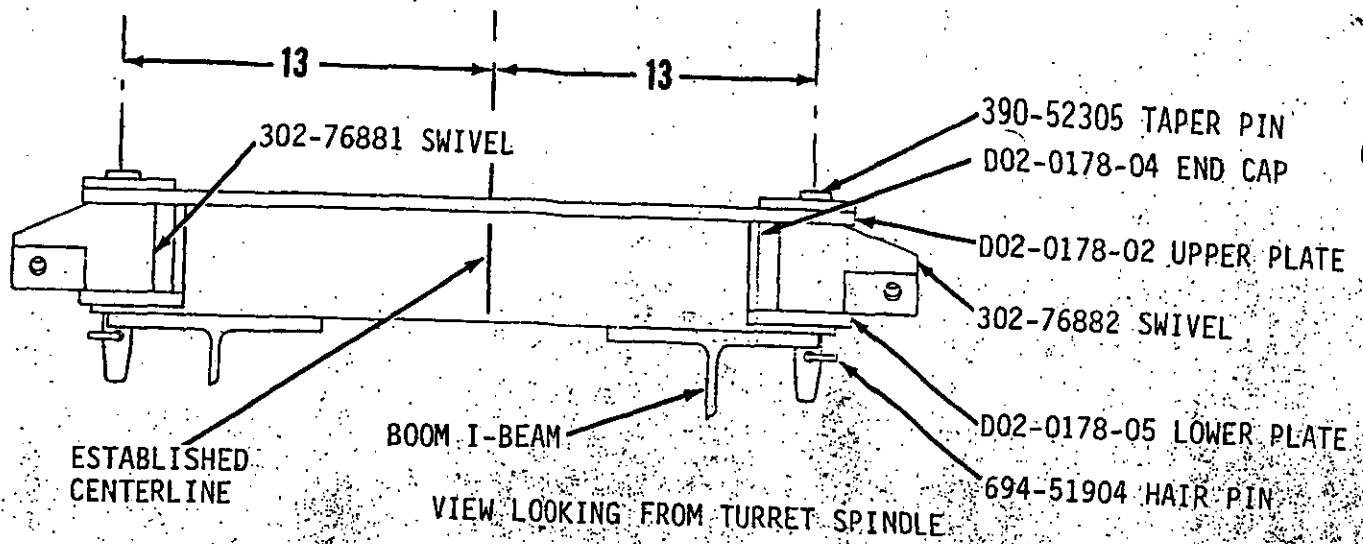
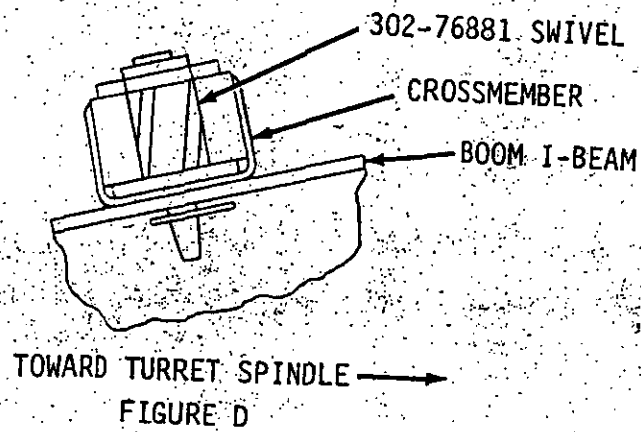
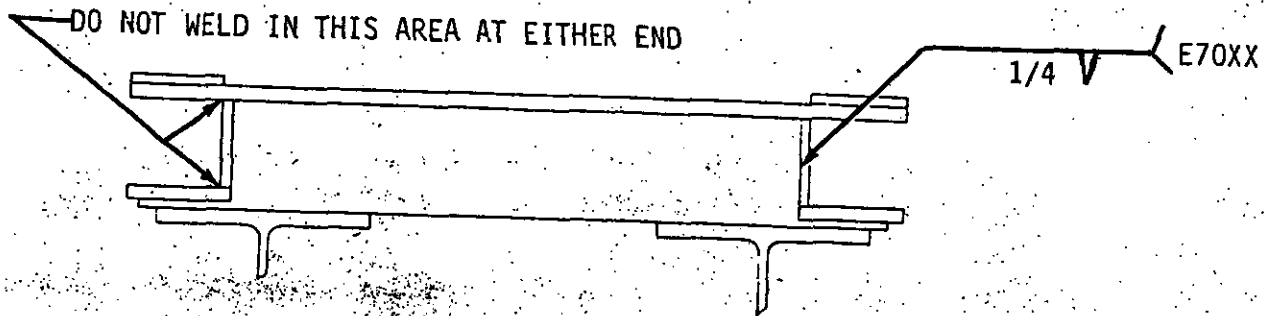
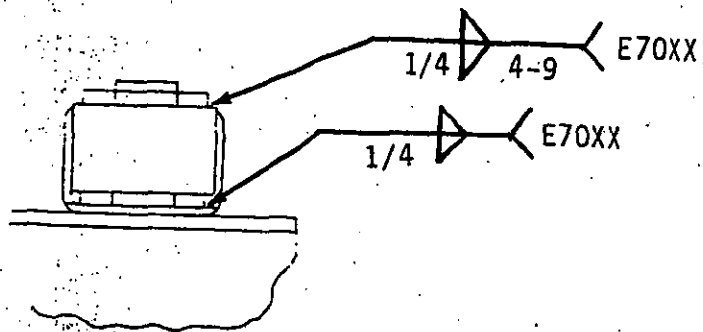
FIGURE E

Install the D02-0178-02 upper plate with reinforcing plates on top, D02-0178-05 lower plate, 302-76881 and 302-76882 swivels, 390-52305 taper pins, and D02-0178-04 end caps. Use the centerline on the crossmember to center the parts as shown in FIGURE D. Tack weld the upper plate, lower plate and end caps in place. Remove the taper pins and swivels and complete the welding as shown in FIGURE E. Install the swivels as shown in FIGURE D using the 390-52305 taper pins and 694-51900 hair pins. Install the floor lift cylinders in the swivels using the 686-09328 GRADE 8 bolts, 696-85324 wrought washers and 691-47832 locknuts.

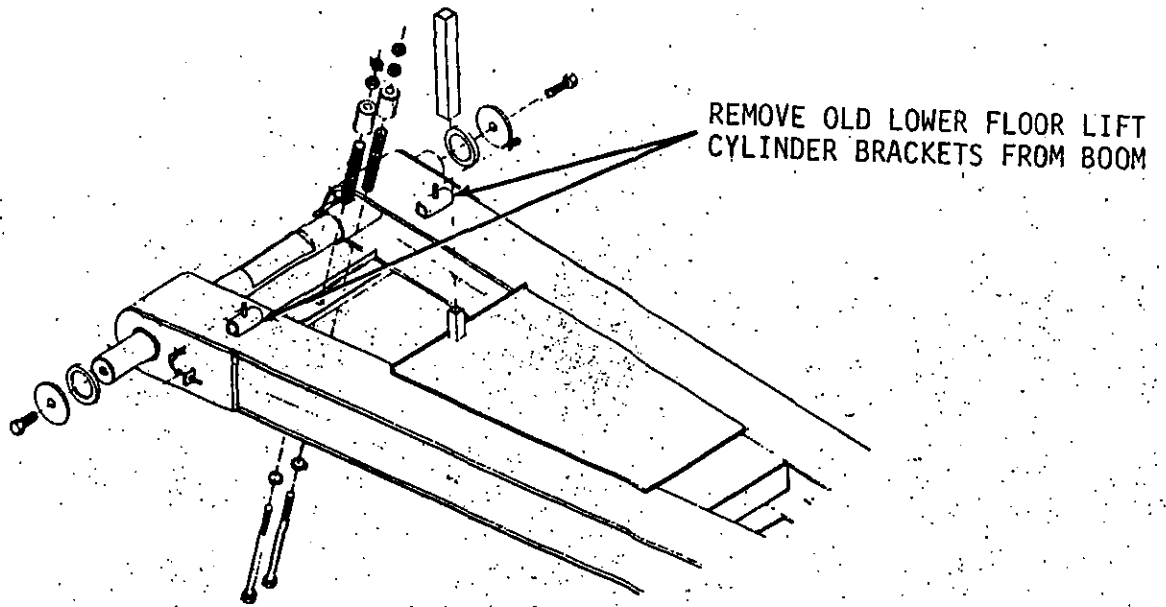
FIGURE F

Cut the old lower floor lift cylinder brackets off of the boom (See FIGURE F) and grind the area smooth. Retract the cylinder rods and secure the 1030600-3 cylinder mounts to the cylinders using the 390-51975 taper pins and 694-51900 hair pins. Position the cylinder mounts and the 1030600-4 stops as shown in FIGURE G and tack weld them to the boom. Remove the floor lift cylinders from the cylinder mounts and weld the clamp brackets and the stops to the boom as shown in FIGURE G. Secure the floor lift cylinders in the cylinder mounts using the bolts and nuts.

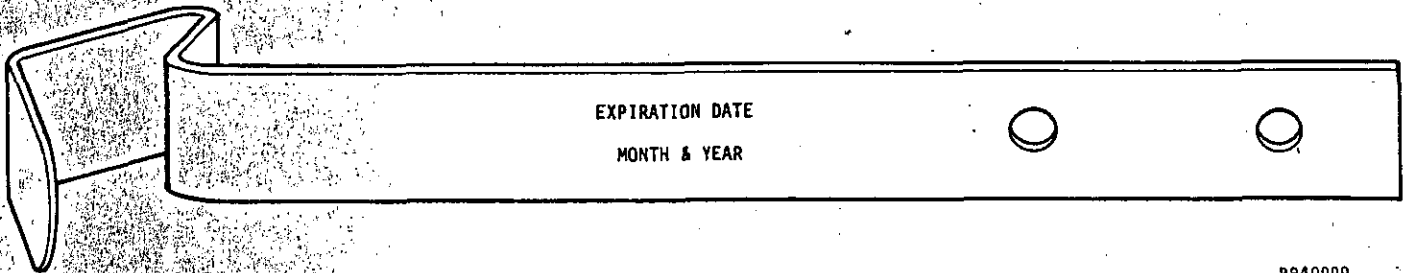
An expiration date is electrically etched into each spring latch in the location shown below.

The expiration date is one year from the date the spring latch is shipped from CHANCE MANUFACTURING CO., INC. ALL SPRING LATCHES MUST BE REPLACED ON OR BEFORE THE EXPIRATION DATE. DO NOT OPERATE THE RIDE UNTIL ALL SPRING LATCHES HAVE BEEN REPLACED. Destroy the old spring latches immediately after removal.

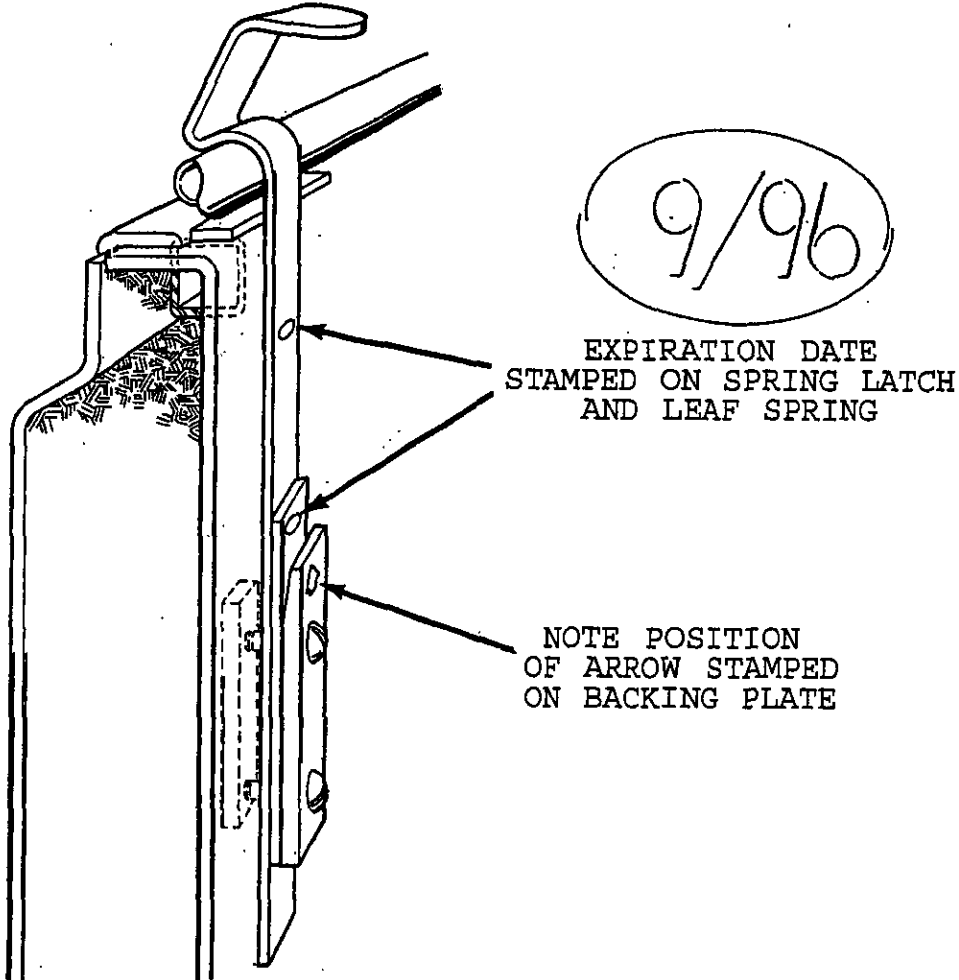
Chance Rides, Inc., through testing and design change, has developed a new spring latch assembly for the lap bar on the seat of the above noted TRABANT/CASINO amusement rides. This new spring latch assembly makes use of a new style backing plate, a new leaf spring, and a spring latch. This design extends the life of the spring latch.

IMPORTANT: The spring latches, leaf springs and backing plates must be installed exactly as shown in this bulletin.
