Wheel axle – Flitzer Ride; Tivoli Coasters, Viererbob

Non destructive testing – Flitzer - Ride

Wear inspection / Non destructive testing / -- Addition to the maintenance checklist and daily lubrication schedule:

Facility: Flitzer Ride

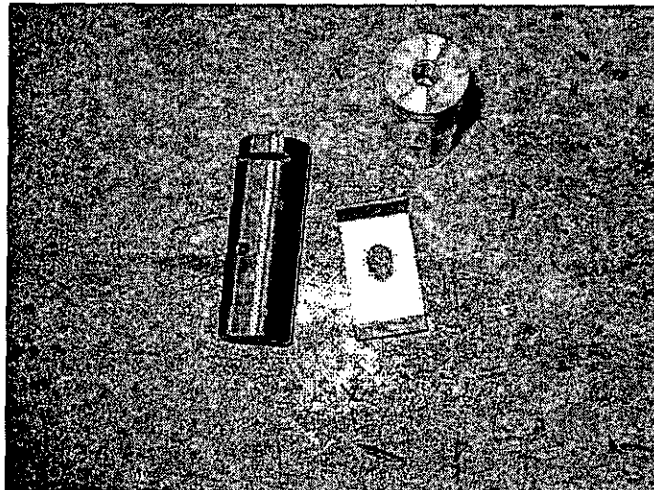
Previous wheel axle and safety plate:

Zierer constantly strives to improve safety related components of its amusement rides. Therefore, we would like to inform you our improvement to the wheel axles of the wheel housings of our Flitzer Ride, Tivoli Coaster and Viererbob ride.

We recommend you consider replacing the wheel axles and the safety plates of your ride with the new modified version, in order to make your ride even safer.

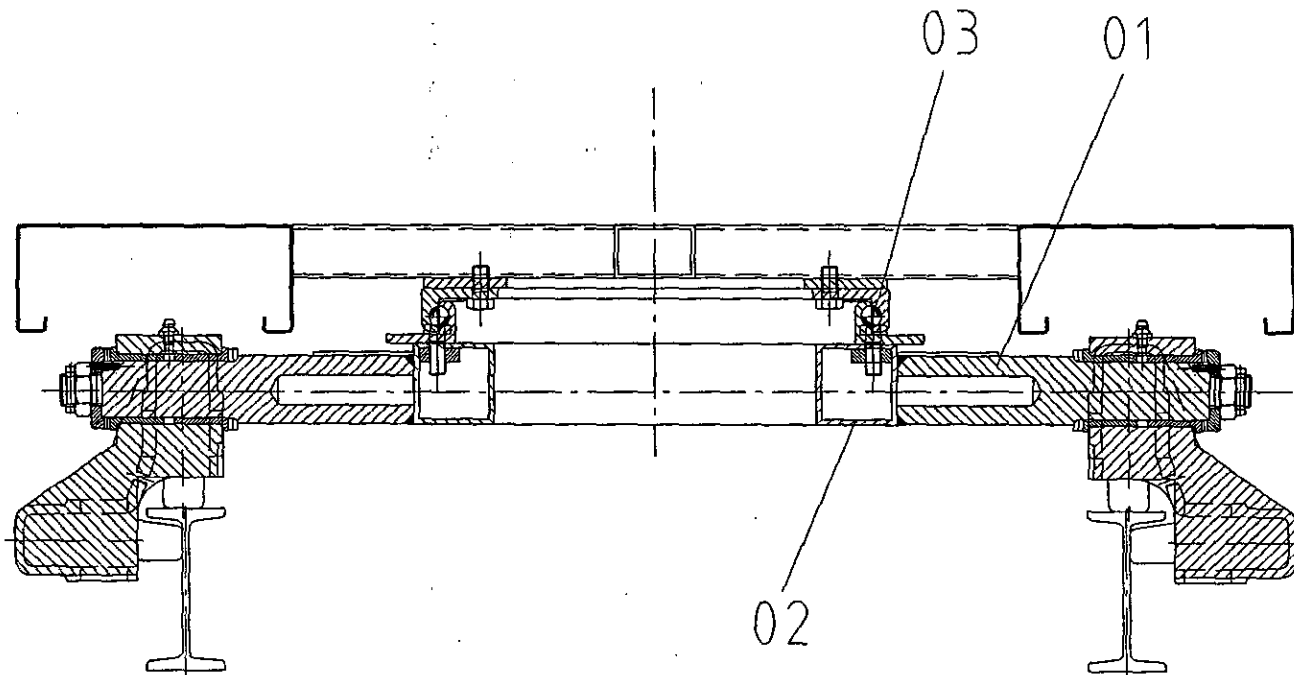
Components	Drw.-No.	Pos.	Time code	Test method code	Remark
Car:					
Car frame / Body	027-10-01	01	M	C2	Check welding seams, check for cracks and deformation
Car frame / Body	027-10-01	01	Y6	B1 or B2 or B3	Check welding seams, check for cracks and deformation
Choke at front axle	027-10-02	01	Y1	B1 or B2 or B3	Check welding seams, check for cracks
Front axle, stub	027-10-02	02	Y1	B1 or B2 or B3	Check welding seams, check for cracks, check for deformation
Front axle, frame	027-10-02	03	Y6	B1 or B2 or B3	Check for cracks
Elastic bearings	027-10-02	03	M	C1 or C2	Check for play and wear
Bolt -- front axle	027-10-02	05	Y6		Check for play and wear
Rear axle, stub	027-10-03	01	Y1	B1 or B2 or B3	Check welding seams, check for cracks, check for deformation
Rear axle, frame	027-10-03	02	Y6	B1 or B2 or B3	Check welding seams, check for cracks,
Roll bearing slewing rim / rear axle	027-10-03	03	Y10	A1 or A2 or A3	Check for play

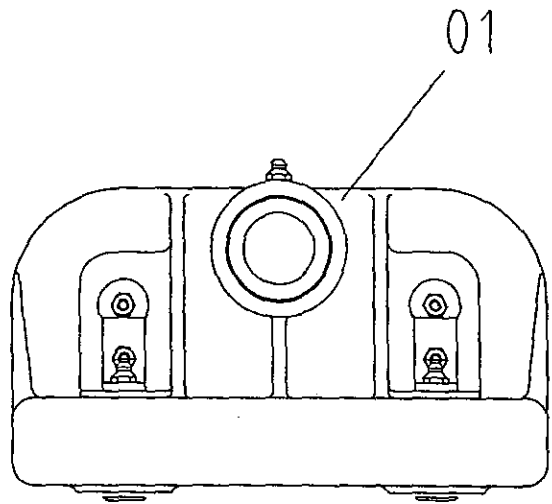
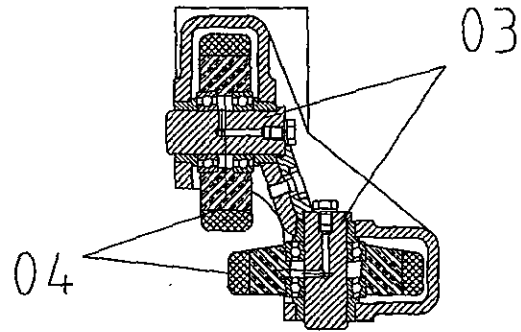
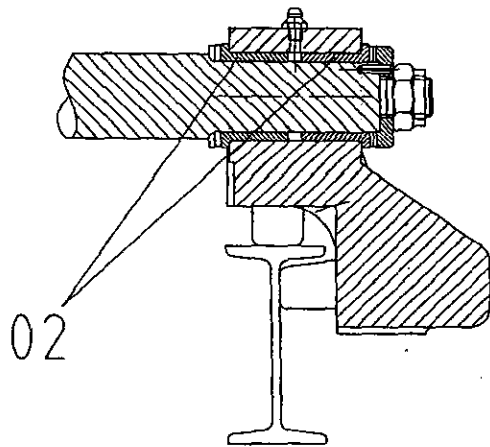
Wheel housing	027-10-04	01	M	C1 or C2	Check for cracks
Wheel housing	027-10-04	01	Y1	B1 or B1 or B3	Check for cracks
Bearing bush	027-10-04	02	M	C1 or C2	Check for wear and deformation

Wheel axle + bushing for wheel axle	027-10-04	03	M6	C1 or C2	Check for wear
Wheels	027-10-04	04	M	C2	Check for wear
Clamping device	027-10-05	01	M	C2	Check for wear and play, check for cracks
Release bar, bushing, actuating blocs	027-10-06	01	M	C2	Check for wear and play
Hand rails / head rest	027-10-07	01	W	C2	Check for loose bolts
Brakes:					
Magnet brake support + switch mechanism	027-10-08	01	W	C2	Check for cracks
Magnet brake support + switch mechanism	027-10-08	01	Y	B1 or B2 or B3	Check for cracks
Safety / bloc brakes	Photo # 1	01	W	C2	Check for wear on lining, check for wear on the guiding of the brake bars, check for cracks
Safety / bloc brakes	Photo # 1	01	Y6	B1 or B2 or B3	Check for wear on lining, check for wear on the guiding of the brake bars, check for cracks
Frame, drive unit	Photo # 2	01	M	C1 or C2	Check welding seams, check for cracks
Rails and Frame/Columns:					
Column/Frame	Photo # 3	01	W	C2	Check welding seam, check for cracks, check anchor bolts for tight fitting,

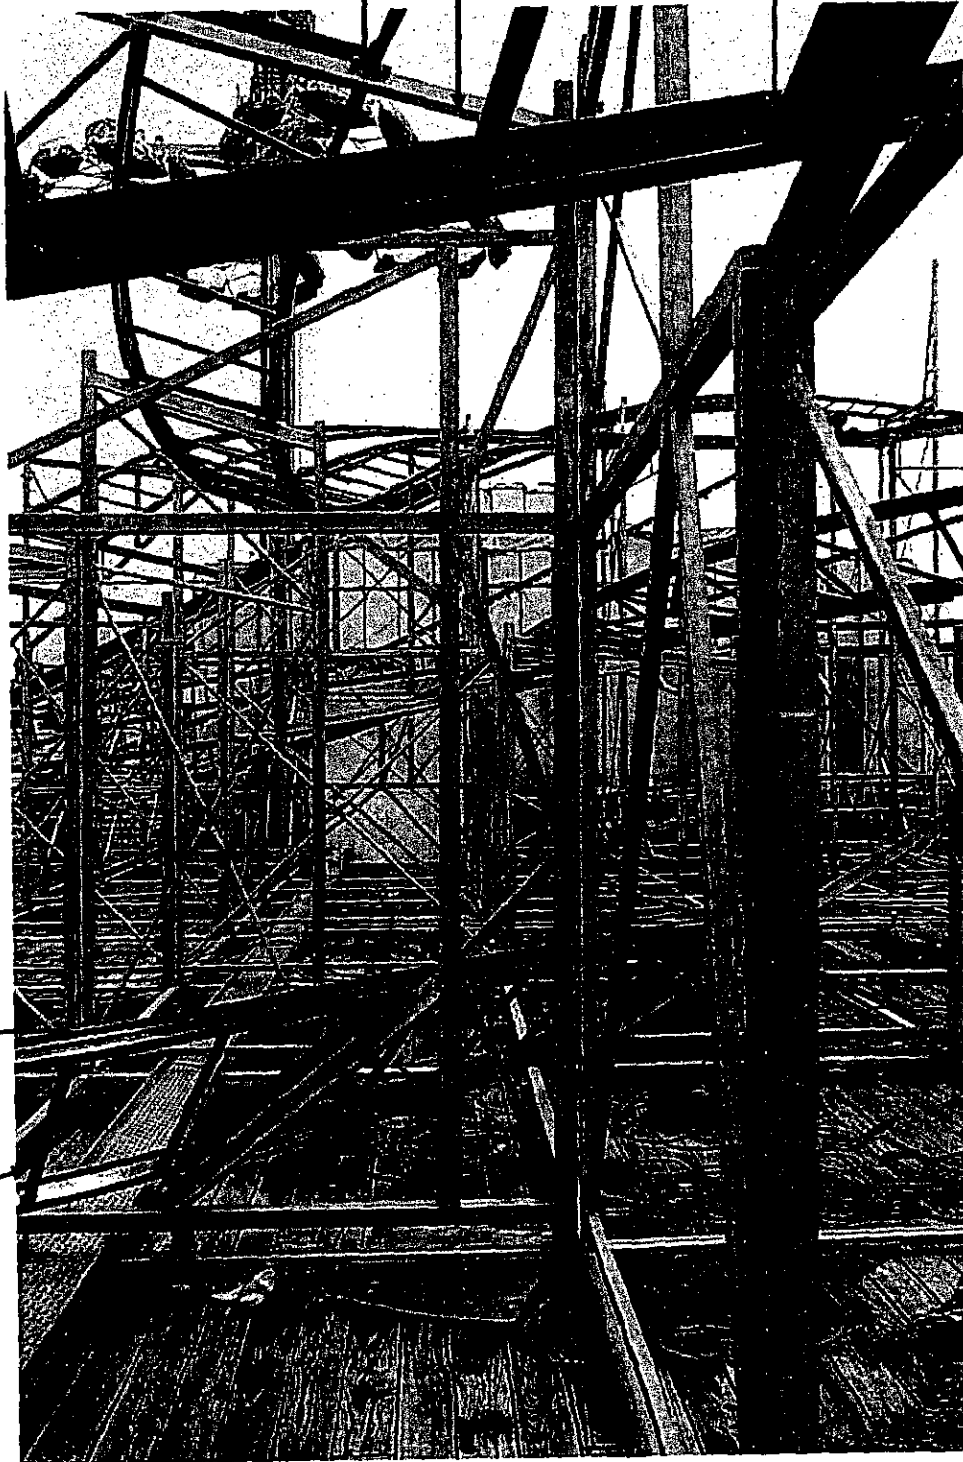
Photo # 3
Column / Frame

Track to track connection	Photo # 3	02	W	C2	Check welding seam, check for cracks, check connecting bolts
Track to column/frame connection	Photo # 3	03	W	C2	Check welding seam, check for cracks, check connecting bolts
Track to cross bracket connection	Photo # 3	04	W	C2	Check welding seam, check for cracks, check connecting bolts
-Track	Photo # 3	05	W	C2	Check for cracks and wear
Footing, struts	Photo # 3	06	W	C2	Check for cracks, check connections
Anti roll back	Photo # 4	01	W	C2	Check for play on the bolt, check for cracks and wear
Lift system:					
Chain	Dwg # 2	01	M6	C2	Check for wear and elongation
Chain sprocket	Dwg # 1+2	02	M6	C2	Check for wear
Bolt/Axle for sprocket	Dwg # 2	03	M6	C2	Check for wear
Sprocket support	Dwg 1+2	04	Y10	B1 or B2 or B3	Check for cracks
