407.

Lamborghini Wave Swinger cracking

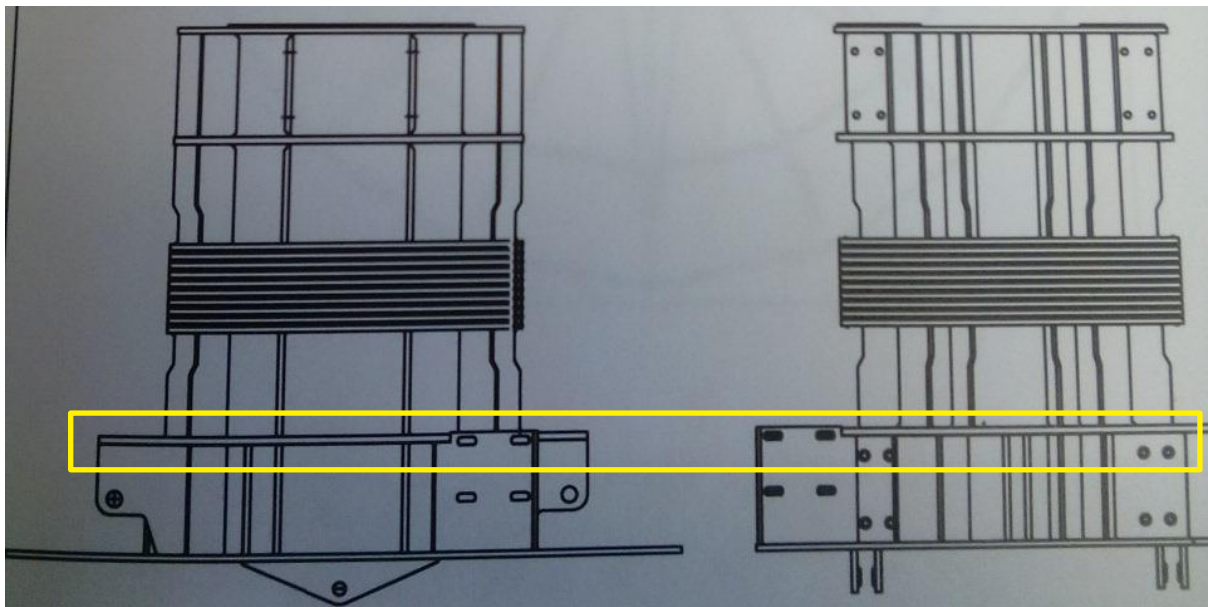
The defects were located in the welds that join the vertical gussets to a horizontal plate that locates the slewing ring as indicated in the accompanying diagram.

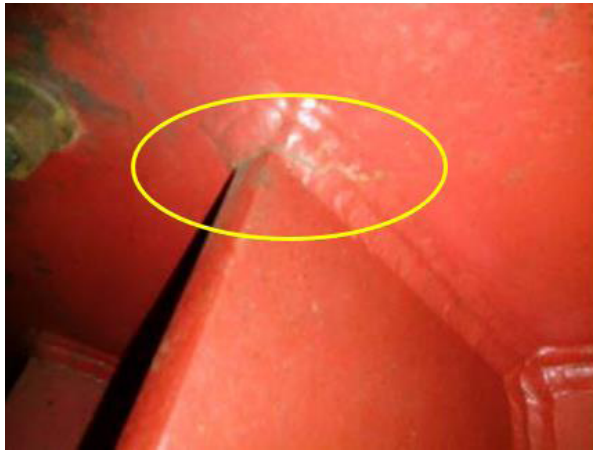
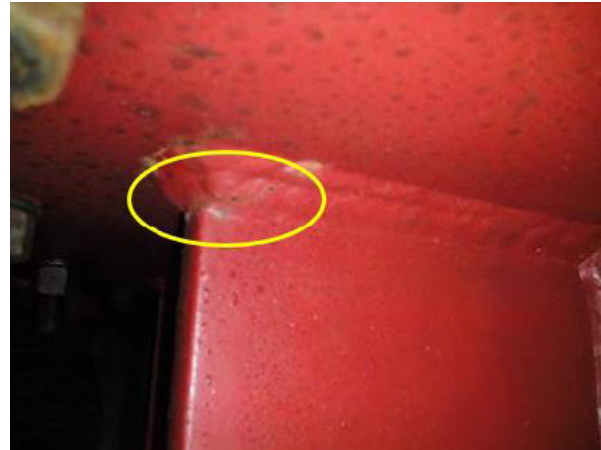
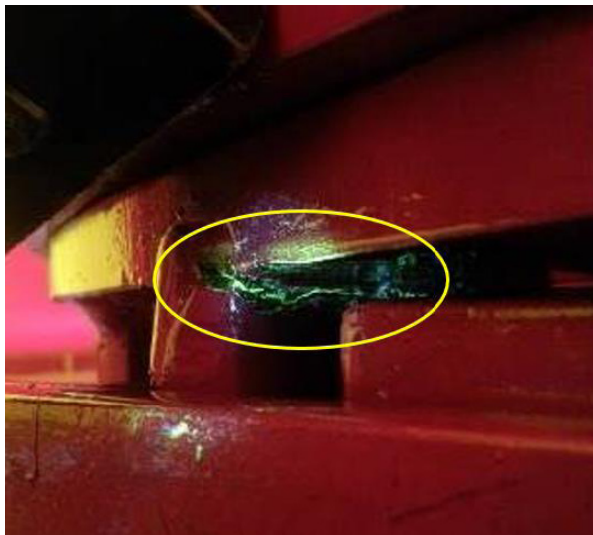
Lamborghini Wave Swinger cracking

We have received a report from a UK registered inspection body that numerous areas of cracking have been found on the fixed outer basket of a Wave Swinger (2012) manufactured by Lamborghini, by means of both visual and NDE inspection.
