TECHNICAL BULLETIN — June 2016

403. Hoerbiger hydraulic cylinders

Service Bulletin

Action required in relation to attention items as described by Hoerbiger Micro Fluid GmbH.

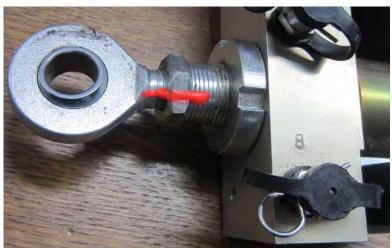
Figure 2: how to apply torque striping on the threaded screw assembly at the bottom.

- : The supplier added an additional requirement on the length of the threaded screw assembly. Due to the adjustment function of this connection it is not guaranteed that the threaded screw assembly is within the specified range.
- : Checking this connection was included during installation of the HLU in the vehicle.
- VRP&S' advice : Check the length of the threaded screw assembly. If applicable it needs to be corrected. For the correct settings, please refer to the text below for the LE32 units and table 2 for the LE25 units (these values are created from the Supplier's document). Add torque striping to the connection (see figure 2) and perform a weekly check on this area.

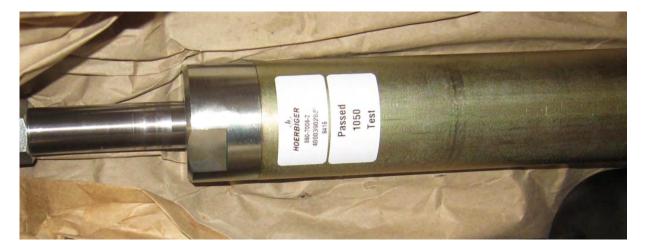
All HLU's, at the customer warehouse should be checked if they are labelled with "passed 1050 cycle test". If this is not the case, contact VRP&S to make sure the HLU's will be tested prior to assembly into a vehicle. The picture below shows the correct indication that the HLU has passed the 1050 Cycle test.

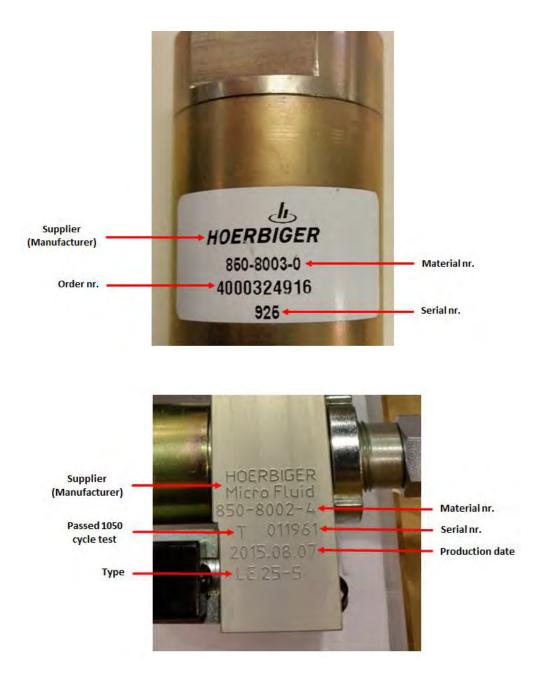
As of May 2015, the assembly date is embossed on the valve manifold of the LE unit (see image). Since HOERBIGER does not warehouse LE units, this date can also serve as the decisive date for replacement when conducting visual inspections.
