National Association For Leisure Industry Certification

TECHNICAL BULLETIN — October 2015

402. Trailer hitching points

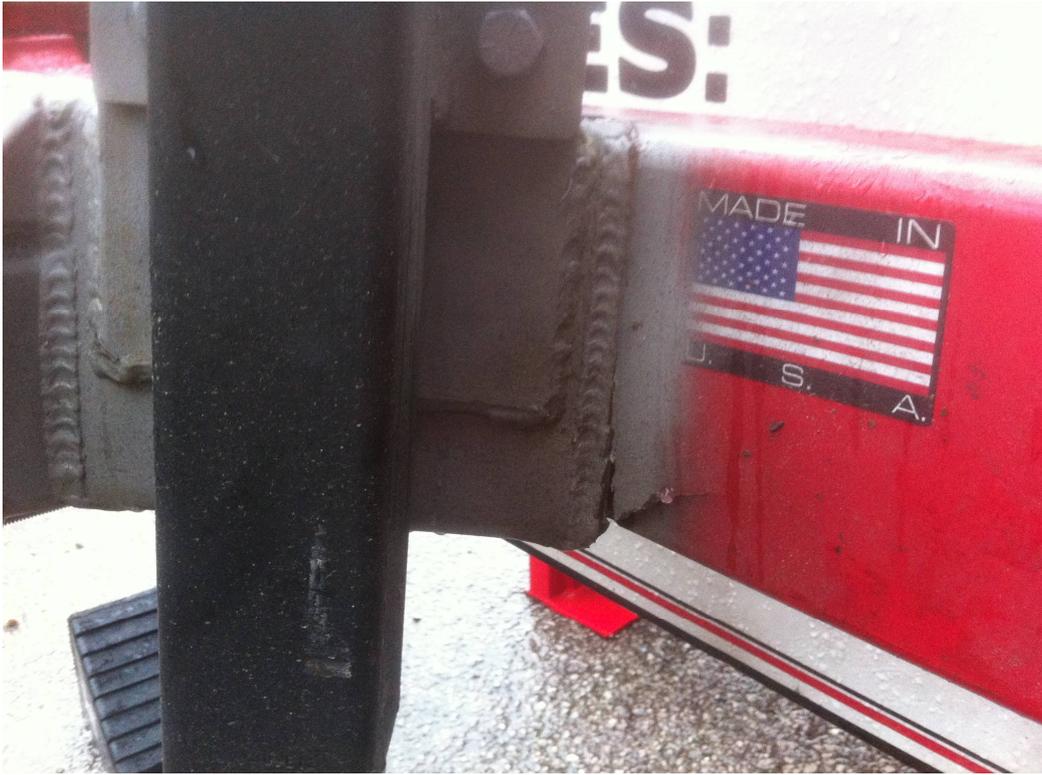
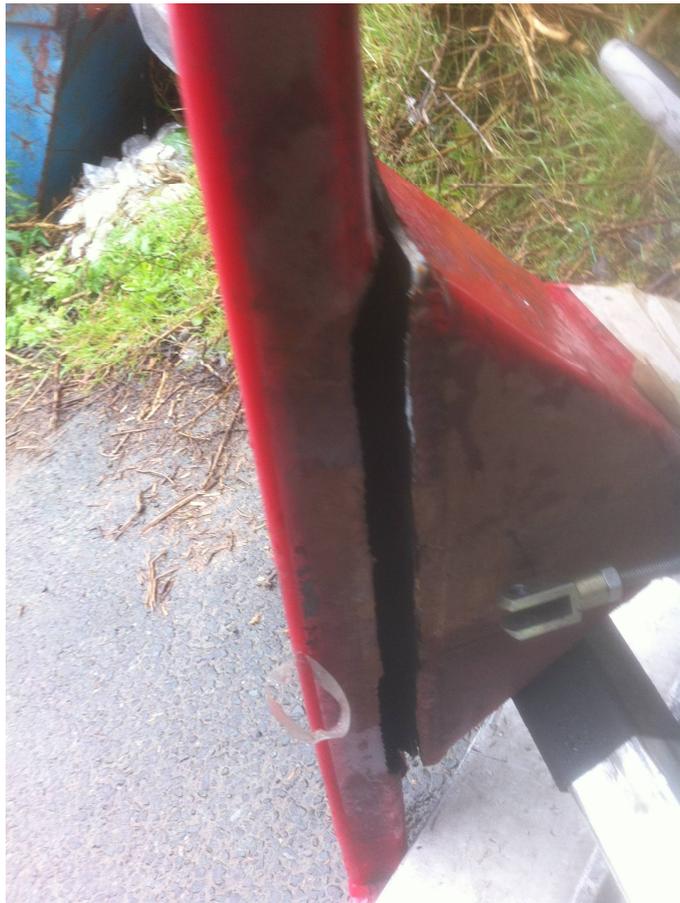
An inspection body has reported finding cracking on the trailer hitch for a Spectrum Sports mobile zip line, as shown in the photos below. The committee was informed that the cracking occurred on an early model of the device which has since been modified to address this problem.

The trailer hitch is not used during the operation of the device and the cause of the cracking has been attributed to the towing loads rather than to the forces exerted during operation of the device. Nevertheless, controllers and inspection bodies are urged to check the hitches on mobile trailer devices as part of their inspection and maintenance checks; not only could cracking in this area result in a serious incident during the transportation of the device, but there is a risk that the cracking could propagate into the structure of the ride.
