NAFLIC

TECHNICAL BULLETIN — June 2016

407. Lamborghini Wave Swinger cracking

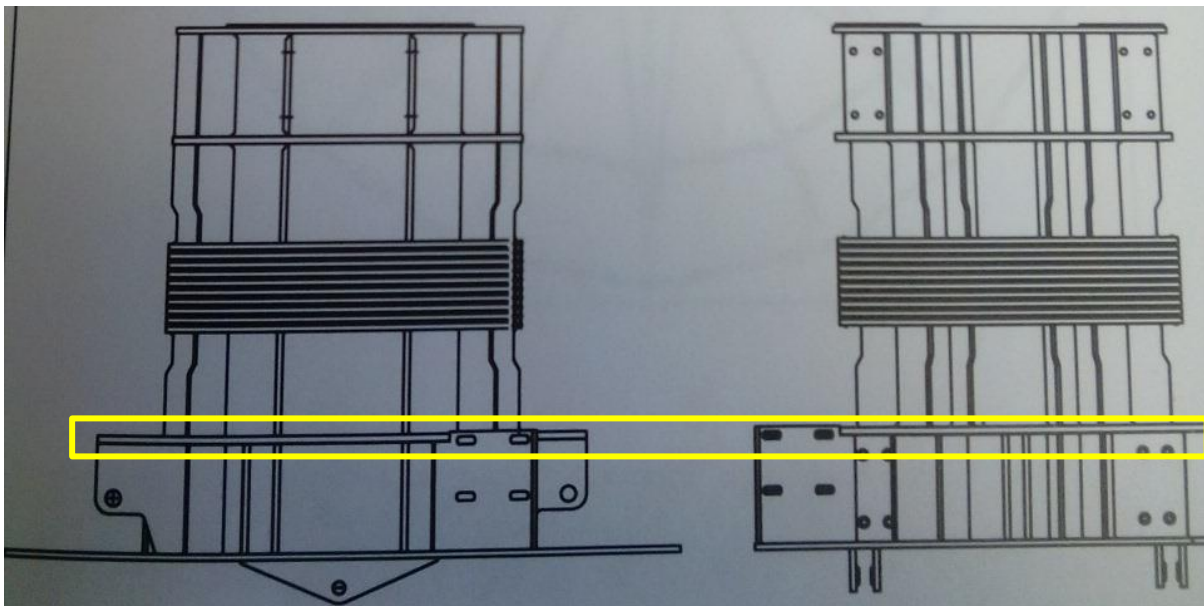
We have received a report from a UK registered inspection body that numerous areas of cracking have been found on the fixed outer basket of a Wave Swinger (2012) manufactured by Lamborghini, by means of both visual and NDE inspection

The defects were located in the welds that join the vertical gussets to a horizontal plate that locates the slewing ring as indicated in the accompanying diagram.
