TECHNICAL BULLETIN — June 2016

416. Vekoma Suspended Looping Coaster spindle failure

Service Bulletin

<p>Abstract of issue:</p> <p>(Dis)Assembly procedure vertical spindle main axle Suspended Looping Coaster.</p>
<p>Reason for release:</p> <p>This service bulletin gives detailed information about (dis)assembling the main axle spindle and rear axle spindle. Also a chapter is added in order to pay extra attention during (dis)assembly of the spindle because a spindle failed during disassembly at one of our customers.</p>
<p>Action to be taken:</p> <p>Add these instructions to your operation and maintenance manual.</p>

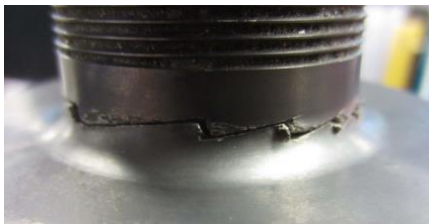
During disassembly of the vertical spindle with article number 3009834 a spindle failed at one of our customers. The spindle in question failed at the location just below the thread of the flange nut on top of the main axle (see figure 3) It is suspected that the failure occurred due to incorrect disassembly of the flange nut (01201-52-2155 with article number 3008526) leading to a torsional overload. Further investigation to the root cause of the failure is still ongoing.

Figure 3: Spindle failure

While the investigation is still ongoing more detailed maintenance instructions are required.

Pay extra attention to this particular connection (for loose nut with stub) during daily inspection.

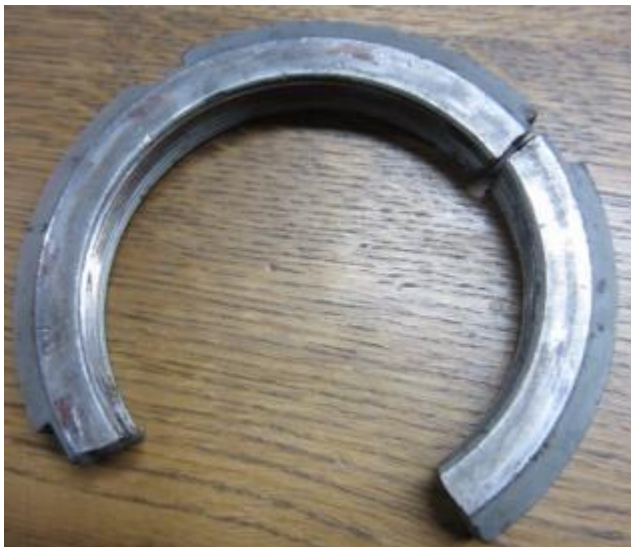
For disassembly of the KM nut at the bottom of the vertical spindle use proper tooling (SKF). Other tooling will damage the KM nuts which result in premature failure. The KM nut will break. See also figure 4.

Figure 5: Broken KM nut due to use of improper tooling (assembly or disassembly)

Always use the correct tools for assembling the locking nuts.

Check the locking nuts for damage and cracks. In case of cracks or other damages the locking nuts must be replaced by new locking nuts.
