Vekoma Boomerang coaster car axle cracking

SAFETY ALERT MESSAGE

Subject : Incident.

Service Bulletin

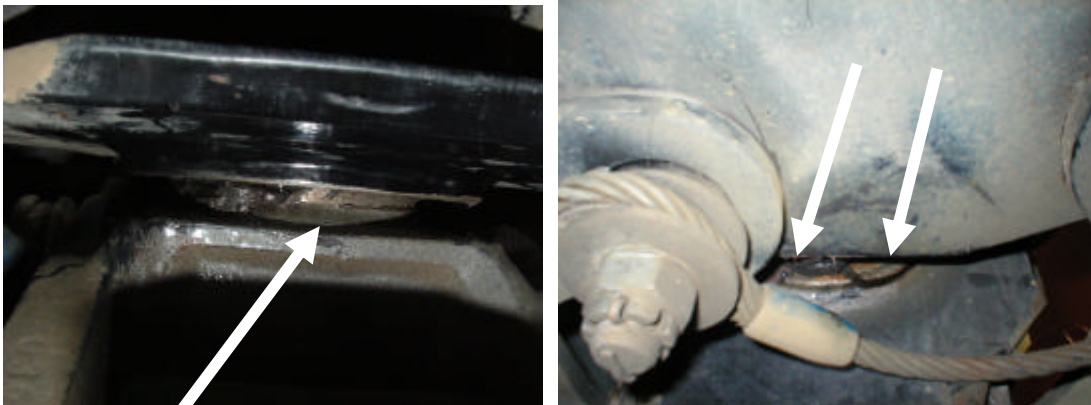
- The picture below shows that the weld itself is visual for inspection.

- Carefully weekly visual inspection as described in the manual to all welds on the axles, with special attention to welds as indicated with arrows on the pictures above and on the drawing below.
- Make sure that the actual paint is brittle, so the paint will crack when the surface below cracks.
- Make sure that the surface is clean and preferable painted in a lighter paint. This makes it easier to see indications.
- When there is any doubt, an additional NDT (UT and ET, or MT) inspection will be needed.
- We strongly recommend performing a major NDT (UT and ET, or MT) examination on these parts during the next winter stop.
- If there are any indications, please contact Vekoma Rides Parts & Services.
Tel.: +31 475 409 222
