448.

Round-Up box section deterioration

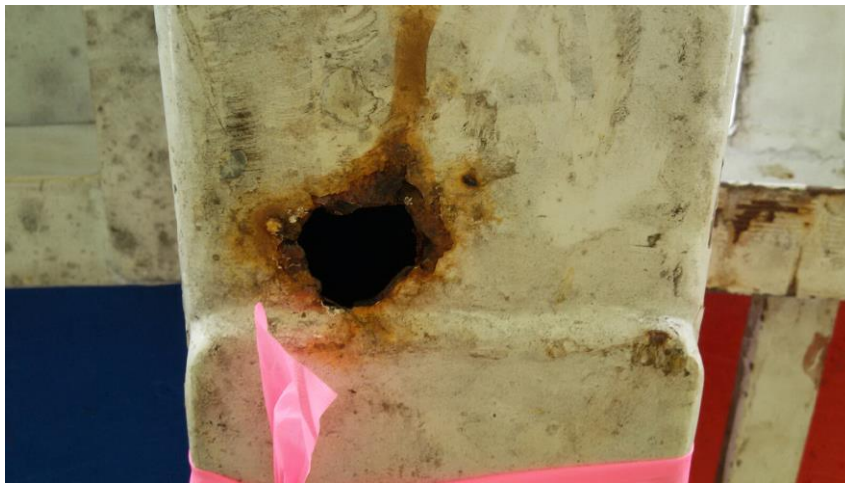
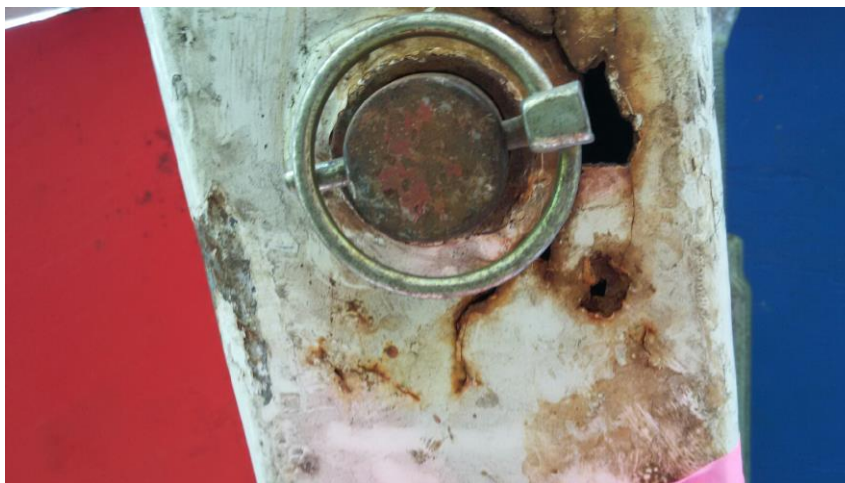
We have received information from the New Hampshire Department of Safety in the US relating to the deterioration of box sections within sections of a Round-Up ride. The accompanying photos show the bottoms of the sweeps where the cage pins are keyed. The name of the manufacturer and the age of the device are unknown.

This serves as a reminder to IBs that box sections on rides are prone to this type of deterioration, where the thickness of sections can reduce, in some cases resulting in damage as shown in the photographs.
