481.

4-in-1 bungee trampolines

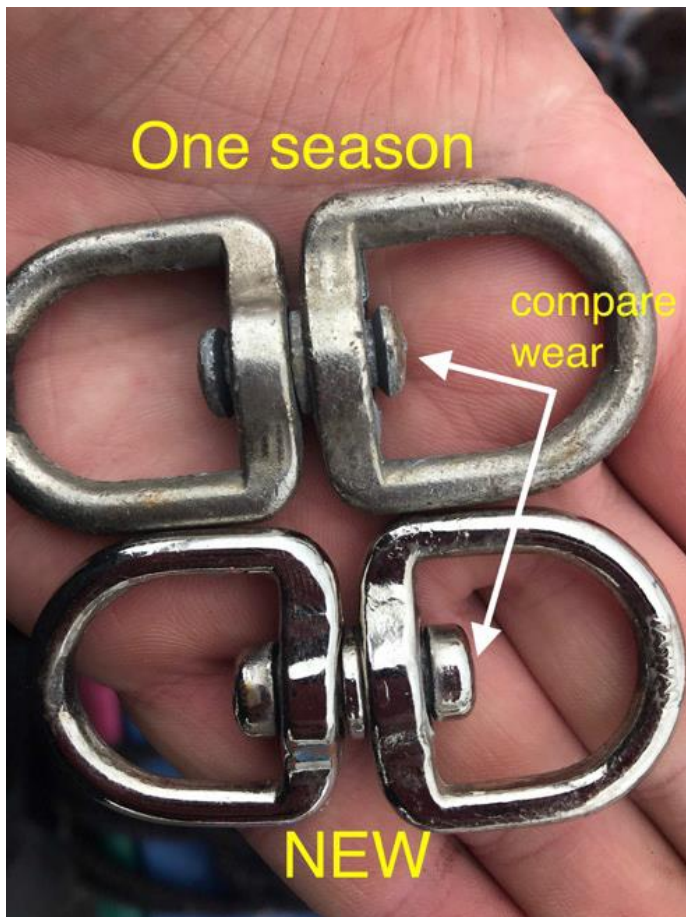
While operators are aware of the need to regularly inspect the ropes, harnesses and bungee cords they should also pay attention to the pulleys and connections. Below is an image of a swivel joint that was one season old and had already worn past its service life. When replacing these components it is advisable to look for CE markings on the replacements and ensure they have been manufactured for the climbing industry and as such meet the requirements for supporting people.

Not all components are made equal and it may be the case that spending a little extra on higher quality components may provide a longer life span and save operators costs in the long term.
