## 503.

# Intamin overhead restraint cracking

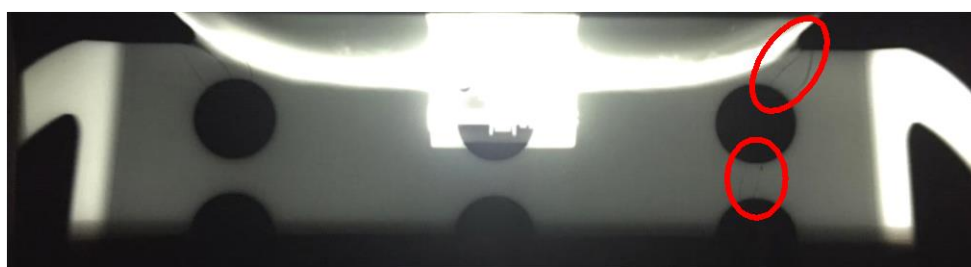
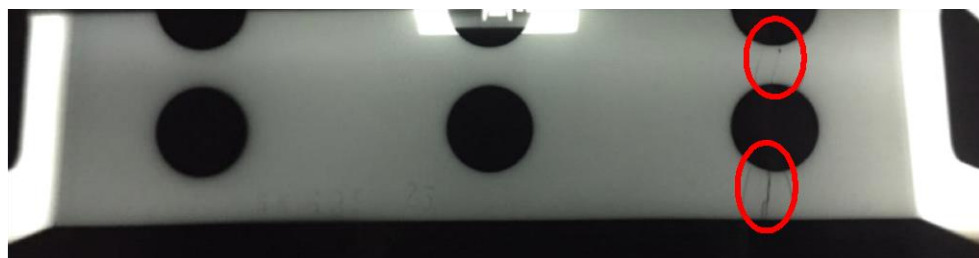
ABDOMINAL REGION SHOWN  
IN RADIOGRAPHS BELOW

Cracks propagate from the edge of the weld at the interface between the steel tube and the plate that wraps around the passengers abdominal region, which form the internal structure of the padded restraint (refer to upper and lower regions of a single restraint radiograph below). It is understood that the manufacturer has revised the restraint design to improve longevity.

Comment(s): Suitable NDT techniques such as radiographic (x-ray) inspection should be performed periodically to identify internal failures on safety critical restraint components, taking note of any stipulations made by the device manufacturer, design reviewer and inspection body. In this example, it was possible to detect completely failed components through increased flexing of the abdominal wrap-around 'wings' of the restraint. However, this is not recommended as a method of in-service inspection as it may accelerate restraint failure.
