515.

Fabbri Ferris Wheel pivot pin failure

NAFLIC has received the following information from a member IB in relation to a Fabbri-built Ferris Wheel. The information may also apply to other similar devices.

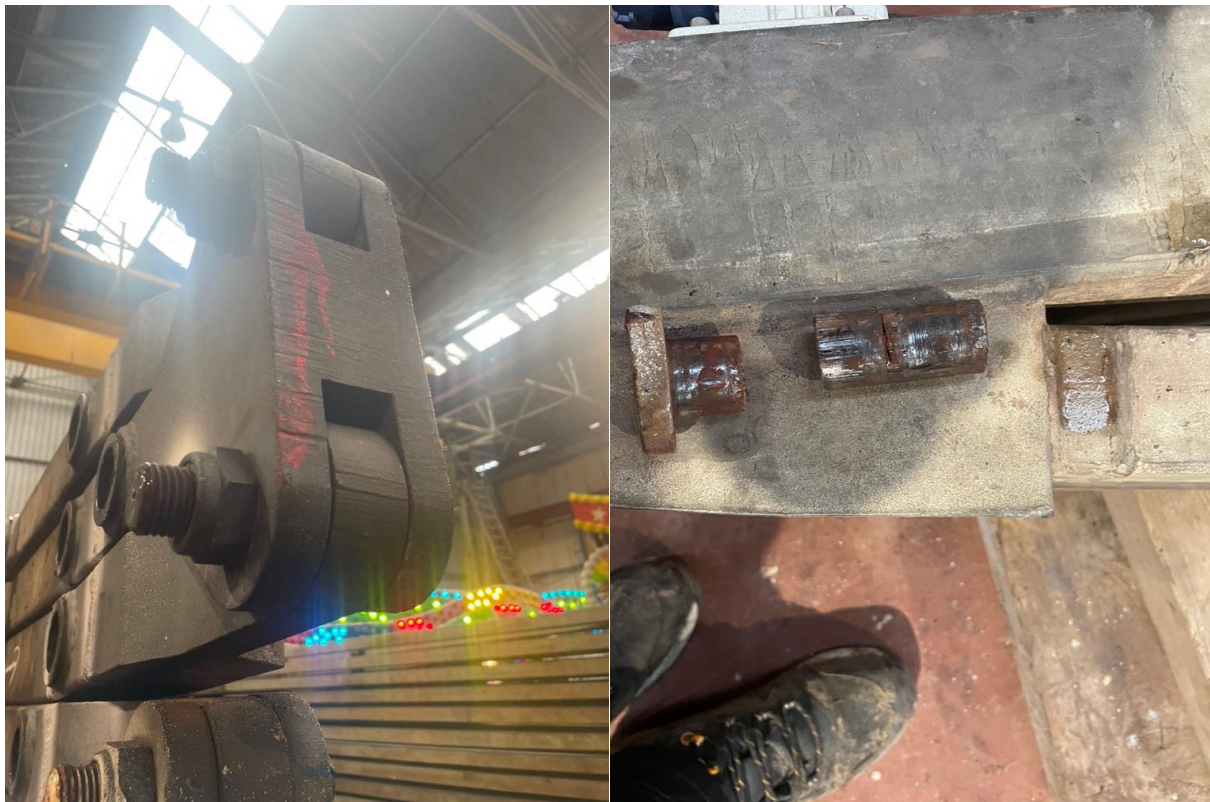
During repair work being carried out on a damaged arm, the removal of a pivot pin was necessary. The removed pin was found to have failed and was split into two halves at the shear point where the pins pass through the arm lug and centre arm retaining bracket. Subsequent ultrasonic inspection was carried out on the remaining arm pivot pins and 17 of the remaining 35 pins inspected were found to have one or two indications, all of which were located at the shear points.

Upon conferring with operators of similar devices the cause would seem to be a lack of lubrication causing the pins to seize. When the arms are pivoted in or out they shear the seized pins due to their weight and large leverage.

Left: one of the arm fixing brackets incorporating two arm pivot pins. Right: a completely sheared pin.

It is suggested that operators and inspectors should consider the need to inspect these pins on a regular basis. Failure of a pin during ride set-up could lead to serious injury.
