518.

SBF-Visa Taxi ride support arm cracking

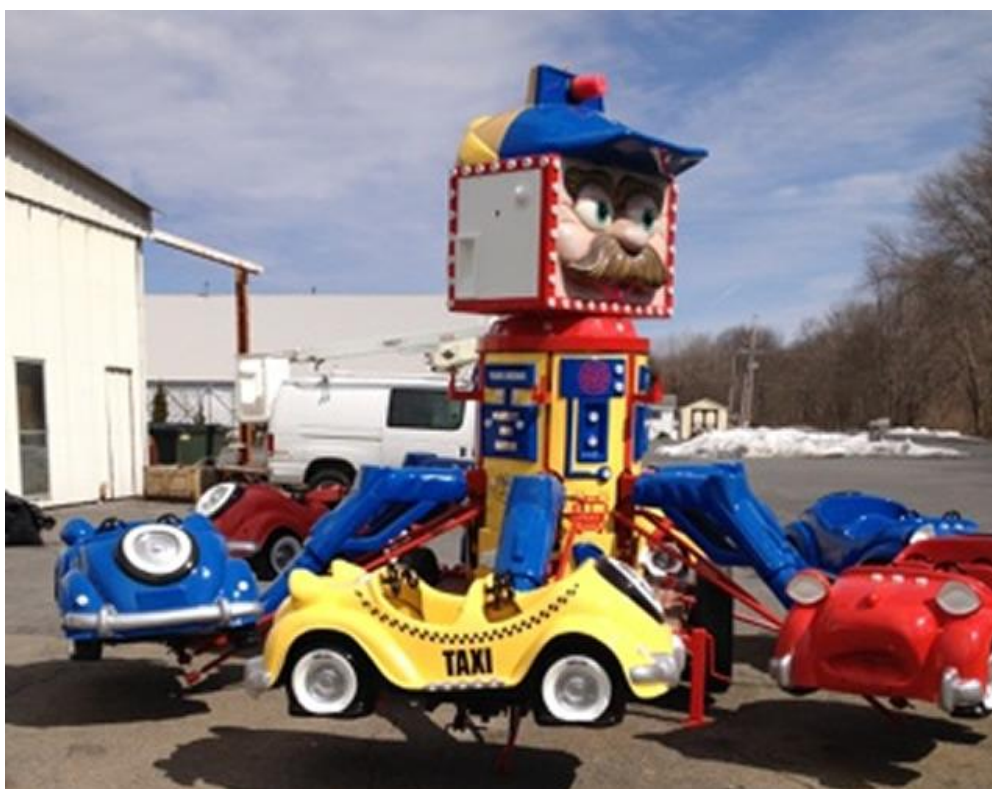
NAFLIC has been informed by a UK inspection body that during the inspection of an SBF-Visa Taxi ride crack indications were found in two of the five support arms ends. The indications are not visible without the aid of MPI. The arms are used to keep the ride gondolas level when the main arms lift. The image below is an example of this ride type.

You can see the support arms in the image above. They are the red bars located under the main blue arms. The cracks were found on both the outside and inside of the arm end Gab, the point where the small levelling arm pins to the bottom of the seating. (See accompanying images on the following page).
