SERVICE LETTER 1 (SER-KR)

Service Bulletin

Ride Manufacturer: Huss Maschinenfabrik
Ride Name: Top Spin
Model Number: All

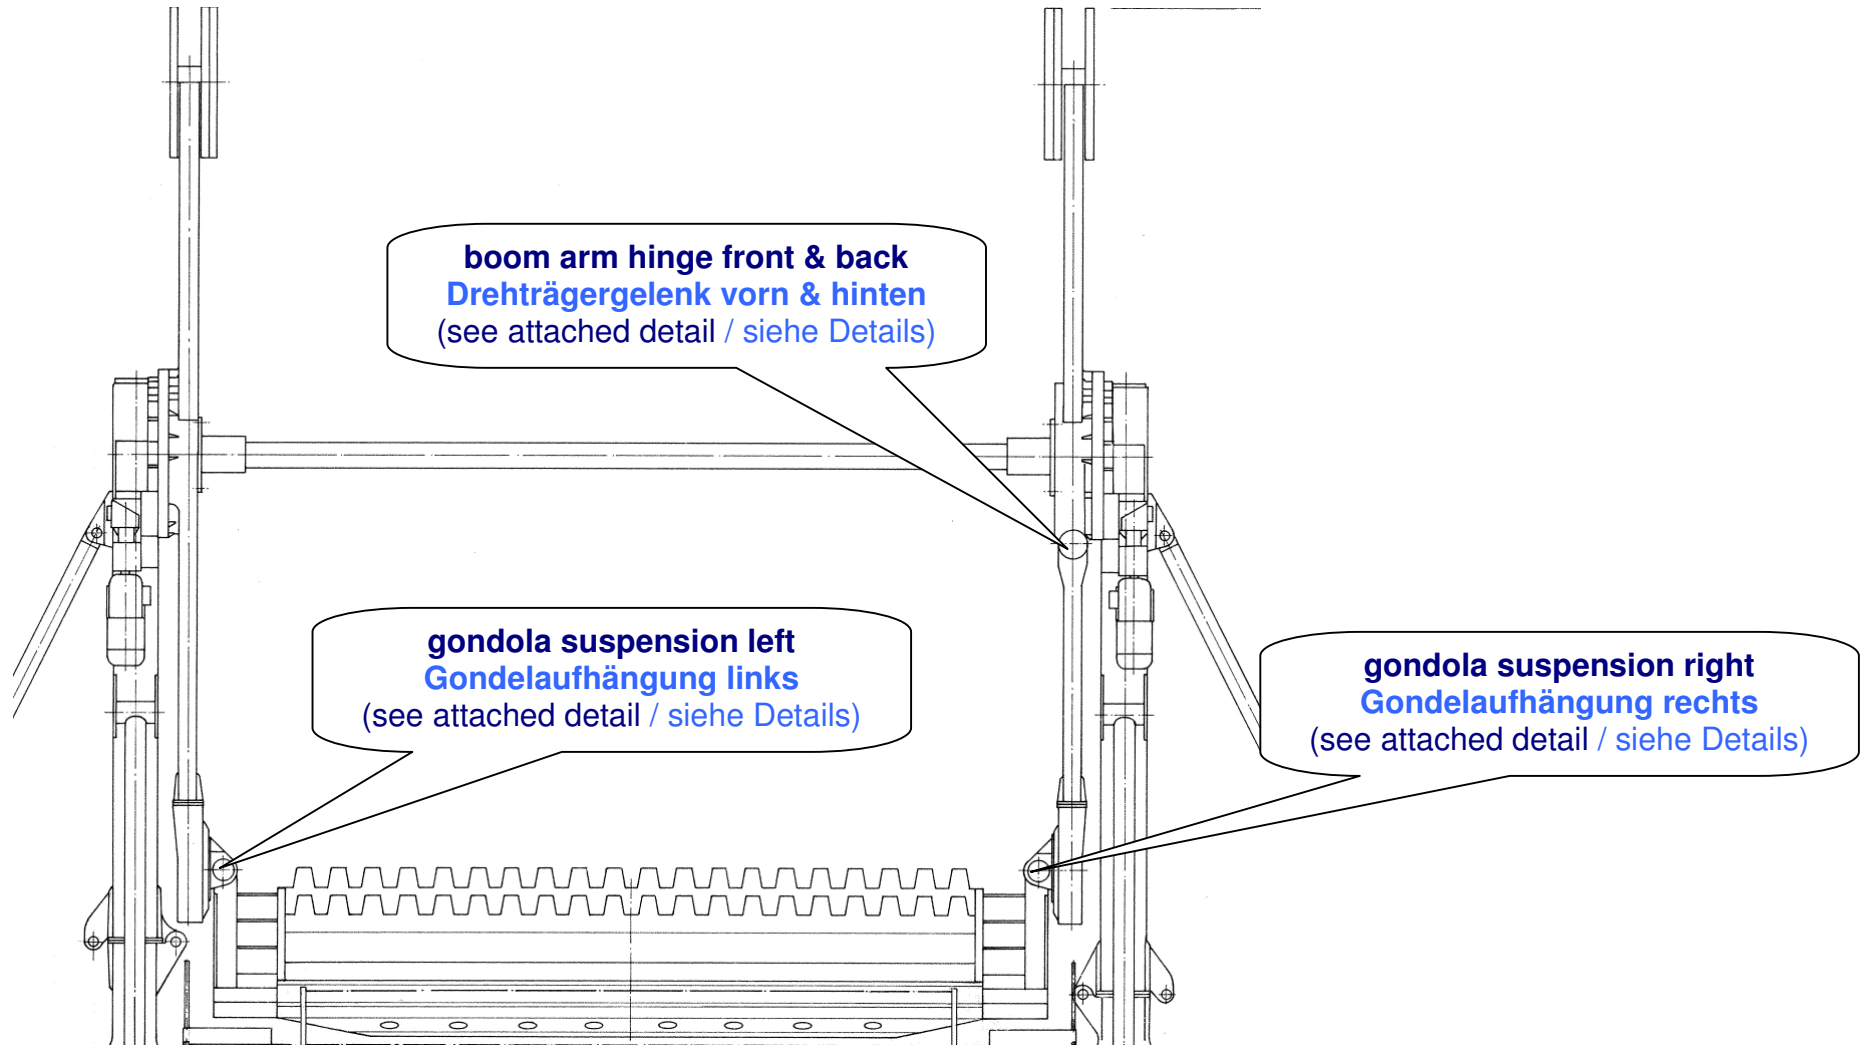
Overview / Übersicht

Based on field data collected from TOP SPIN installations worldwide, we would like you to check your ride for possible wear at the swing arm hinge as well the gondola suspension. The enclosed drawings/pictures shall help identifying the locations where to take the necessary measurements. They can be taken by your personnel or our field service engineers.
