**DATE:** March 2, 1999  
**TO:** CPSC, CARES MEMBERS, NAARSO MEMBERS & Others  
**FROM:** Mike Rinehart, Investigator/Operations & Management Consultant II  
**SUBJECT:** "Rodeo Rider" by S&S Accident of 1/24/99, King Richard's Fun Park

This accident occurred on 1/24/99, at King Richard's Fun Park in Naples, Florida. The ride consists of a tower-boom, permanently mounted on a pad, supporting five fiberglass seats via two 1/4" wire ropes. The ride also comes on a trailer mounting for temporary shows.

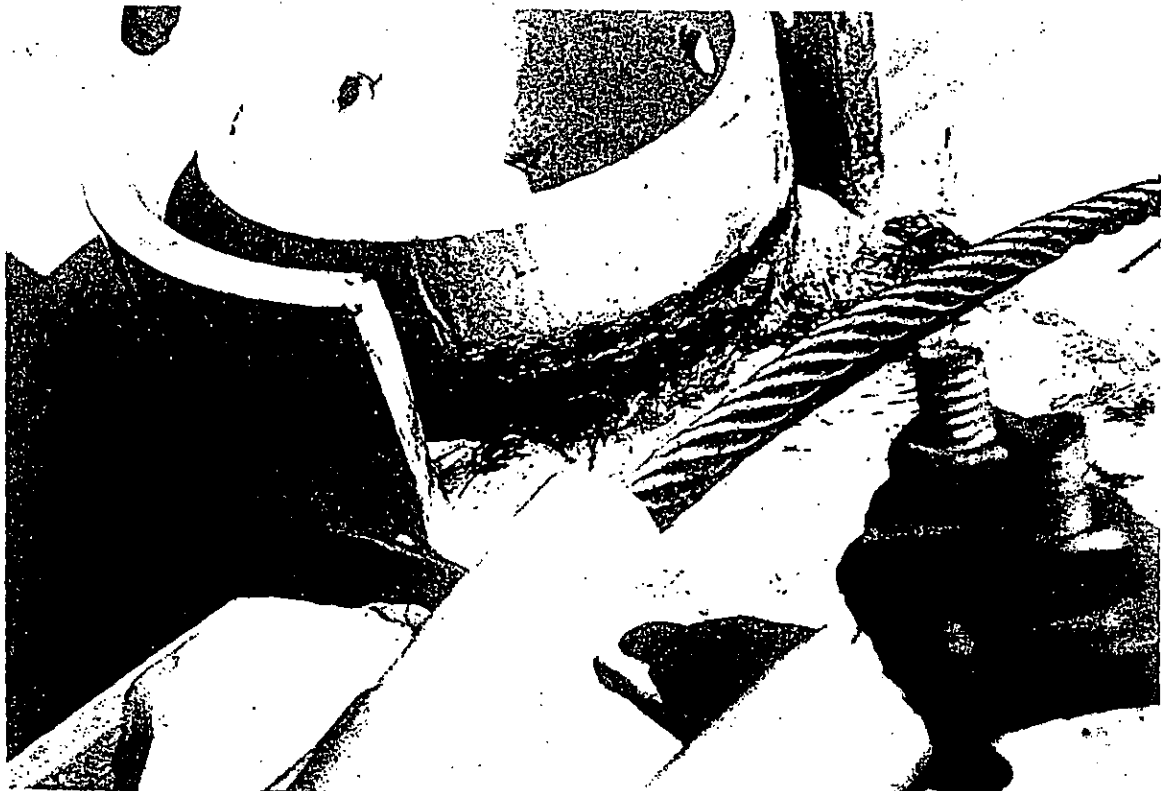
- At the actual failure site more advanced degradation was possibly present due to a wearing action and higher shock loads from ride use.
- The area of the failure at the capstan is difficult to access for inspection and requires removing the ride car itself and removing the wire rope from the capstan.

Photo 22: East cable fracture
