SAFETY BULLETIN

RISE: ORBITER

SUBJECT: CAR ATTACHMENT PINS

BULLETIN NUMBER: 00120

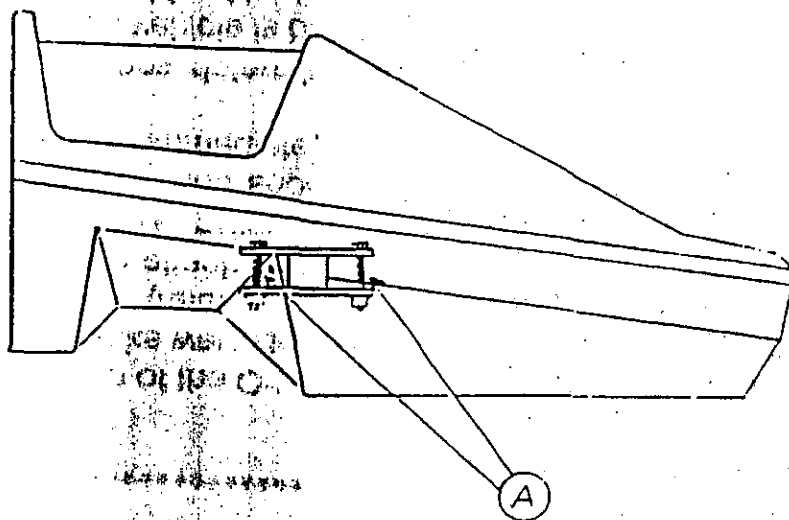
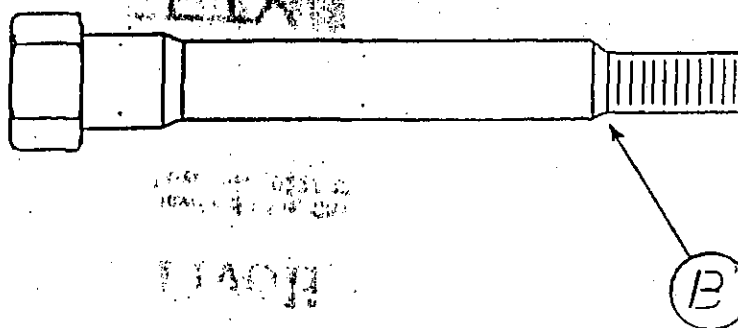
Through routine inspection of the Orbiter Amusement Ride seat attachment pins, (refer to Point A) cracks were detected in the area where the threaded portion meets the pin shaft (refer to Point B). It is recommended by Tivoli Enterprises that these seat attachment pins be inspected by an approved non-destructive testing (NDT) process to determine condition of pins. If cracks are detected, these pins should be replaced immediately. This inspection should be done immediately and then on an annual basis.

After investigation, Tivoli has determined that cracking of pins is due to excessive tightening when vehicle is being attached to sweep. As stated in the manual, these pins should not be tightened in excess of 70 foot pounds. The ride is supplied with an electrical impact wrench which is to be used only to speed the operation of installing and removing these pins. If abused, excessive tightening could damage pins. Use impact wrench to bring pins down until it meets the base metal only.

If it is in owner's or inspector's opinion that use of this impact wrench is being abused by the operator, it is recommended by Tivoli that the electric wrench be replaced with a 3/4" drive ratchet hand wrench.
