CHANCE
MANUFACTURING CO., INC.

Service Information

Ride: TWISTER

Subject: INSTALLATION OF RESTRAINING BELTS

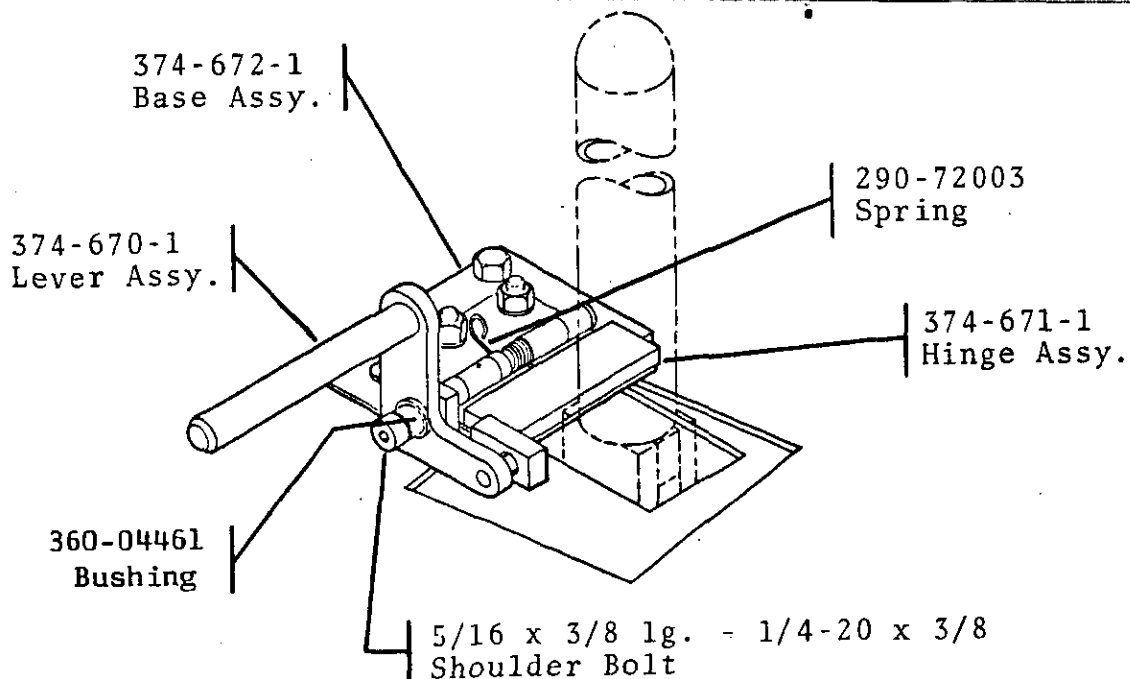
REPLACEMENT PARTS

To adjust handle, loosen the jam nut and adjuster on the control rod underneath the porch. Turn adjuster until Control Handle is vertical and tighten jam nut.

374-610-3 Control Handle Detent Assy.
