NAFLIC

TECHNICAL BULLETIN — June 2016

414. Huss Topple Tower cracking

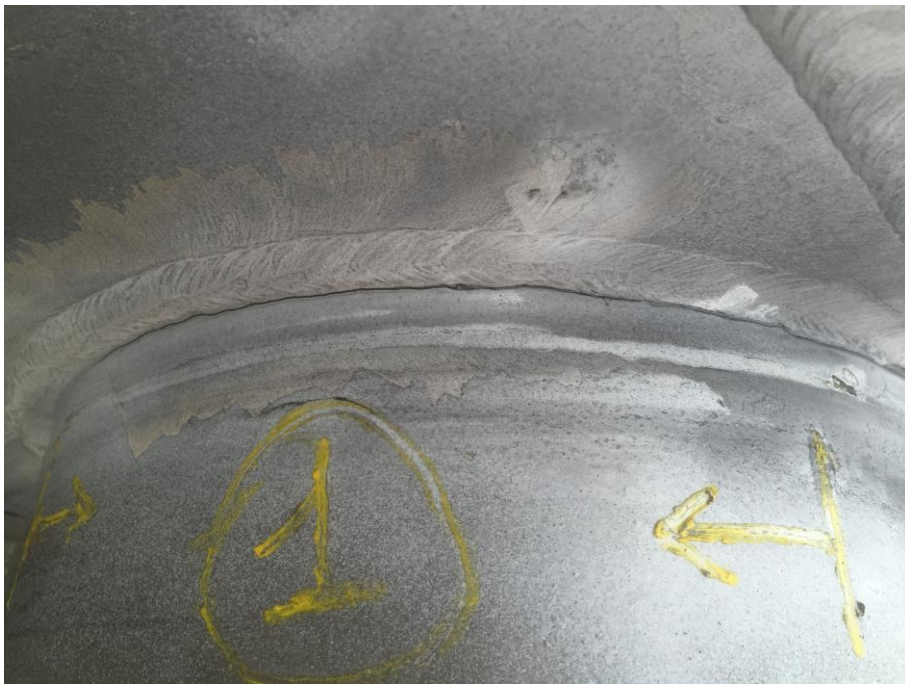
Initial visual inspection indicated cracking to the circumferential weld attaching the stub axle to the pivot block (See Figs. 2 and 3). Subsequent NDT (MPI) revealed two cracks, 1x250mm and 1x300mm (See Figs. 4 and 5).

A repair procedure and NDT schedule is available from Huss.
