SERVICE BULLETIN

To: _____
From: Rich Mascolo
Fax: +1 (732) 842-1114
Company: _____
Voice: +1 (732) 842-9898 235
Subject: MaxFlight Safety Service Bulletin 2000-00
Sent: 4/13/00 at 5:30:00 PM
Pages: 1 (including cover)

Units Affected: All MaxFlight Simulators [VR2000, VR2002, VR2500 and MT3000]

Purpose: To ensure security of both Pitch and Roll Encoders

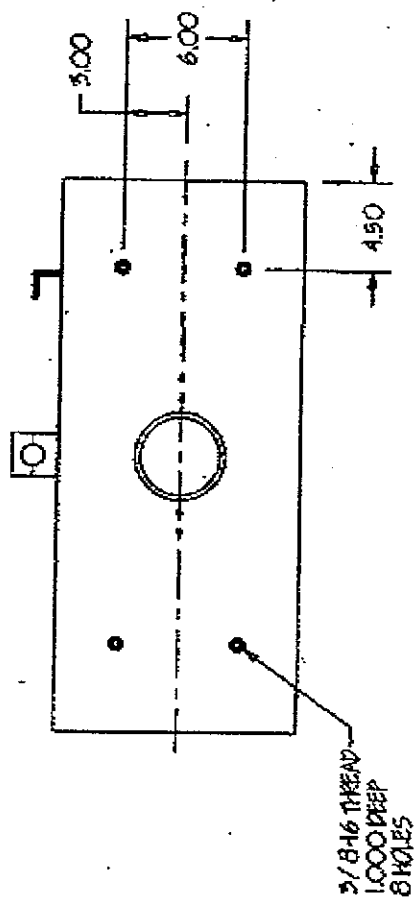
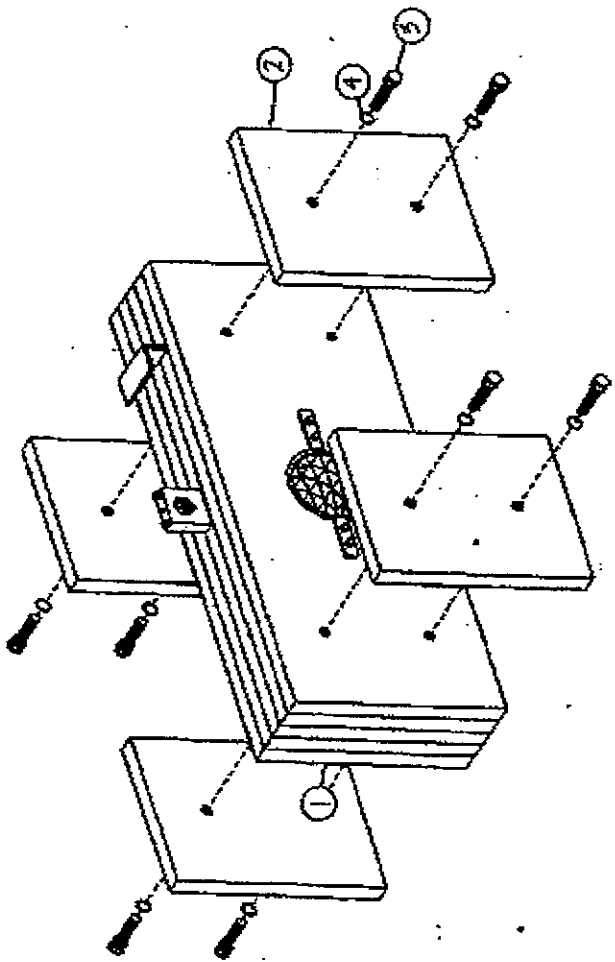
Title: Counterweight Add On Plate Assembly

ITEM	QTY.	DESCRIPTION (PART NO.)
4	8	0070 3/8" Lock Washer
3	8	0080 3/8-16 1/2" AHSI Bolt
2	4	A9-02 Counterweight Add On Plate
1	1	510-005 W2002 Counterweight Assembly
