TECHNICAL BULLETIN — July 2014

378. Zierer Wave Swinger Service Bulletin

Service Bulletin

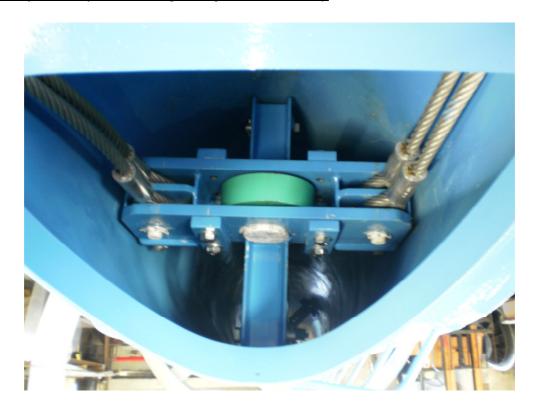
3.2. Hydraulic Cylinder - Safeguarding Guide Cross Top

<u>Lifting Cylinder-safeguarding [top] Zierer Article: HZ020078</u>
2 items of additional fork-safeguardings prevent the cylinder joint head from slipping away in the event of a breakage of the suspension. The fork-safeguardings are installed axially with a set of 4 screws each, and a distance of 138 mm to one another, at the guide cross.

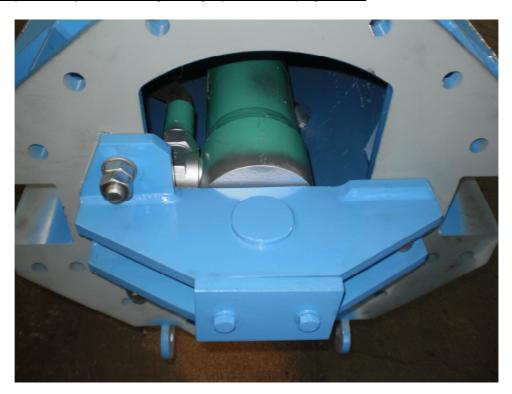
3.3. Hydraulic Cylinder – Safeguarding Cylinder Clamping Bottom

<u>Lifting Cylinder-Safeguarding [bottom] Zierer Article: HZ020079</u>

1 item of additional counter-plate prevents the release of the cylinder clamping in the event of a breakage of the suspension. With this plate, the cylinder is additionally secured. The plate is bolted in the center with 2 screws to the cylinder eye.
