NUMBER: B391R1087-0

SERVICE BULLETIN

Ride: FALLING STAR

Subject: Inspection of Front Sweep Arm

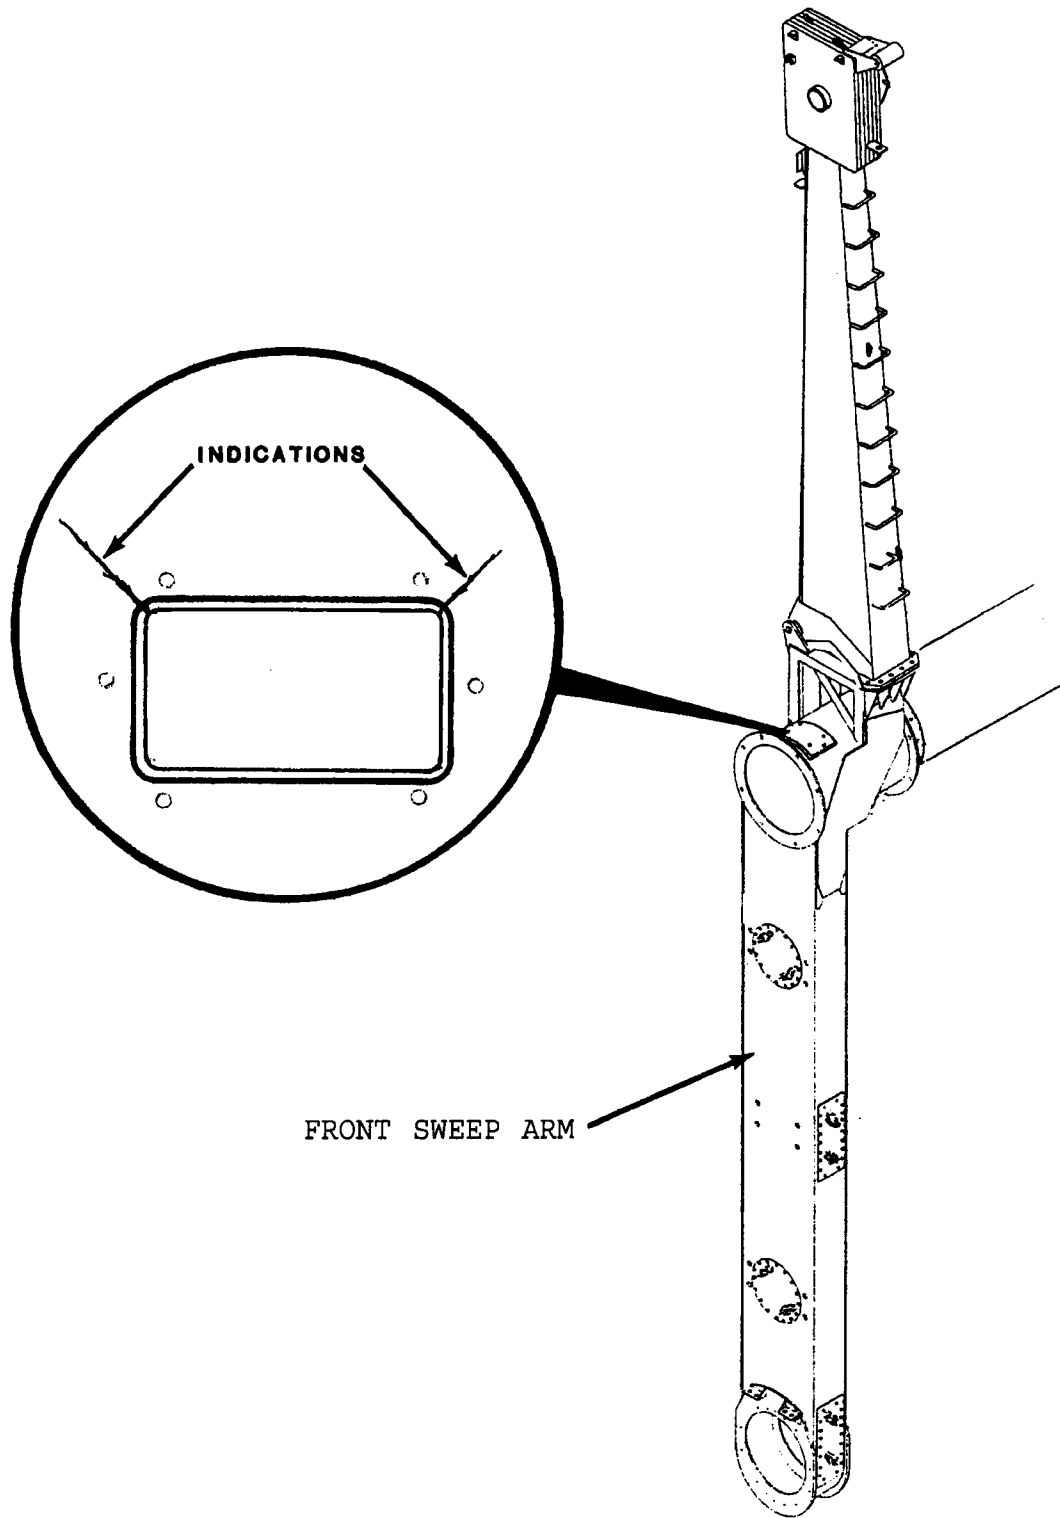
Chance Rides, Inc. has become aware that it is possible for cracks to propagate from the corners of the inspection port which is located at the top of the front sweep arm on the FALLING STAR amusement ride. Chance Rides, Inc. requires all owners/operators to perform the following inspection at each set-up, or weekly, whichever occurs first.

1. Remove the cover from the inspection port.
2. Visually inspect around all four corners.
3. Using an inspection mirror and a flashlight, inspect around the inside of all four corners.
4. If any cracks are found, DO NOT ATTEMPT TO WELD OR REPAIR THE RIDE, contact Chance Rides Customer Service immediately. DO, NOT OPERATE THE RIDE UNTIL CHANCE RIDES CUSTOMER SERVICE HAS BEEN NOTIFIED AND THE APPROVED REWORK COMPLETED.
