Bulletin No:	B414R1215-0		
Release Date:	July 30,	1999	
Effective Date:	July 30,	1999	
Supersedes:		N/A

INVERTER (Portable Model)

414

Inspection and Replacement of Secondary Restraint Bar (T-Bar) Closeout Panels

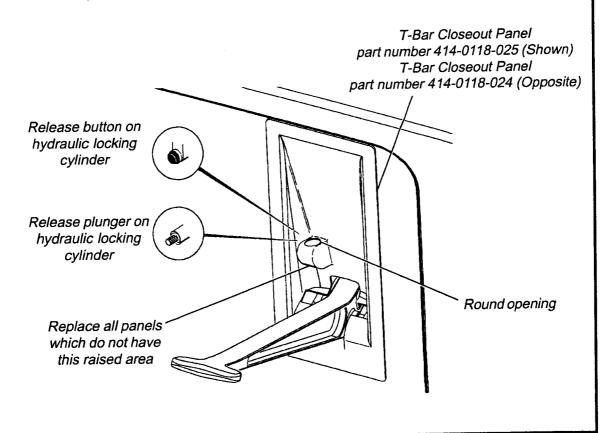
Inspect all T-bar closeout panels (8 right hand panels and 8 left hand panels) for raised area over manual release on hydraulic locking cylinder. Replace all panels which do not have this raised area.

NOTE: For hydraulic locking cylinders with release plunger, the closeout panel must have openings in both the top and bottom of the raised area. Replace the panels with the parts shown below as required, or rework by cutting a 1-1/8" diameter hole in the bottom of the raised area.
