August 9, 2007

To: Pharoah's Fury Owners

RE: Internal Lap Bar Corrosion – Rev.2

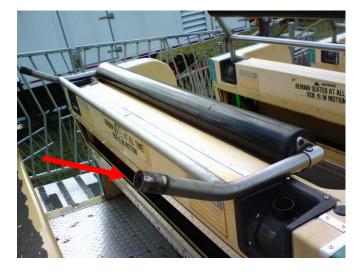
A recent inspection revealed severe corrosion of the bolts holding the lap bars to the frame of the Chance Pharoah's Fury. This was detected after an inspector noted excessive play in the restraint when the device was in the "locked" position. The corrosion of the bolts was not easily seen and the extent of the corrosion was not recognized until the bolts were removed and examined.

You are directed to immediately inspect all the bolts that connect each lap bar to the frame (as shown) and to replace the bolts as necessary. The required bolts are grade 5, 3/8"-16 x 2 $\frac{3}{4}$ " with lock washers.

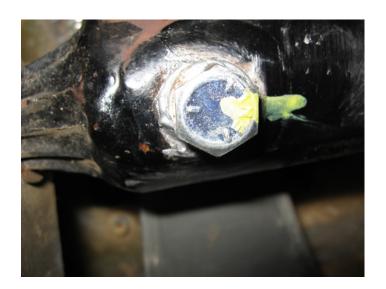
The bolts are not easy to view. You must remove the fiberglass panel and look up at the bolt, as shown in the photo on the next page (courtesy of Rockwell Amusements). The bolts screw up into the center of the restraint. The initial photo did not make this clear.
