NUMBER: B402R1104-0

SERVICE BULLETIN

Ride: WIPEOUT

Subject: Ball Stud Recall

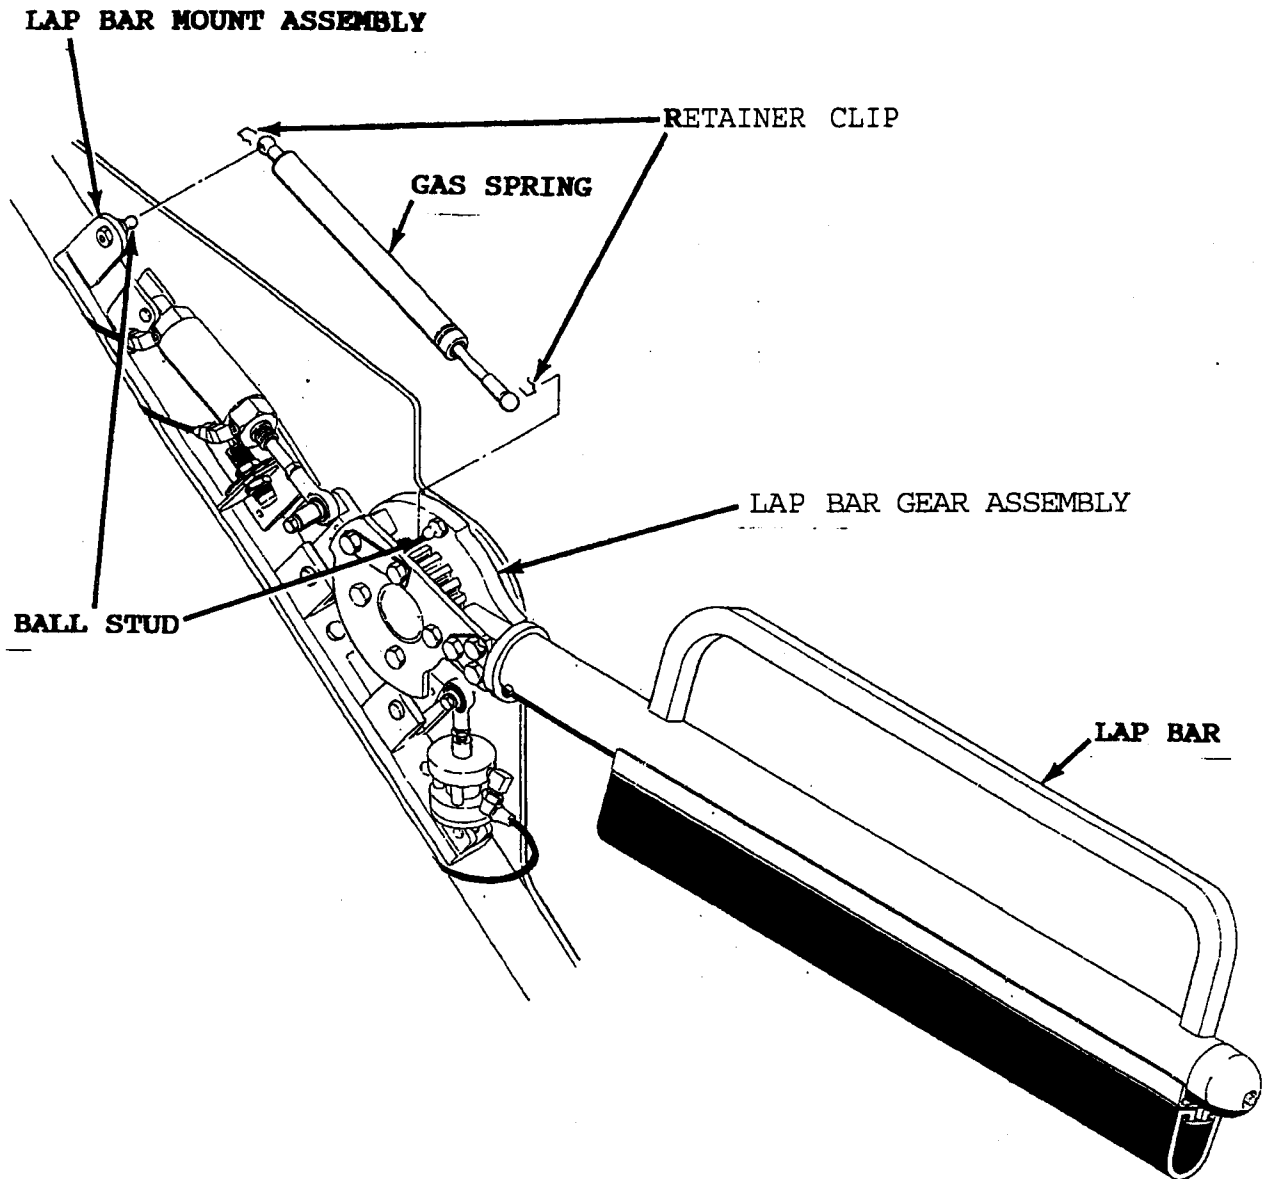
Chance Rides, Inc. has become aware that some parts not adequate for their intended use were received and possibly used on some WIPEOUT amusement rides. These parts are the ball studs holding the gas springs in place on the lap bars. If a ball stud breaks the lap bar can fall to the closed position, causing possible injury to passengers.

Ball Stud Replacement Procedures:

Install the 40 ball studs, 2 per lap bar, part number 27536300 as shown in this bulletin. To receive credit for ball studs shipped with this bulletin return the completed Certification Of Compliance and the old ball studs within fifteen (15) days from receipt of bulletin.

1. Access lap bar locking mechanism by removing countertop panel.
2. Remove retainer clip from each end of gas spring.
3. Remove the gas spring from the ball studs.
4. Unscrew one ball stud from the lap bar gear assembly and one from the lap bar mount assembly.
5. Using the new ball studs, reverse the above procedure.
