TECHNICAL BULLETIN — October 2015

397. Huss service bulletin – Top Spin type rides

SERVICE LETTER No. 25-15

Ref.: Top Spin of serial number 69994

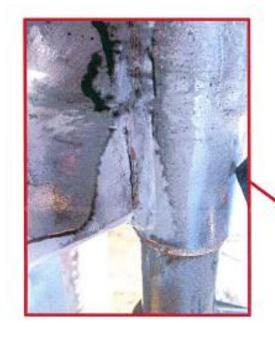
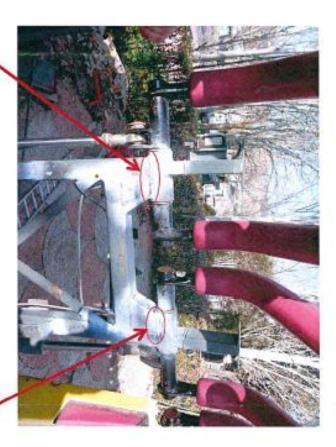
Huss has issued a service bulletin reporting cracking at the mounting points for the overhead restraints on Top Spin type rides. The cracks were detected during maintenance works on a similar ride to a Top Spin in the area of the shoulder restraint support. Related pictures are attached.

While maintenance works at a similar ride of the type Top Spin, cracks in the area of the shoulder restraint support have been detected.

Related pictures are attached.

The manufacturer 'strongly recommends' the area in question be inspected by a certified inspection company.

To ensure the safety of your passengers, we strongly recommend to get the area in question inspected by a certified inspection company.
