TECHNICAL BULLETIN — October 2015

## 399. Nottingham UK Miami Trip defect

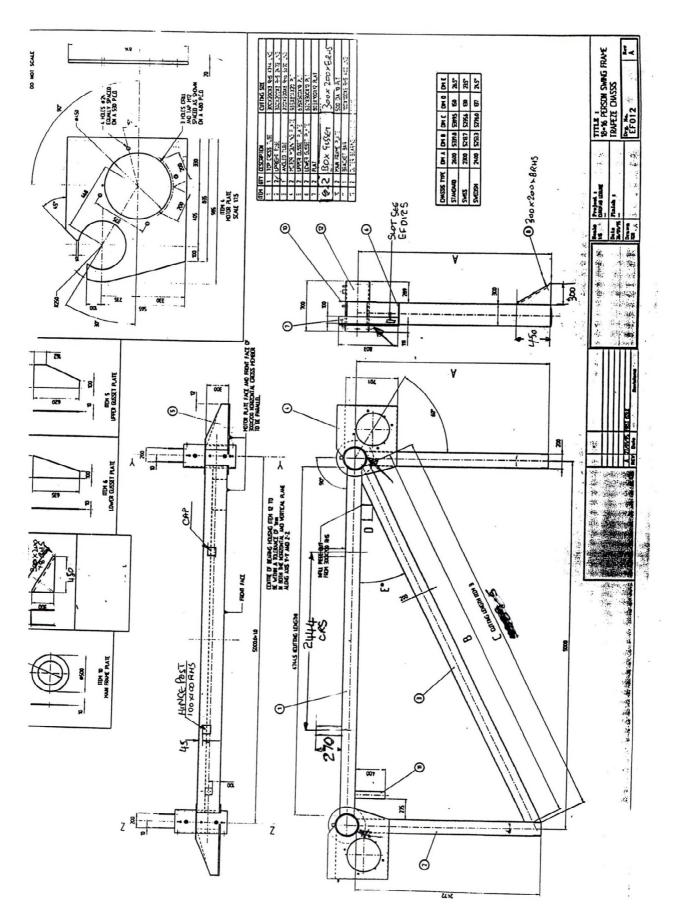
A defect has been identified on a Nottingham UK Miami Trip of around 10 years old. A crack has formed at the weld between the bearing housing and the hydraulic motor mounting plate. This is believed to be a 'one off' incident and it is understood that the ride's use may be heavier than the normal use expected for this type of device. Operators and IBs are reminded to inspect this area carefully.
