FAR Fabbri Booster bearing screw heads

NAFLIC has received a technical bulletin issued by Dr. Eng Alberto Fabbri based in Bergantino, Rovigo, Italy, relating to the discovery of worn screw heads on a FAR Fabbri-built Booster 40/8 ride.

Technical Bulletin

Date: 19 February 2020
Contact: alberto@fabbrirides.com

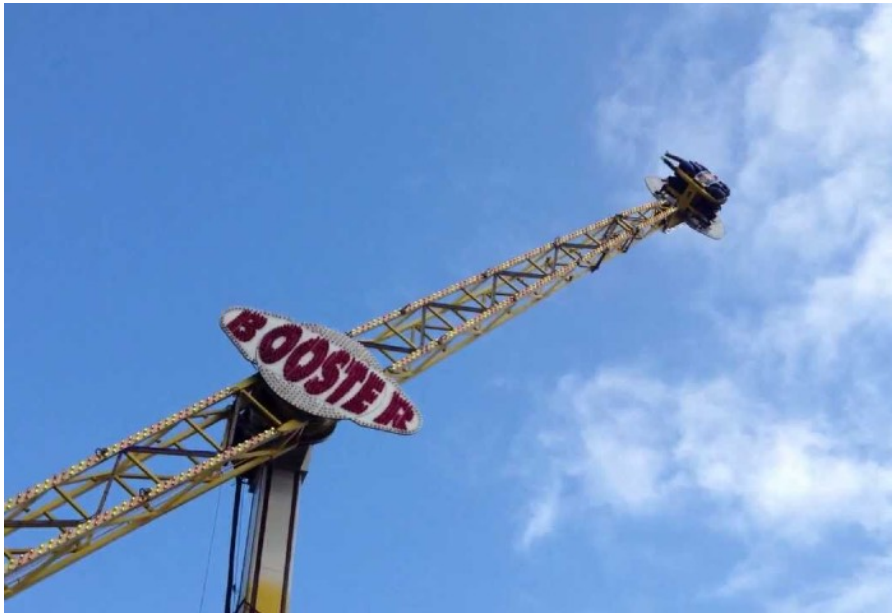
[Note: This image is only for reference]

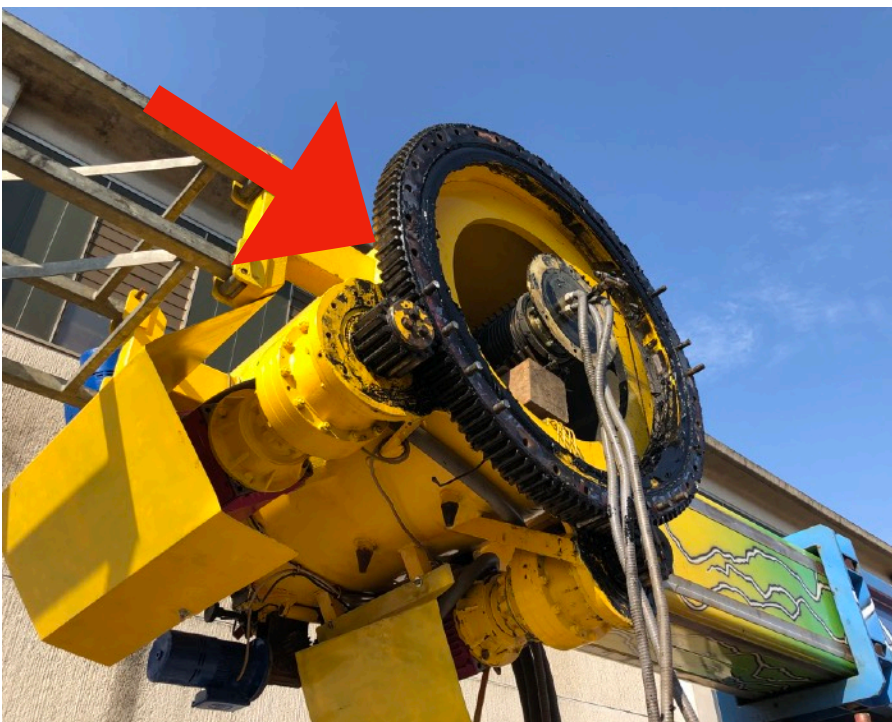
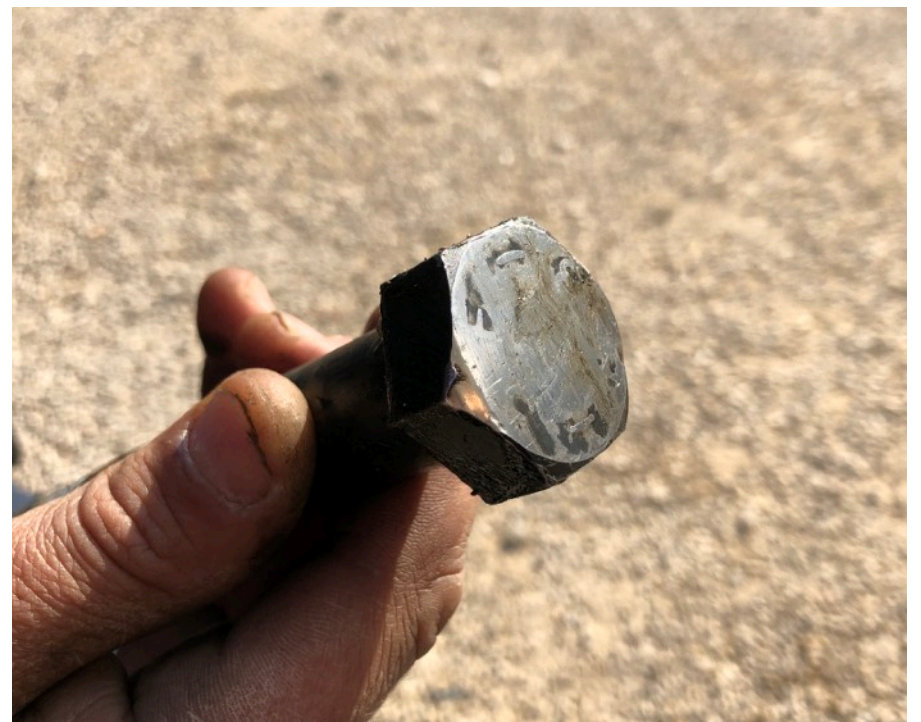
In a BOOSTER 40/8 attraction, originally built by FAR Fabbri (Italy) in the year 2002, we found that the heads of the screws that secure the bearing were worn as a consequence of the excessive play of the bearing which therefore needs to be replaced.
