## FAR Fabbri Booster fatigue cracks

# Technical Bulletin

**Issued by:** Dr. Eng Alberto FABBRI  
Based in 45032 Bergantino RO - Italy  
(Emesso da / Faite par / Hecho por)

**Date:** 20 February 2020  
**Contact:** [alberto@fabbrirides.com](mailto:alberto@fabbrirides.com)

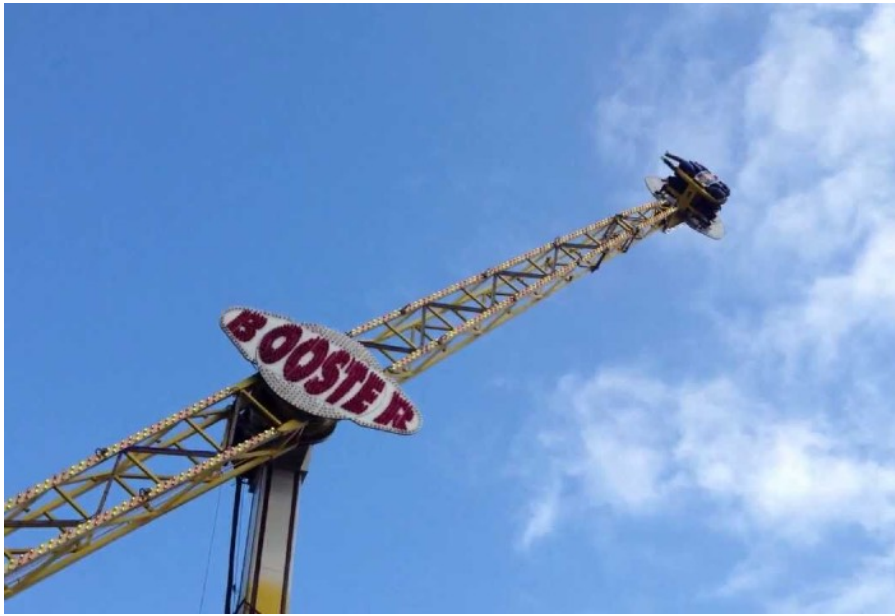
[Note: This image is only for reference]

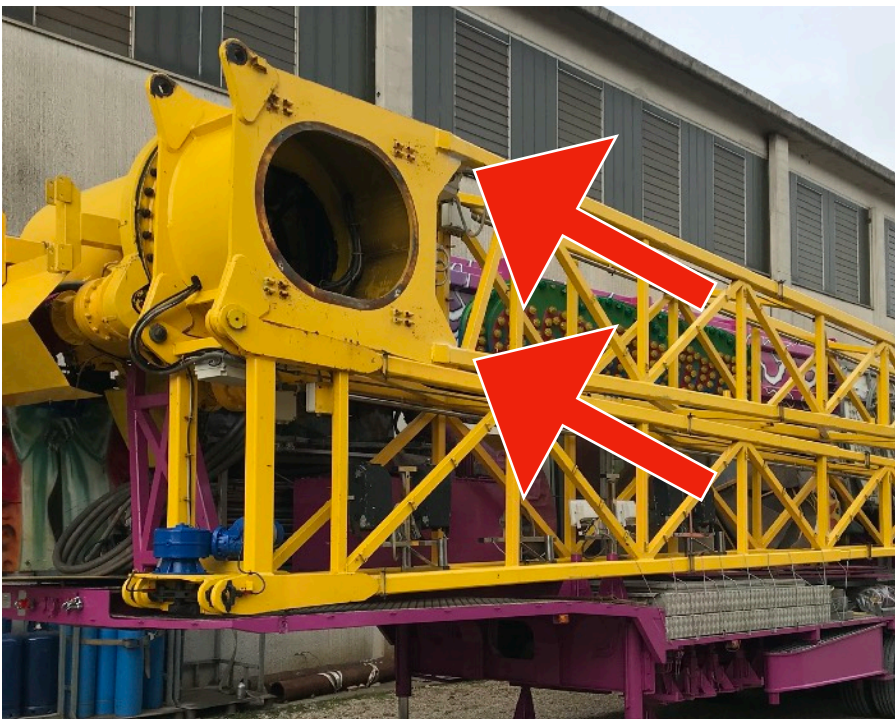
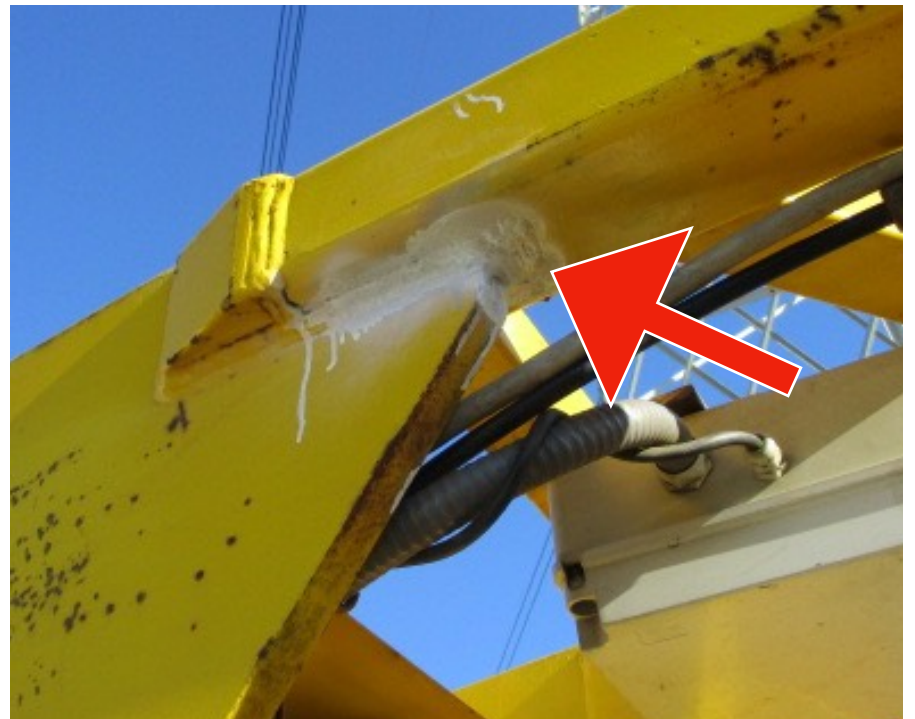
In a BOOSTER 40/8 attraction, originally built by FAR Fabbri (Italy) in 2002, we found fatigue cracks on the fixed arms at the points indicated that need repair and reinforcement to reduce tension.
